EddyMax™ Tube Inspection

Items Inspected: Inlet Heater

Inspection Method: Eddy Current Tube Inspection

Type of Report: Final Report

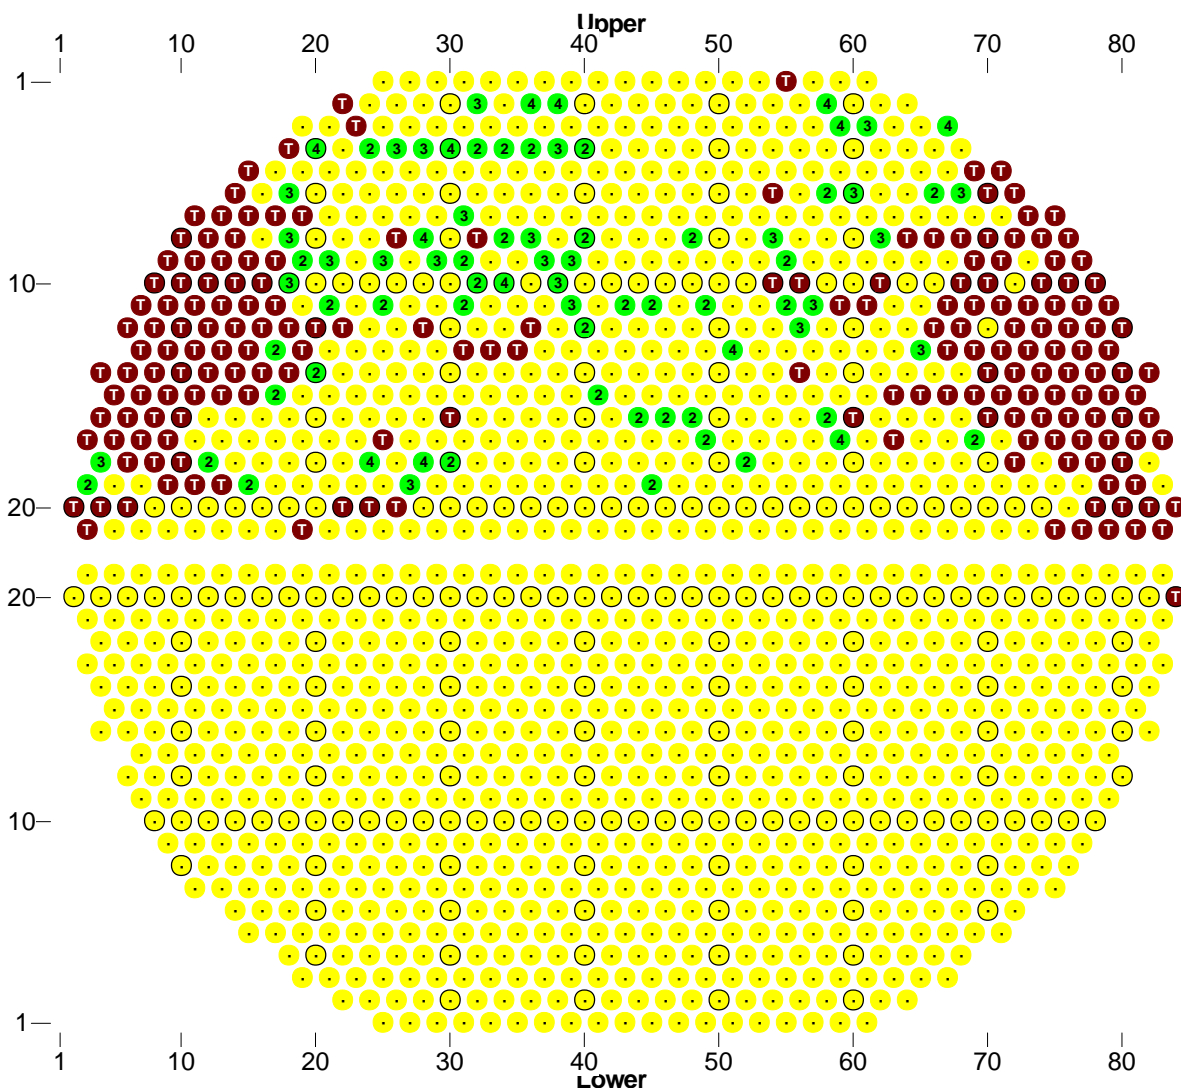
Abbot Inlet Heater
Defect Picture
final result - Diff/Abs

This diagram shows an overview of the whole tubesheet, with the inspection results indicated for each tube examined. The largest indication analysed in a particular tube, is highlighted by a number referencing to the below wall loss legend. For example where a “6” appears, an indication with a depth in the range of 60% to 69% of the tube wall thickness was the largest indication located in that particular tube. Furthermore circles represent internal indications, where squares represent external indications.

The outlet tubes were noted to have suffered the most significant wall loss:-

38 tubes with 20-29% Internal Pitting
 26 tubes with 30-39% Internal Pitting
 13 tubes with 40-49% Internal Pitting

Although these tubes had been cleaned within the unit, hydrocarbon build had not been successfully removed causing many tubes to disrupt successful passage of the bobbin probe.

The Multiple Frequency Eddy Current Tube inspection indicated 77 total tubes, where internal pitting was detected.

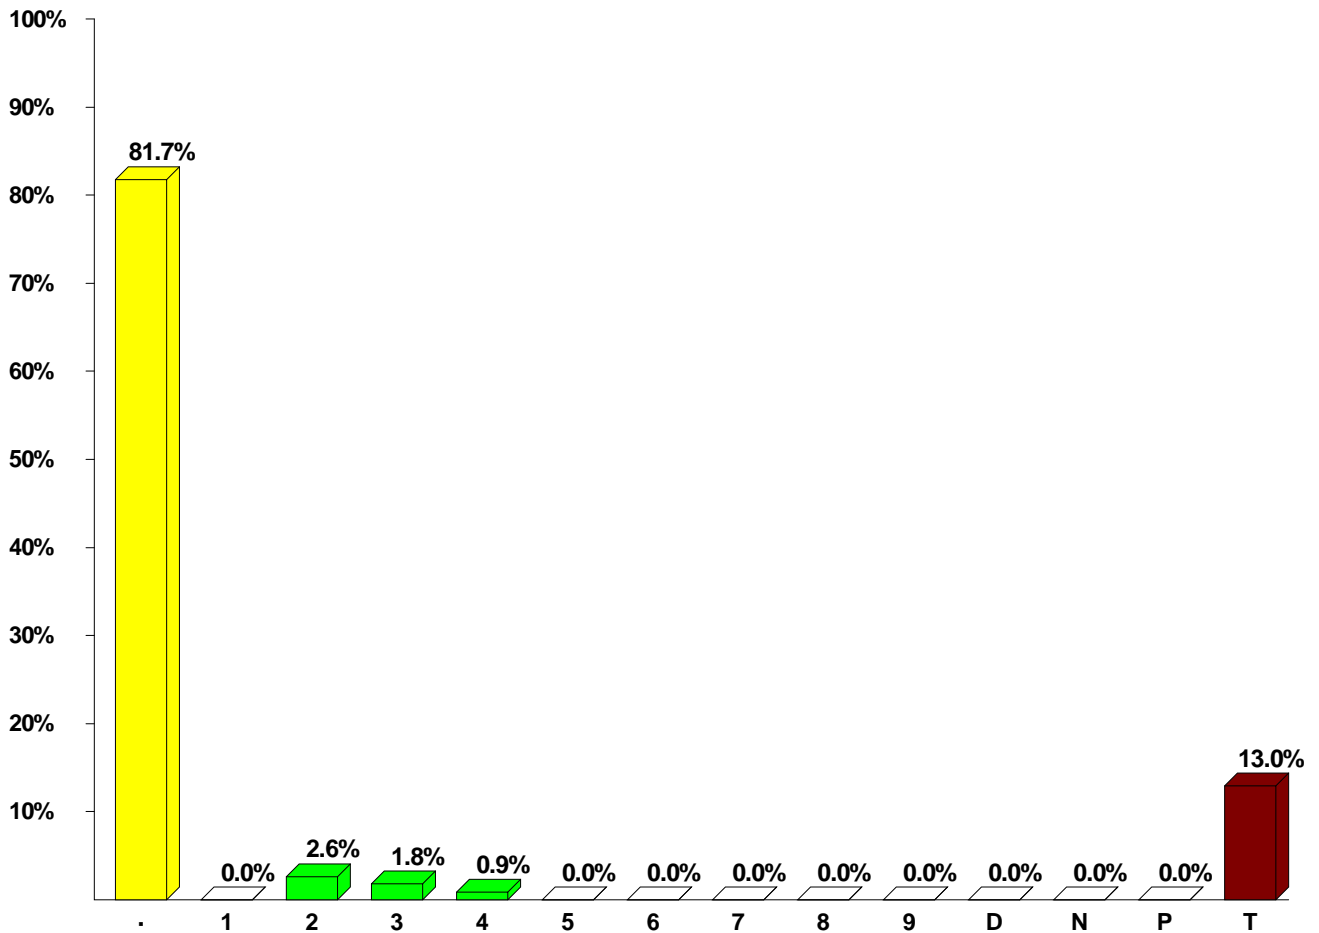
**Abbot Inlet Heater - Statistic
final result - Diff/Abs - all section
(100% = all legs)**

Total number of tubes	: 1450
Total number of tubes inspected	: 1450
Total number of tubes with no through pass	: 188
Number of tubes with existing plus	: 0
Number of tubes with indication other than defects	: 0

10% - 19% internal wall loss	: 0 tubes
20% - 29% internal wall loss	: 38 tubes
30% - 39% internal wall loss	: 26 tubes
40% - 49% internal wall loss	: 13 tubes
50% - 59% internal wall loss	: 0 tubes
60% - 69% internal wall loss	: 0 tubes
70% - 79% internal wall loss	: 0 tubes
80% - 89% internal wall loss	: 0 tubes
90% - 100% internal wall loss	: 0 tubes

[1] : all legs	1450			
[2] : all legs with indication	265		18.3% from [1]	
[3] : all inspected legs	1450		100.0% from [1]	
internal defects	number	% [1]	% [2]	% [3]
① 10 % - 19 %	0	0.0	0.0	0.0
② 20 % - 29 %	38	2.6	14.3	2.6
③ 30 % - 39 %	26	1.8	9.8	1.8
④ 40 % - 49 %	13	0.9	4.9	0.9
⑤ 50 % - 59 %	0	0.0	0.0	0.0
⑥ 60 % - 69 %	0	0.0	0.0	0.0
⑦ 70 % - 79 %	0	0.0	0.0	0.0
⑧ 80 % - 89 %	0	0.0	0.0	0.0
⑨ 90 % - 100 %	0	0.0	0.0	0.0
external defects	number	% [1]	% [2]	% [3]
① 10 % - 19 %	0	0.0	0.0	0.0
② 20 % - 29 %	0	0.0	0.0	0.0
③ 30 % - 39 %	0	0.0	0.0	0.0
④ 40 % - 49 %	0	0.0	0.0	0.0
⑤ 50 % - 59 %	0	0.0	0.0	0.0
⑥ 60 % - 69 %	0	0.0	0.0	0.0
⑦ 70 % - 79 %	0	0.0	0.0	0.0
⑧ 80 % - 89 %	0	0.0	0.0	0.0
⑨ 90 % - 100 %	0	0.0	0.0	0.0
	number	% [1]	% [2]	% [3]
● No Defect	1185	81.7		81.7
○ Dent	0	0.0	0.0	0.0
○ Not Decideable	0	0.0	0.0	0.0
⊗ No Throughpass of Probe	188	13.0	70.9	13.0
⊙ Existing Plug(s)	0	0.0		
○ Tube Not To Be Inspected	0	0.0		
● Tube To Be Inspected	0	0.0
