MEC (Extended SLOFEC) and UT Caisson Inspection Report

Client	Client
Facility	Platform xx
Items Inspected	Open Drain Caisson x
Inspection Method	MEC (Extended SLOFEC and UT
Date Commenced	19th April 2014
Date Completed	20th April 2014
Type of Report	Final
Report Number	K xxxx

EXTERNAL CAISSON INSPECTION REPORT

Final Report: Kxxx Rev 0

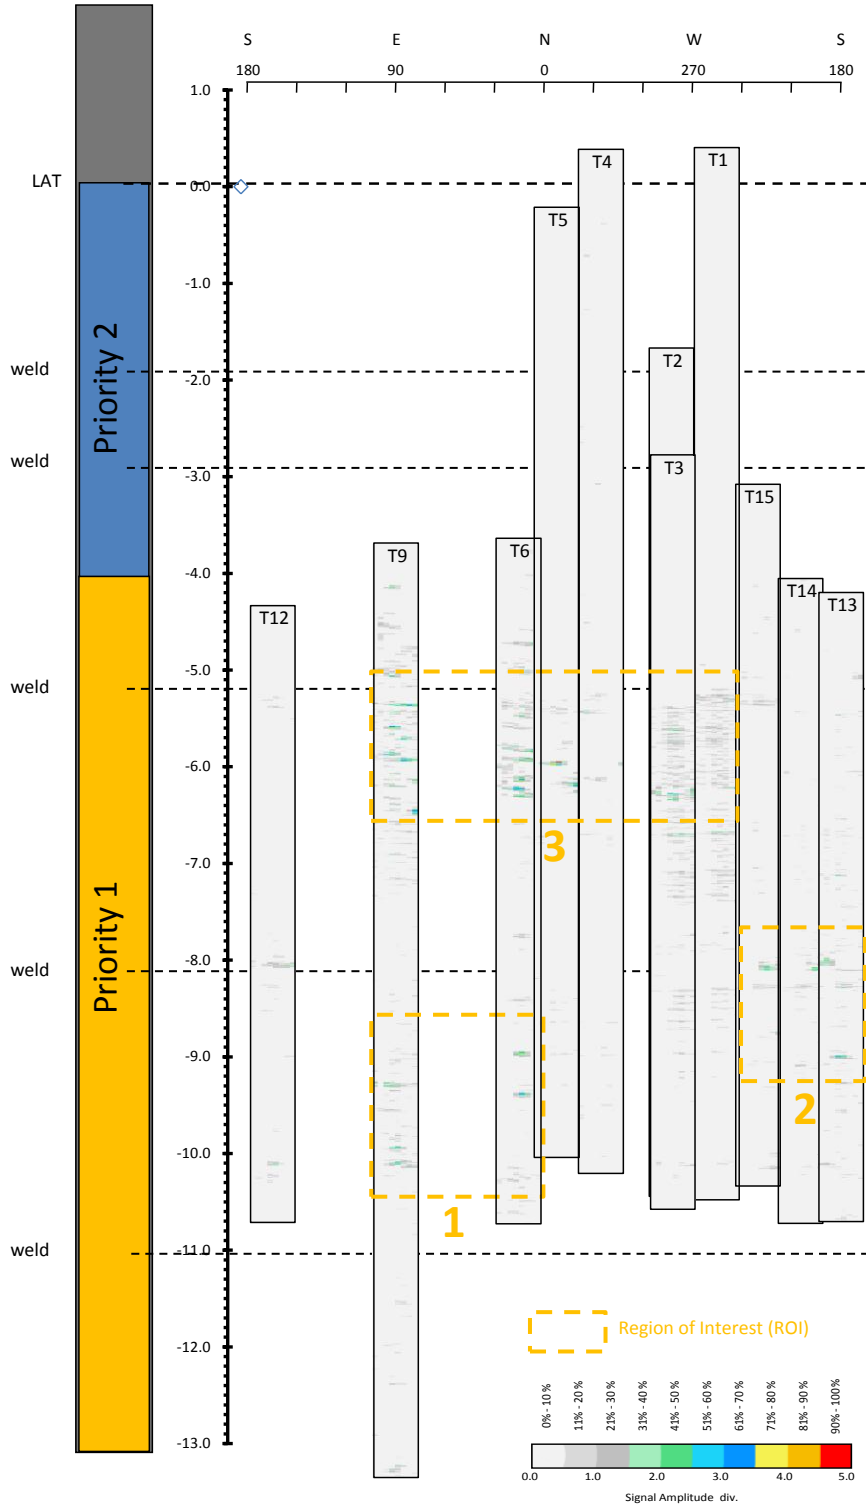
3.1. Scan Results and Track Position Overview (internal corrosion)

Several severe indications of internal metal loss have been found. They are isolated pitting type indications. The wall thickness in between these indications seems to be unaffected. The typical size of these indications is in the region of 20-30 mm with wall loss readings in the order of 60% - 90%. None of them seems to have grown through the surface. However, the depth of the deepest of these indications seems to be close to a through hole.

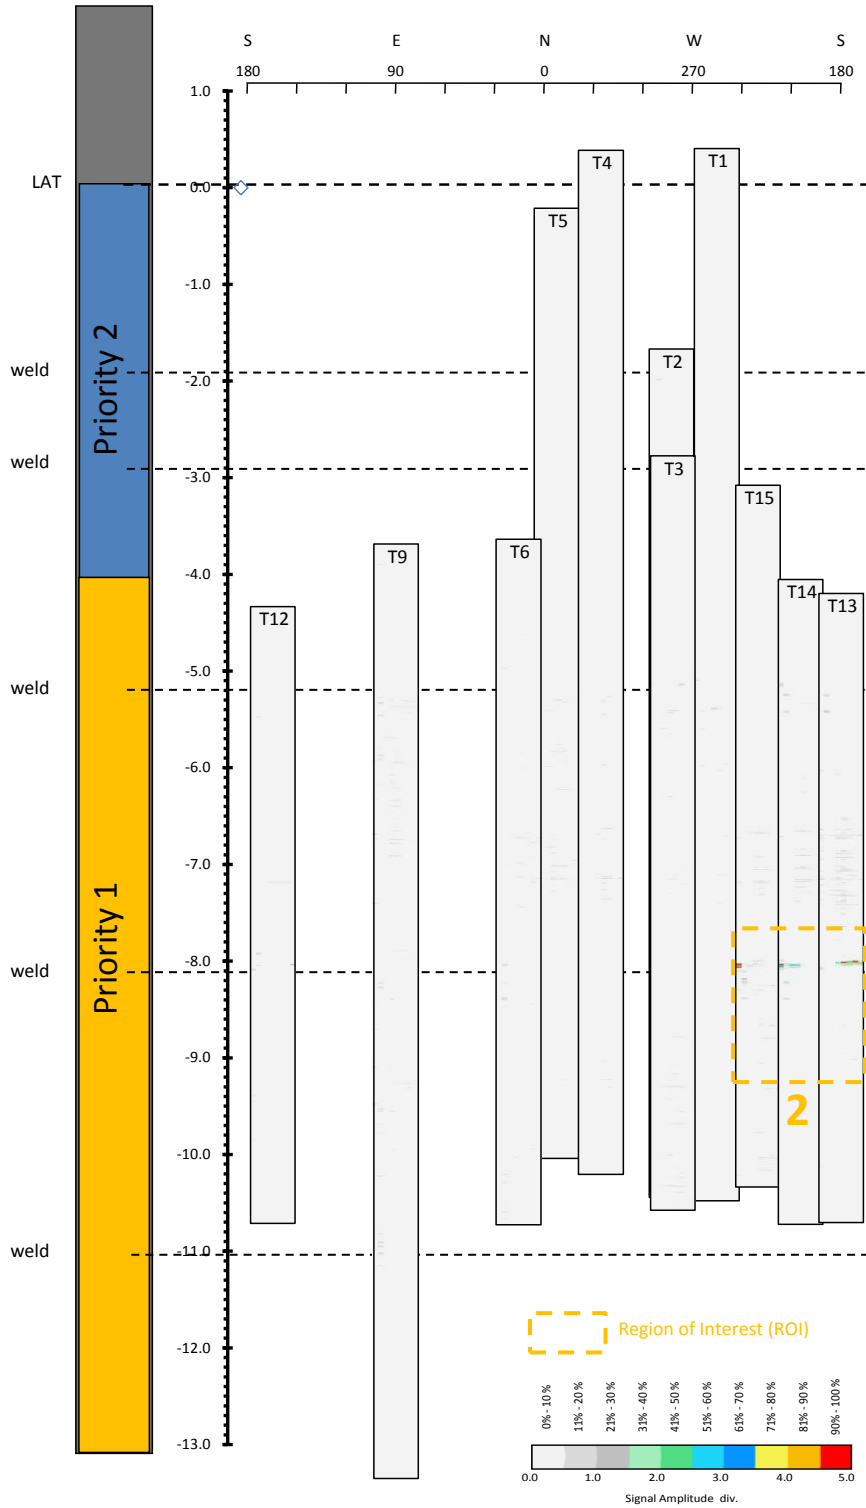
3.2. Scan Results and Track Position Overview (external corrosion)

In addition a severe indication was found immediately above the weld at -8 m (see Figure 11). The components are marked 2.6 to 2.8 in the table. In the MEC-Data it appears internal and external. In some areas the depth of the indication is rated to 100% meaning that it has grown to the outside. It can clearly be assigned to an area observed in the video data. The section is shown in Figure 11. The area is marked in red and also shows a through hole since water in- and outflow has been observed in the corresponding video footage. The axial extend of the indication is in the order of 50 mm. It runs in the circumference for some 50 cm.

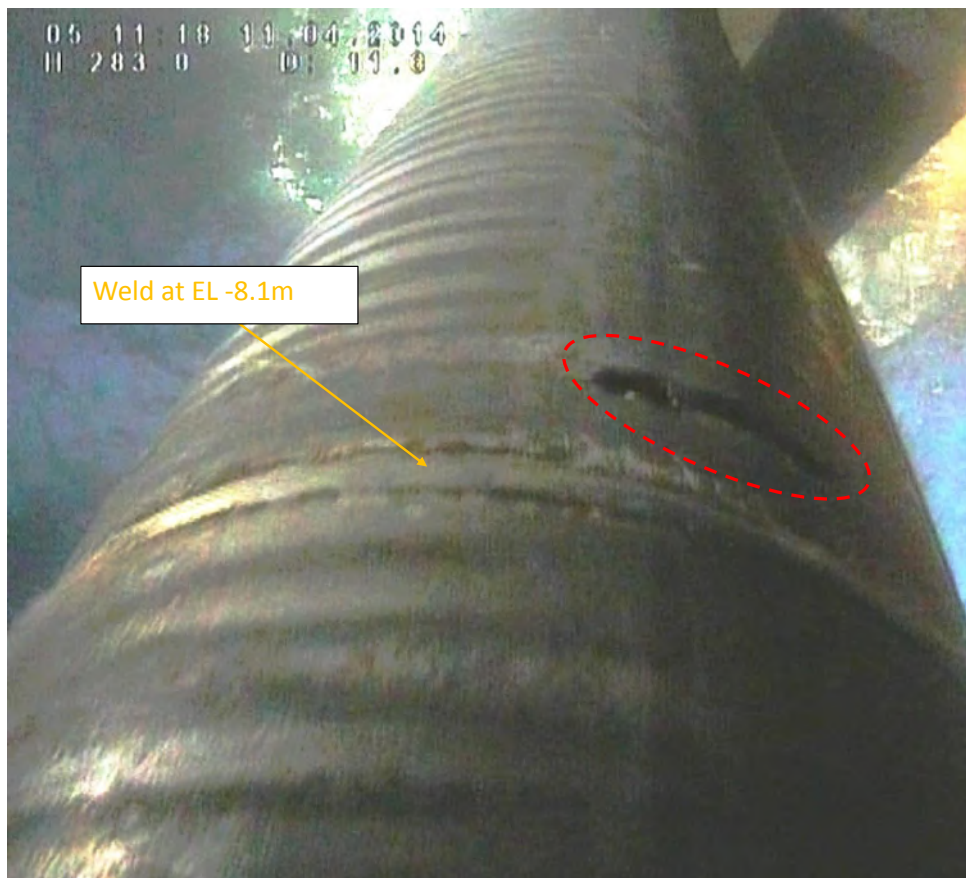
The inspection of caisson x at the Client's platform was carried out between April 10th and April 11th 2014. Several indications of severe internal corrosion were found during the inspection. In particular the elevation at -6 m is affected. In addition a severe circumferentially extended indication near the weld at -8 m has been detected. It corresponds to a through-hole observed in the video data.

Figure 11: View of the south-western weld region of xx at EL -8.1 m (screenshot from video file of Track 14). The area marked in red corresponds to the external indications shown in Figure 9.
