Item	:	30" Cell Fill Lines and Dead Legs
Material	:	Carbon Steel
Scans	:	Longitudinal
Surface Condition	:	Coated

As per instructed a SLOFEC™ - (Saturation Low Frequency Eddy Current) inspection was carried out on the 30" Cell Fill Lines and Dead Leg Manifold

# SLOFEC Pipe Inspection Report

<b>Client</b>	<b>Shell Expro</b>
<b>Items Inspected</b>	<b>P-160, P-161, P-162, P-163 Horizontal Sections Below G.T.F. C4</b>
<b>Platform</b>	<b>Brent Charlie</b>
<b>Inspection Method</b>	<b>SLOFEC™</b>
<b>Date Commenced</b>	<b>07/11/07</b>
<b>Report Completed</b>	<b>21/11/07</b>
<b>Type of Report</b>	<b>Final Inspection Report</b>
<b>Report Number</b>	<b>K-Nr 434-07</b>

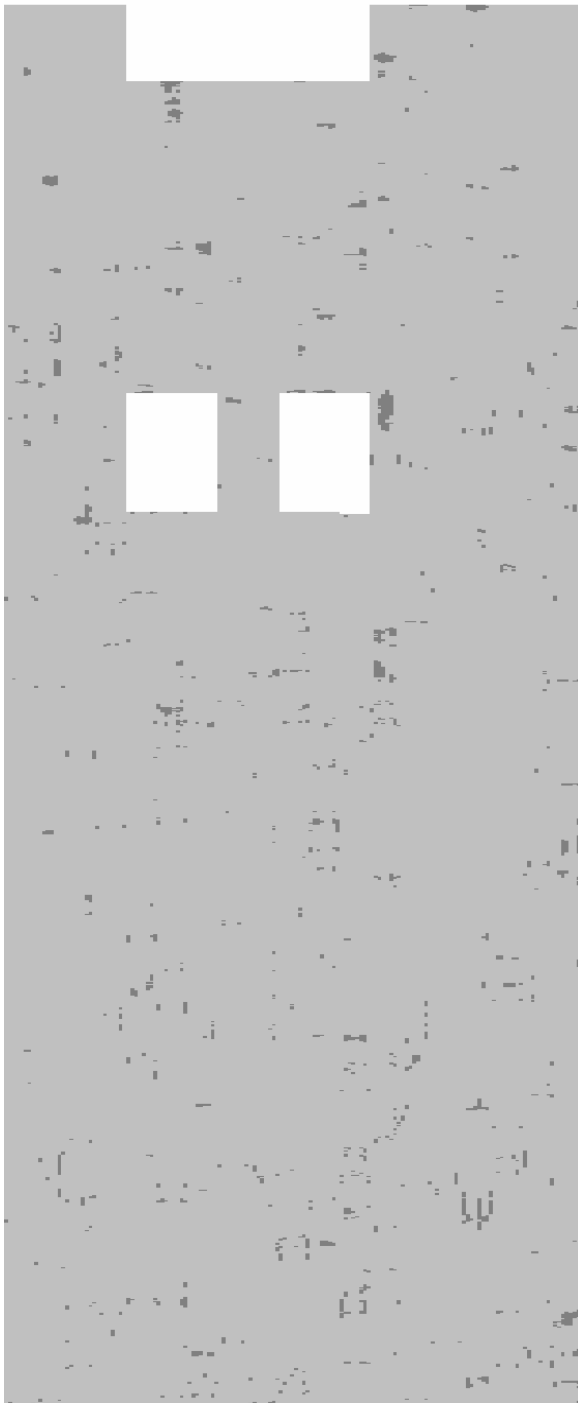
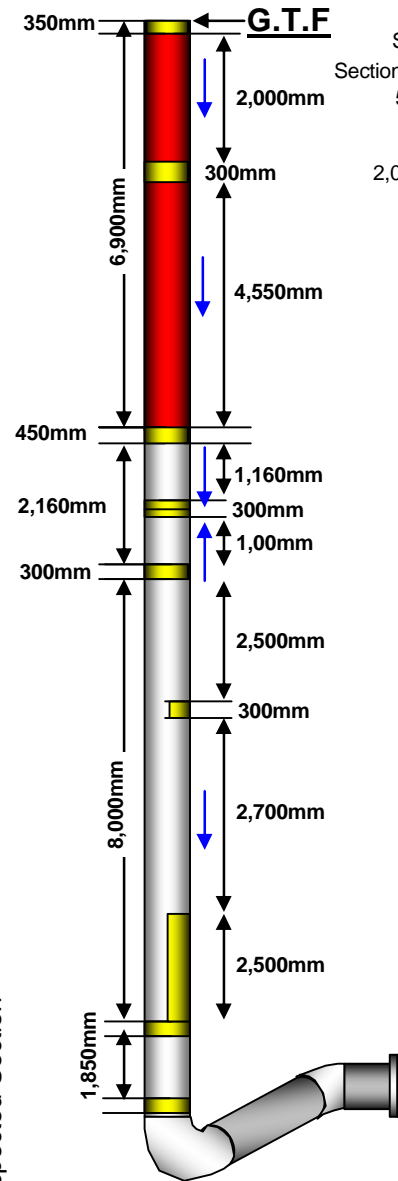
**30" P-163 Section 1**

Section 1  
Section 1 Short at Start  
5-6-10-11  
2,000mm tracks  
5-6-10-11

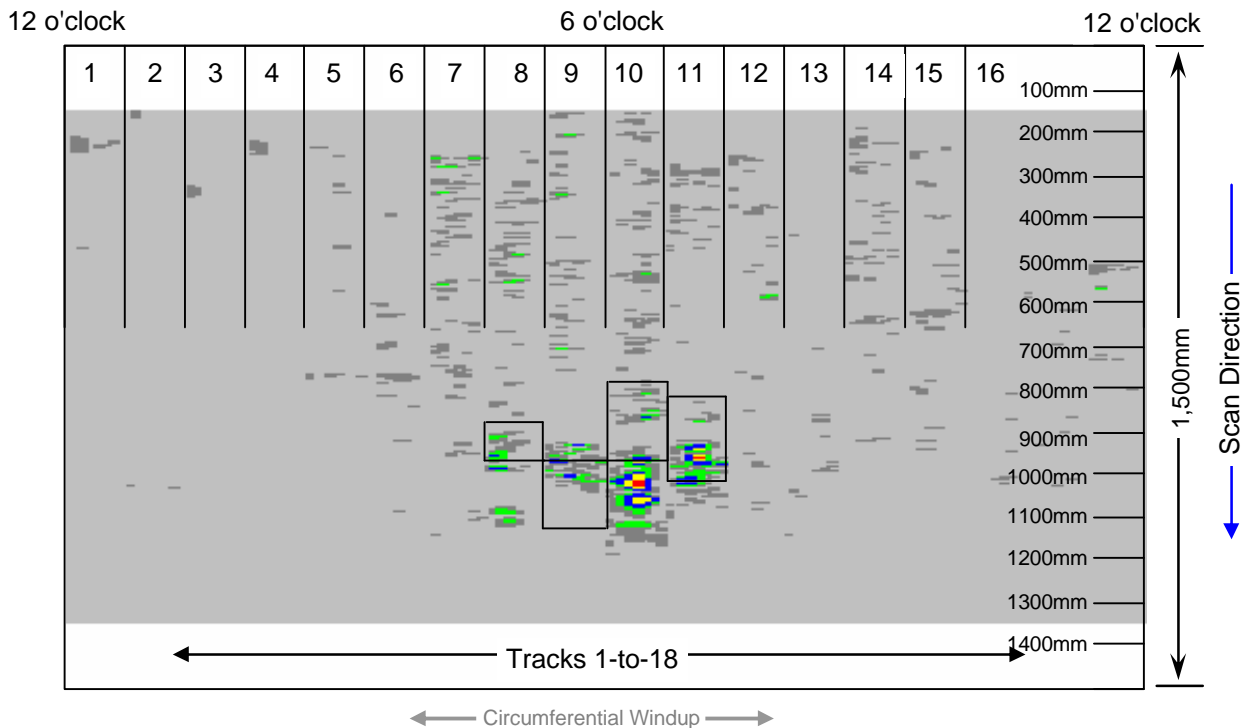
**30" P-161**

Pipe Identification	Section	% Wall Loss
P-160	Horizontal Section BGTF	<20%
P-161	Horizontal Section BGTF	>50%
P-162	Horizontal Section BGTF	30-40%
P-163	Horizontal Section BGTF	20-30%

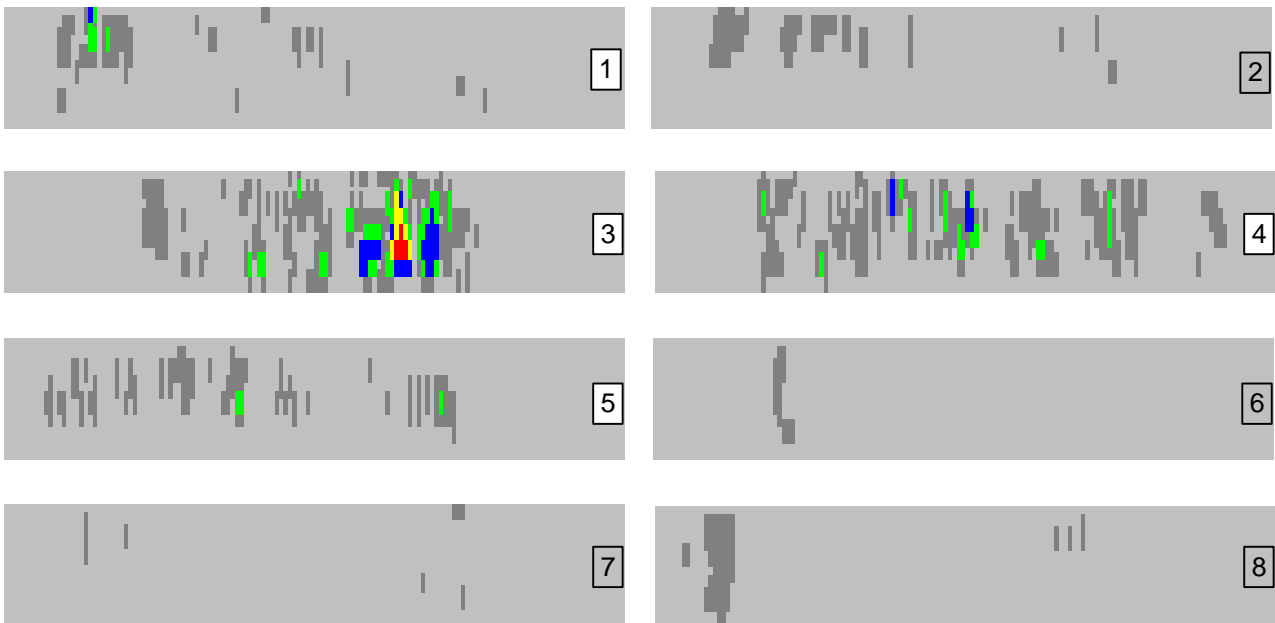
**30" P-161**

The BMP images below are the result of areas found with UT, marked up and scanned with SLOFEC.

Track No's	Indication No's	UT Results	SLOFEC Results	SLOFEC % indicates the most severe indication of each scan.
1	1		20%	
2	2, 3		15%	
3	5		50 - 60%	
4	6, 7, 8		30 - 40%	
5	9, 10, 11, 12		15 - 20%	
6	13		5%	
7	14, 15, 16		5%	
8	17		5%

UT Indication Number 4 is 50mm from the circumferential weld so has no SLOFEC scan.
