MEC Conductor Inspection Report

Client: OIL COMPANY

Facility: Oil Field WHT

Items Inspected: WHT01
30" Conductors No. 1-3

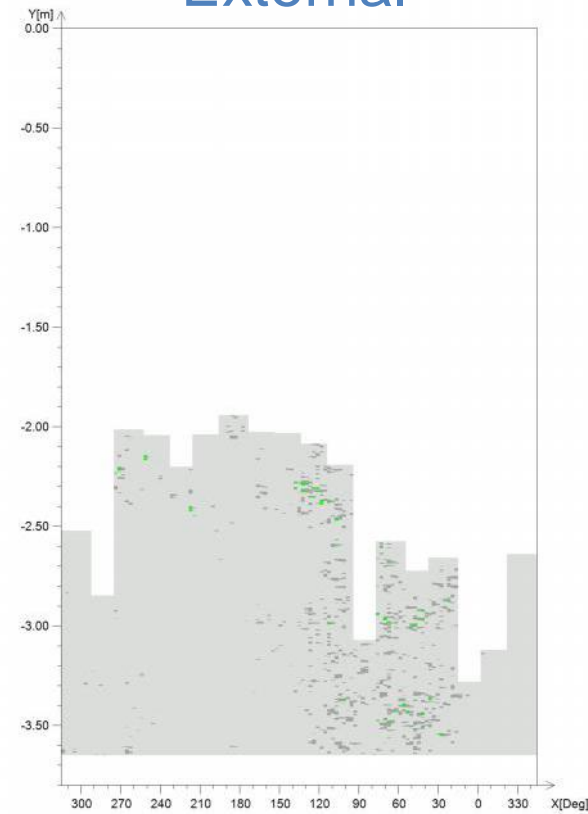
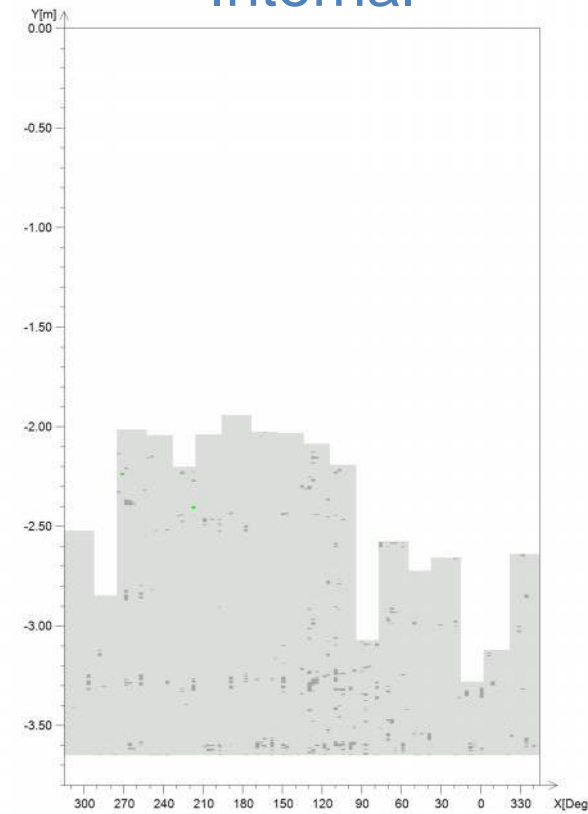
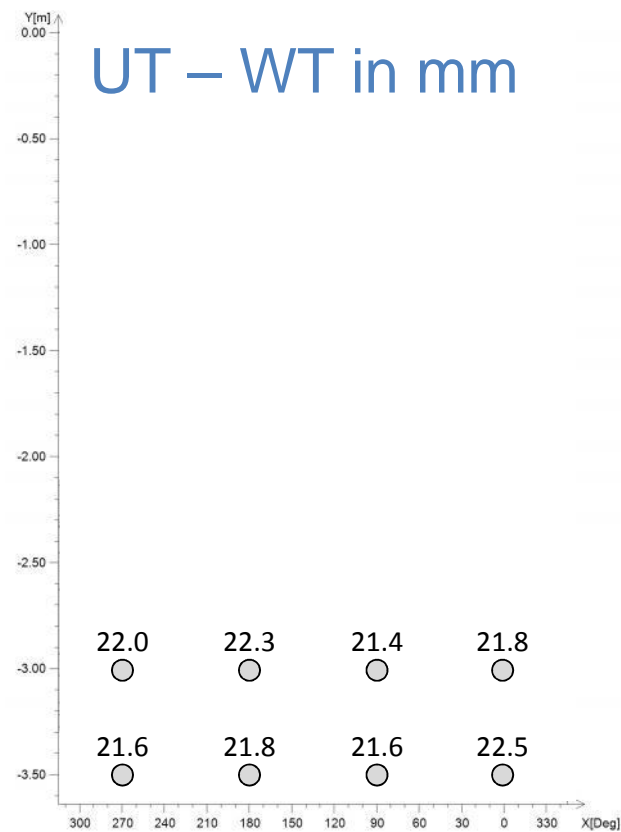
WHT Conductor 1 - Section 1

Isolated minor external corrosion predominantly in the eastern area of section 1 has been found with an estimated depth of 20 - 25%.

Isolated minor external corrosion predominantly in the eastern area of the section. Estimated depth: 20 - 25%.

Guide prevented scan of the upper part of the section.

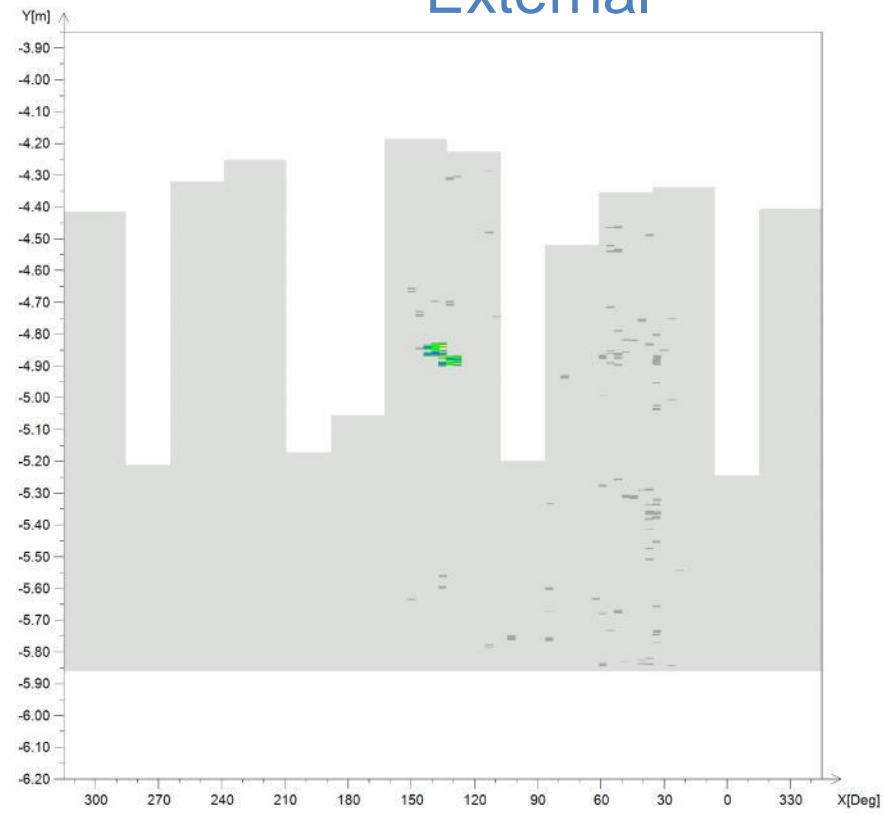
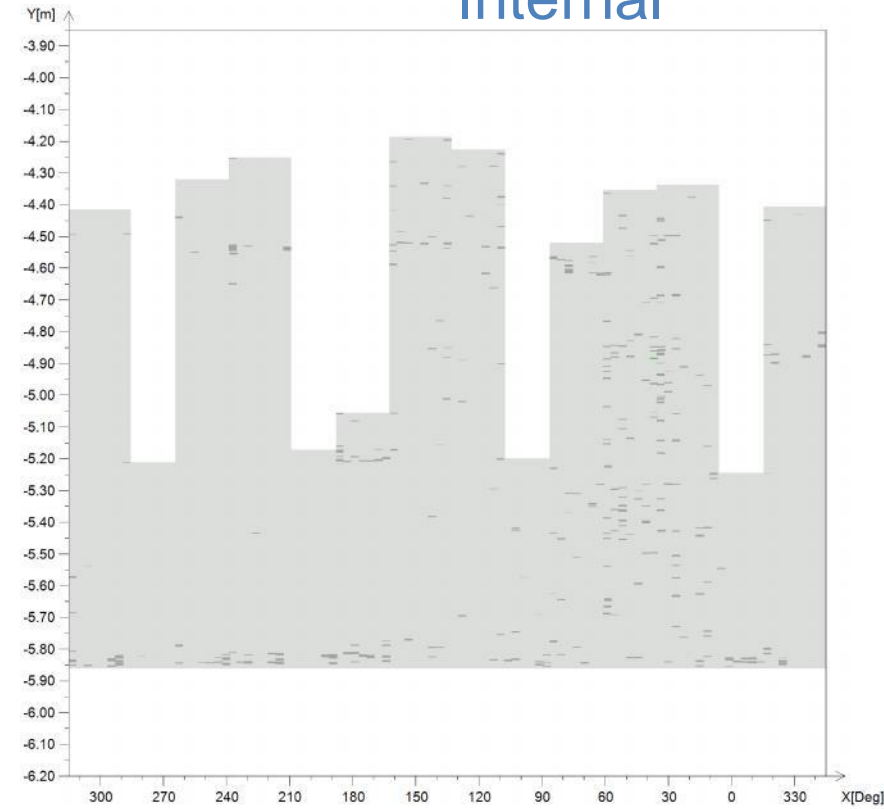
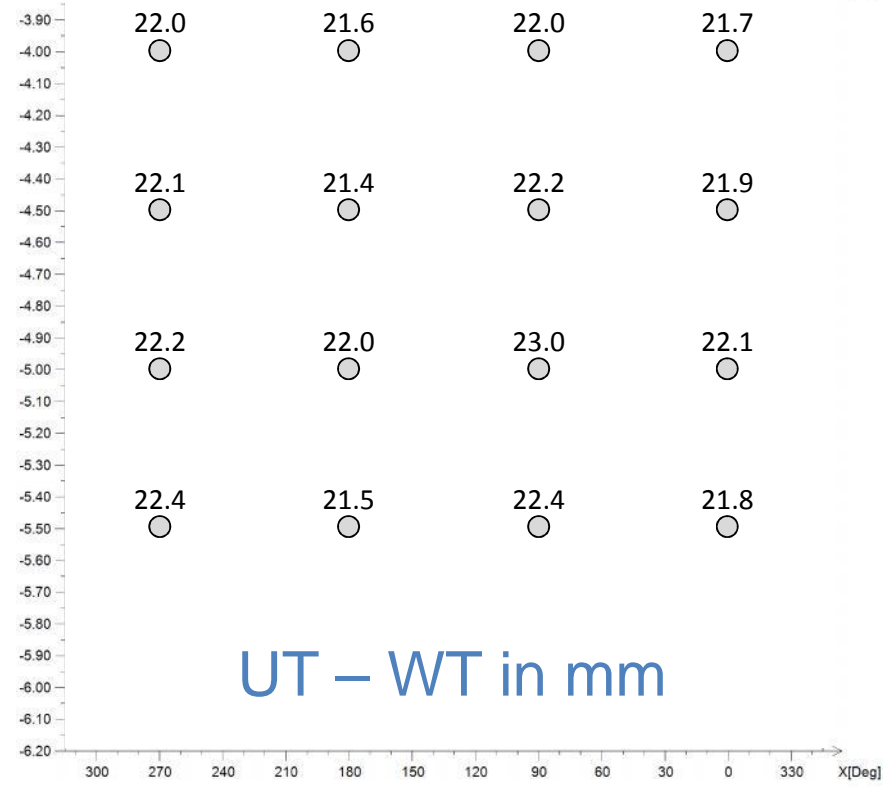
WHT Conductor 1 - Section 2 Wall Loss Condition Map

Localised external metal loss has been detected at section 2 at -4.85 m in the southern area of the conductor exhibiting an estimated depth of 35%.

Localised external metal loss at -4.85 m in the southern area of the conductor.
Estimated depth: 35%.

Some tracks shortened due to lifting pad eyes.

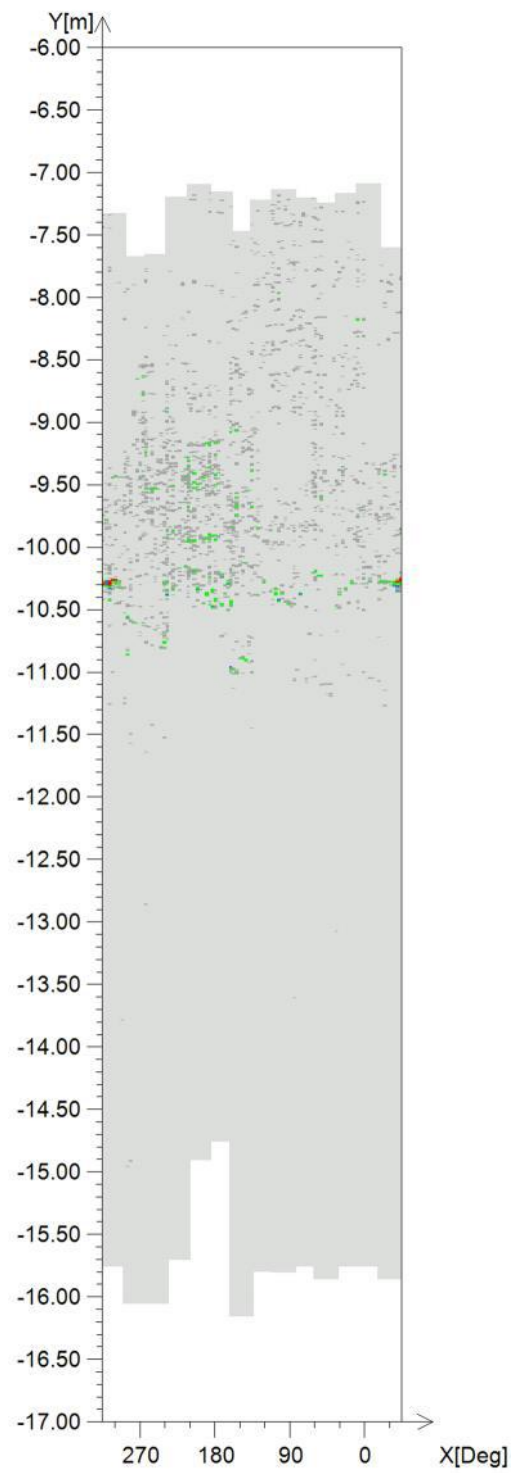
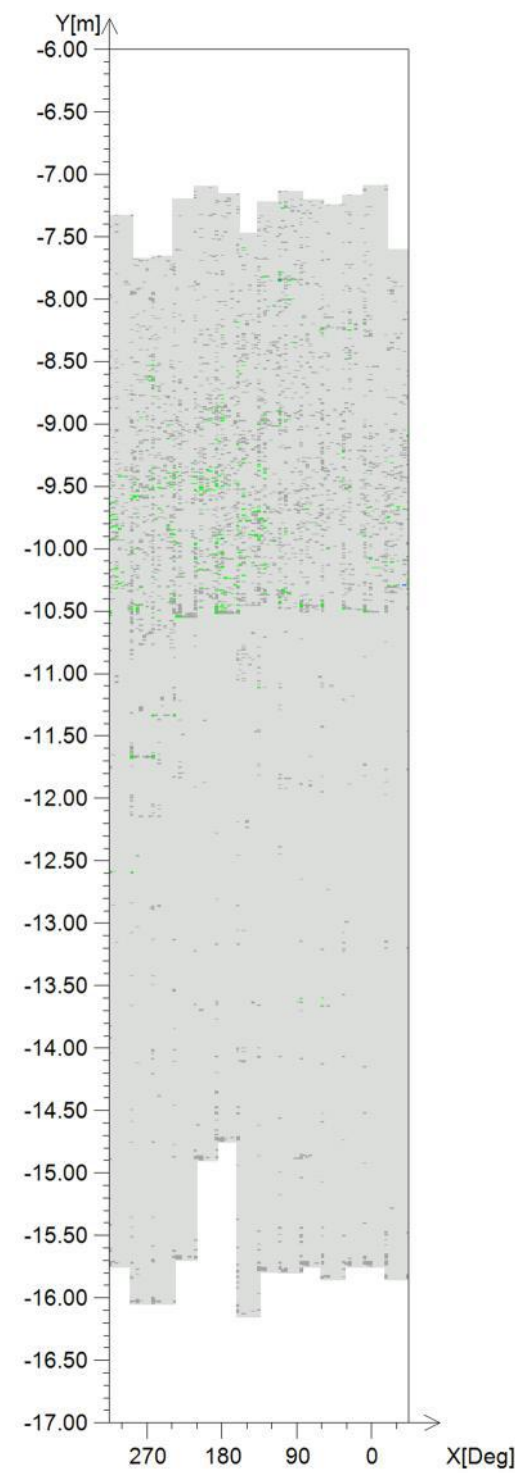
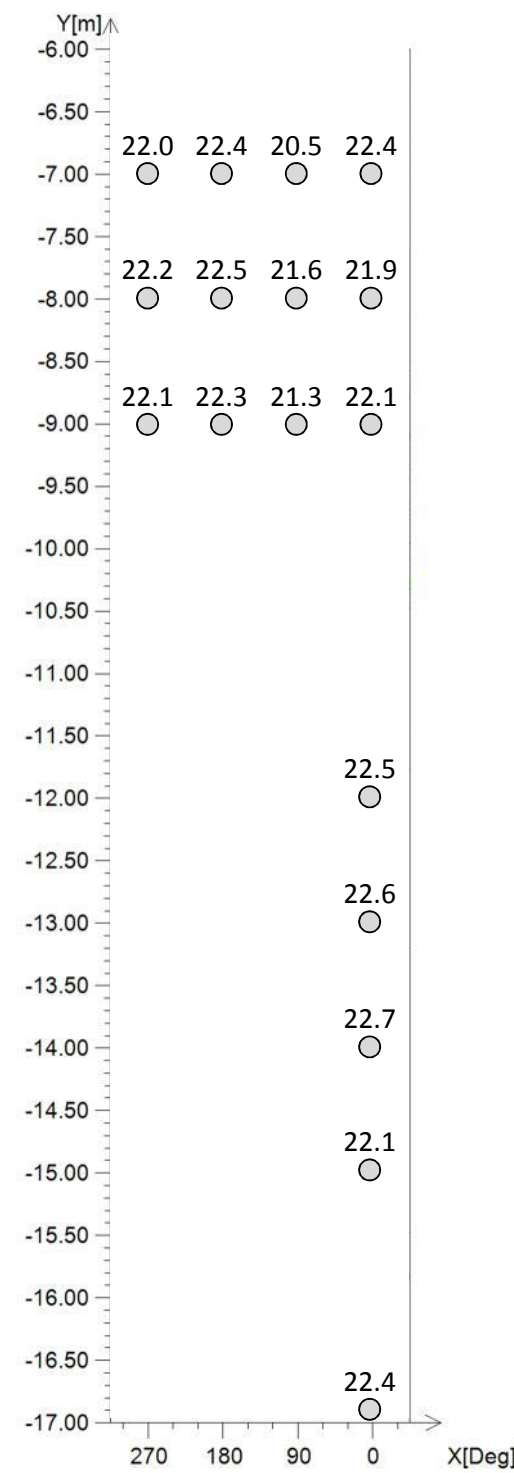
WHT Conductor 1 - Section 3 Wall Loss Condition Map

On section 3, general minor internal and external corrosion between -9m and -10.5m was detected.

Additionally, an isolated external metal loss in the north-western splash zone area of the section around -10.25m exhibiting wall loss of about 80% was found.

General minor internal and external corrosion between -9m and -10.5m.

Isolated external metal loss in the north-western splash zone area around -10.25m exhibiting wall loss of about 80%.

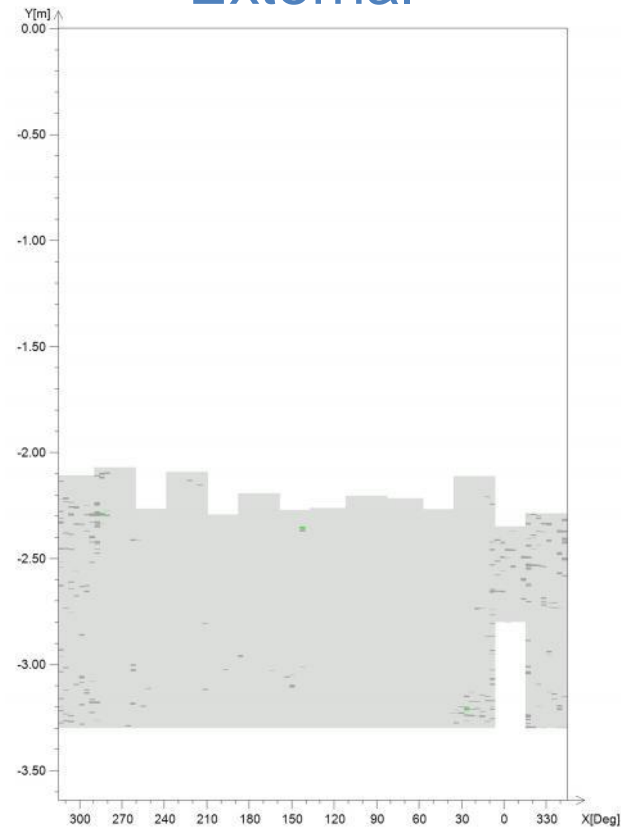
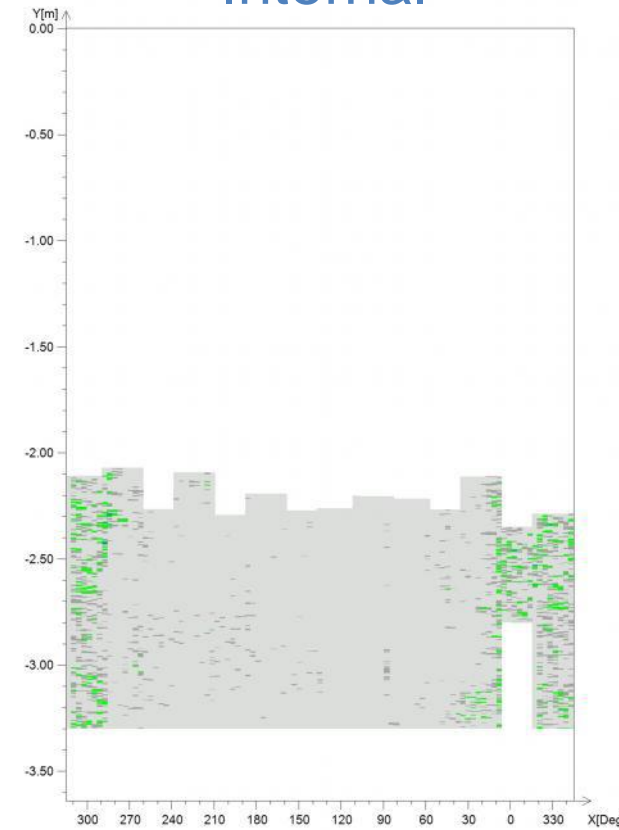
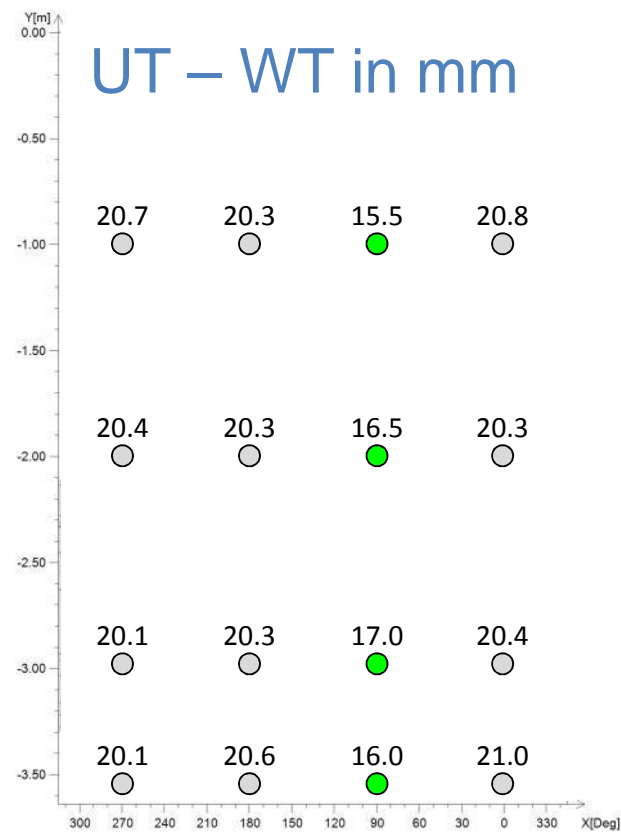
WHT Conductor 2 - Section 1

General internal metal loss predominantly in the north-western area of section 1 has been found exhibiting an estimated depth of 25%.

General internal metal loss predominantly in the north-western area of the section.
Estimated depth: 25%.

Platform structure prevented scan of the upper part of the section.

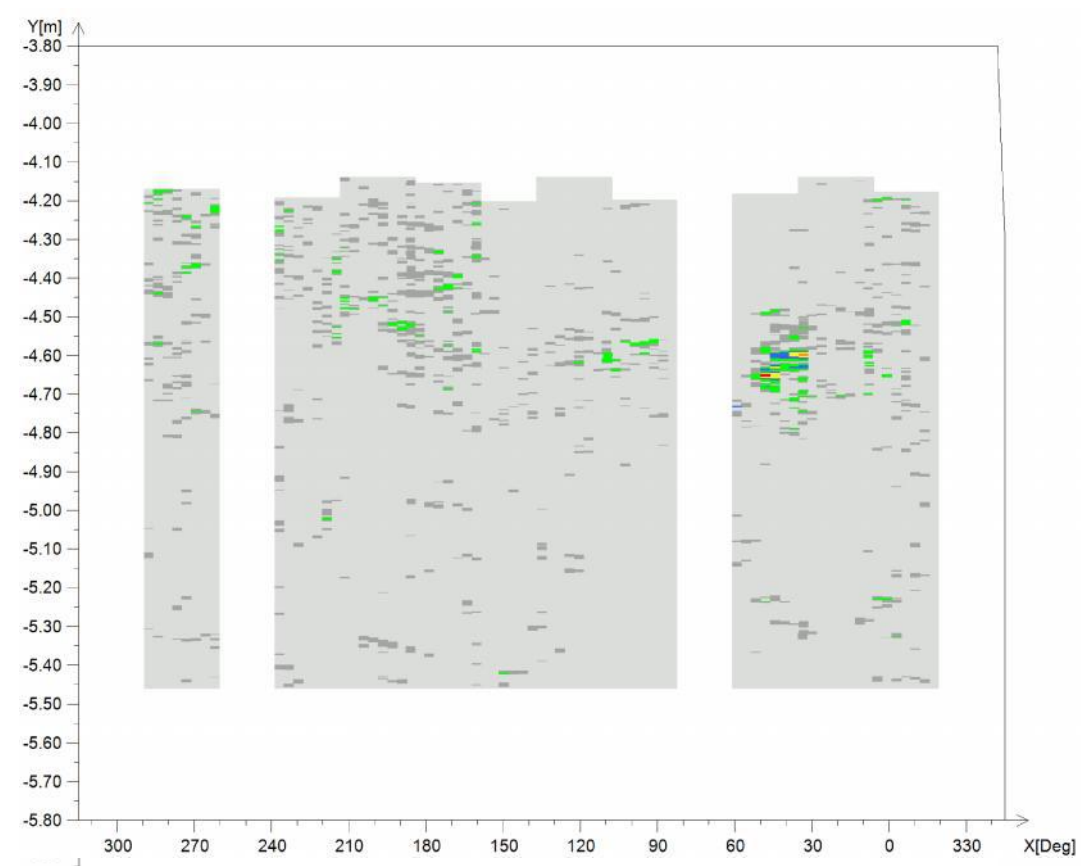
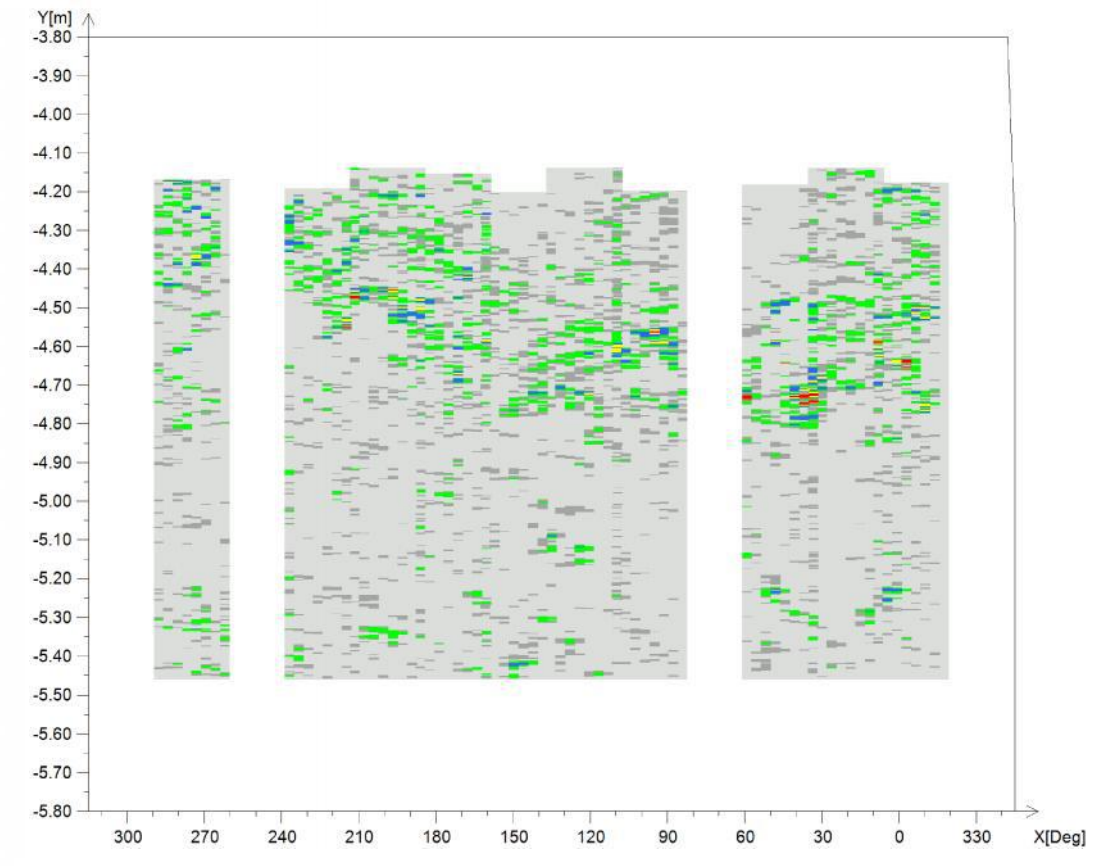
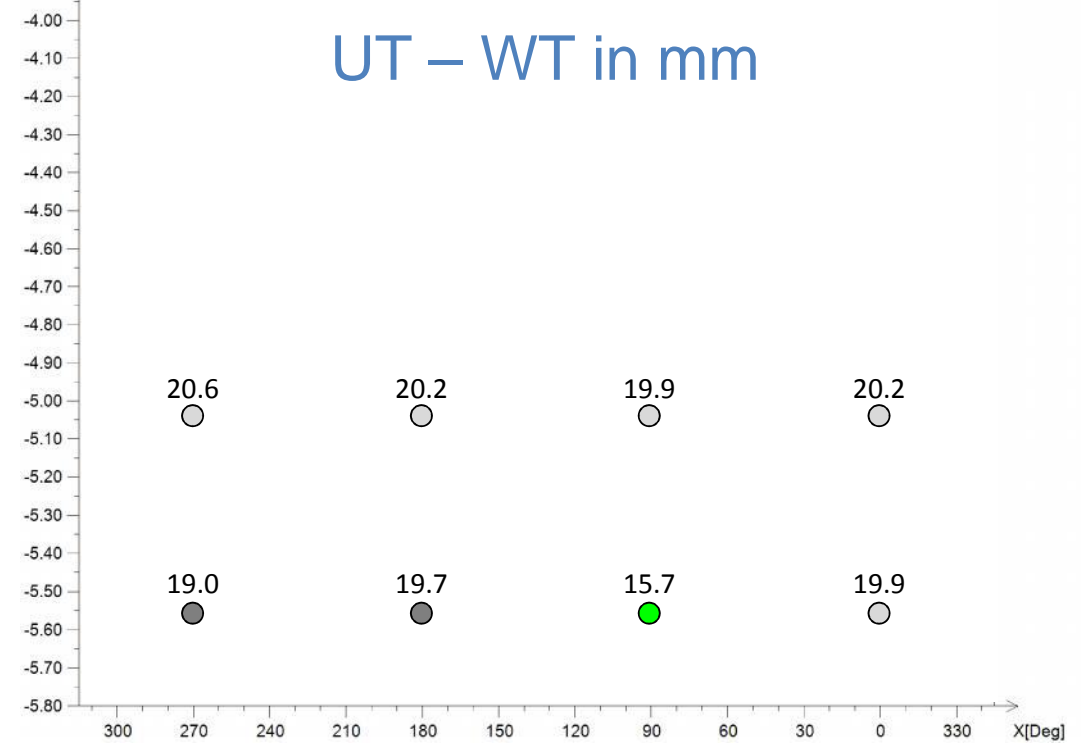
WHT Conductor 2 - Section 2

At section 2, large external and internal metal losses have been detected at -4.65 m and -4.75 m with estimated depths of 45% and 60%, respectively. The external defect corresponds to a corrosion indication confirmed by visual inspection with a depth of approx. 50% wall loss.

Results:
 Large internal metal loss at -4.75 m.
 Estimated depth: 60%.
 Large external metal loss at -4.65 m.
 Estimated depth: 45%.

Remarks:
 Four tracks could not be done due to obstacles (lifting pad eyes)

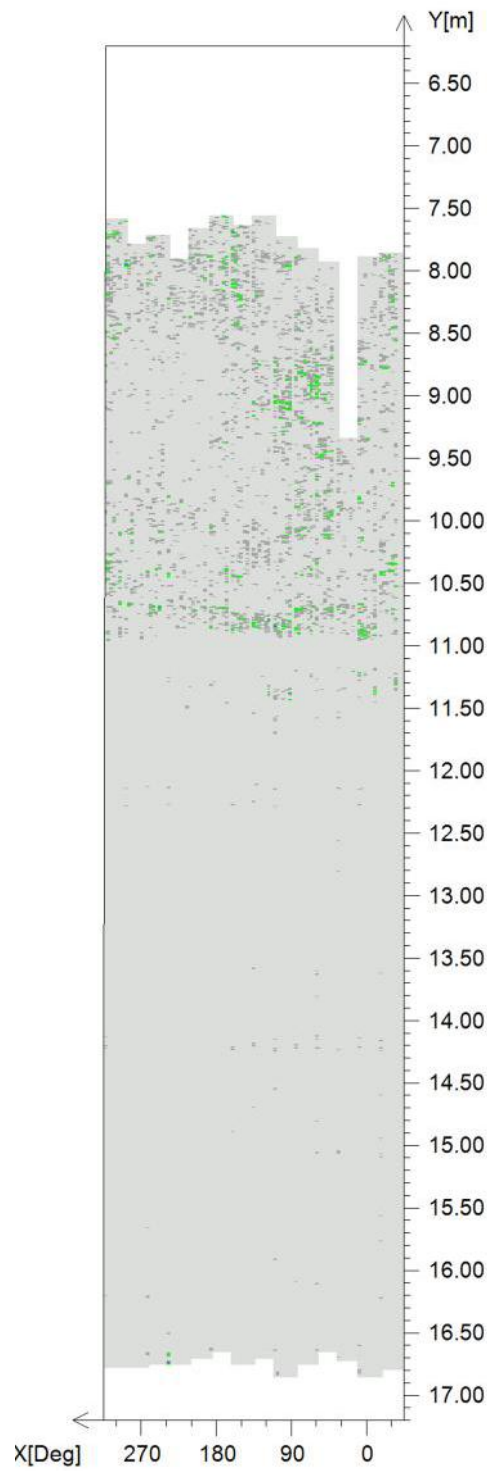
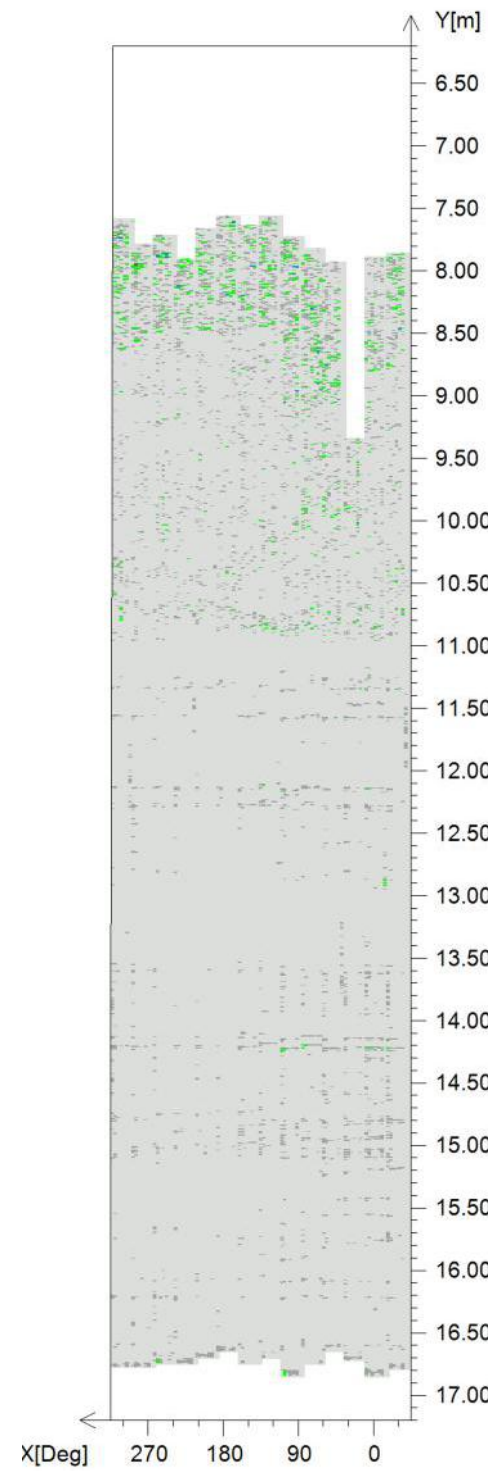
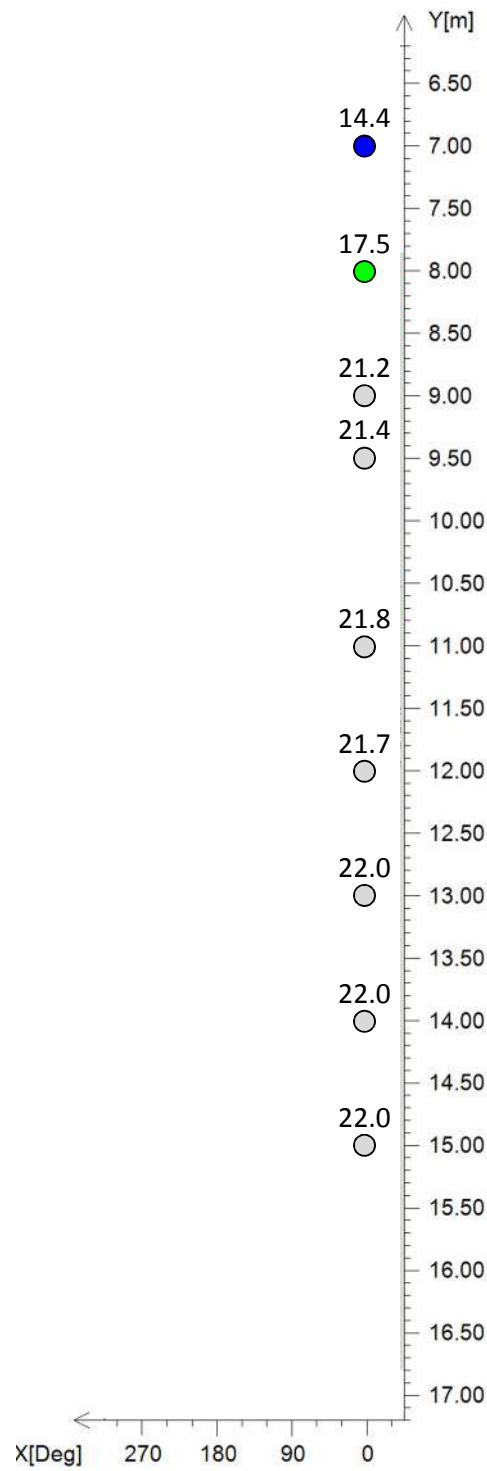
WHT Conductor 2 - Section 3 Wall Loss Condition Map

On section 3, general internal and external corrosion has been found between -7.5m and -9m with deeper pitting-like indications exhibiting wall loss up to 45%.

General corrosion between -7.5m and -9m with pitting-like indications exhibiting wall loss up to 45%.

Cleaning difficult between -6m and -7.5m.

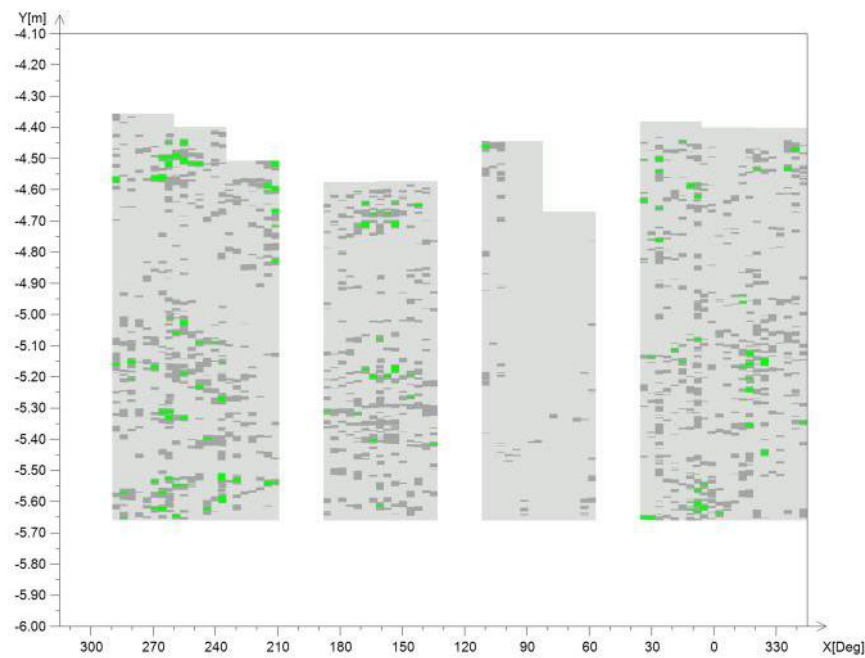
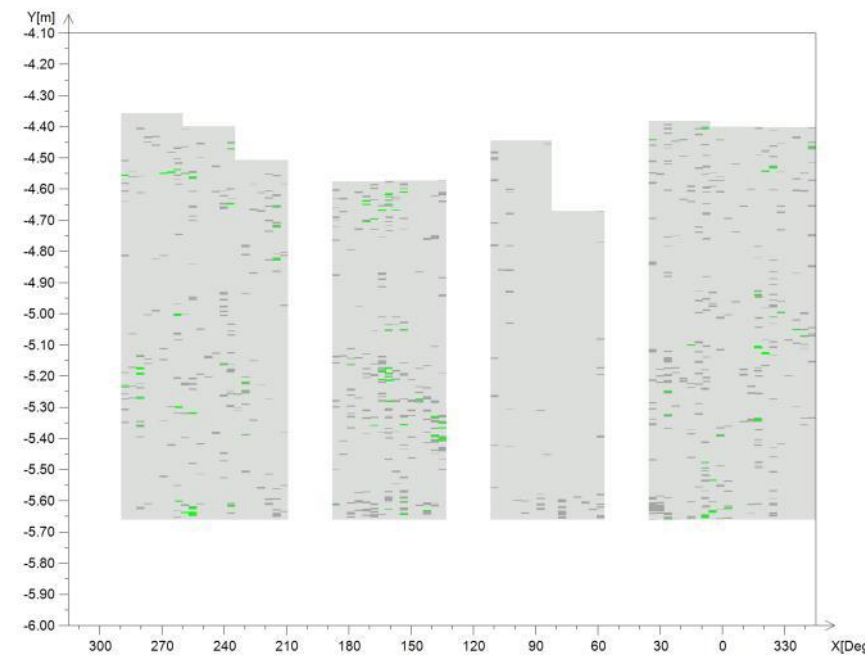
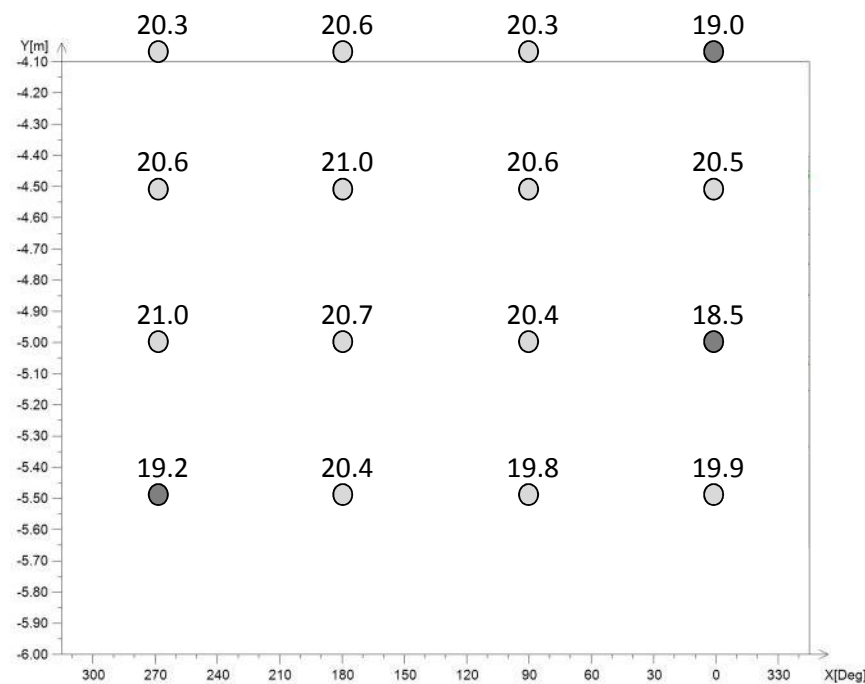
WHT Conductor 3 - Section 2

Section 1 and section 2 only show minor metal loss indications on the internal as well as on the external side. Some indications on the external side are in the range of 20% of the wall thickness.

Minor localised external and internal corrosion detected.

Some tracks shortened due to lifting pad eyes.

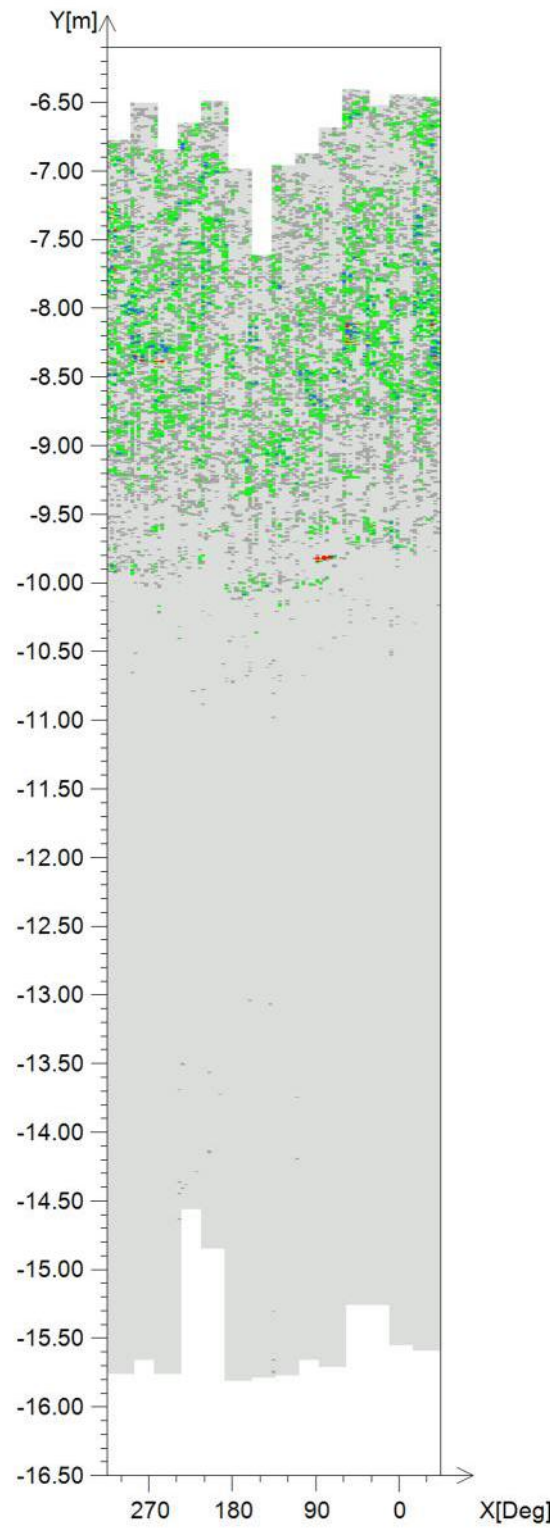
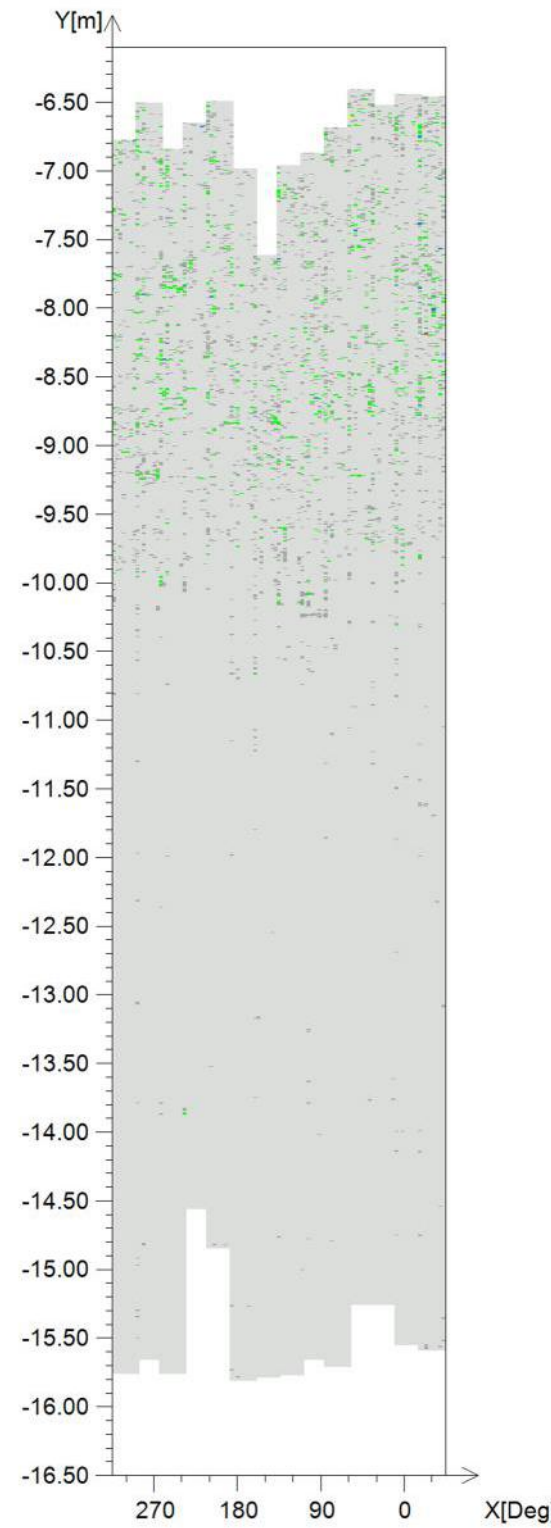
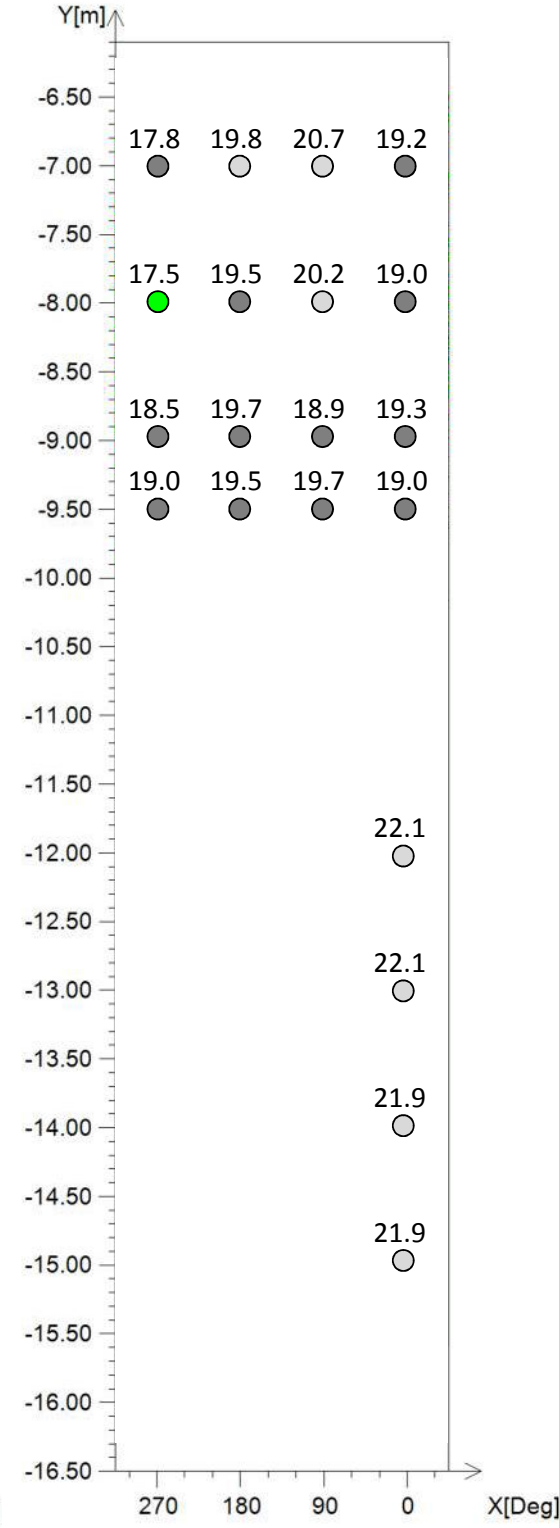
WHT Conductor 3 - Section 3 Wall Loss Condition Map

Section 3 shows more and deeper corrosion sites. All of these are found above the water line on the external surface. On spot of particular interest if found at -9.8m on the East-face (90°). It is small in size, but quite deep. It is about 8 cm in circumferential extend, but only 10mm in axial length. The depth is about 60% of the wall thickness. More deep external indications are found on the West side at about -8.35m.

Extended corrosion found on external surface above the water level. Deepest spot at East (90°) at -9.8m with a depth of 60%.

Further UT measurements on North face (0°):

- 17m: 22.0 mm
- 17.5m: 22.0 mm
- 18m: 28.0 mm
- 19m: 28.4 mm
