MEC™-Pipe Crawler FLEXIBLE RISER INSPECTION REPORT

Facility: Site FPU

Items Inspected: 13" Flexible Riser

Report Number: K0xx-15

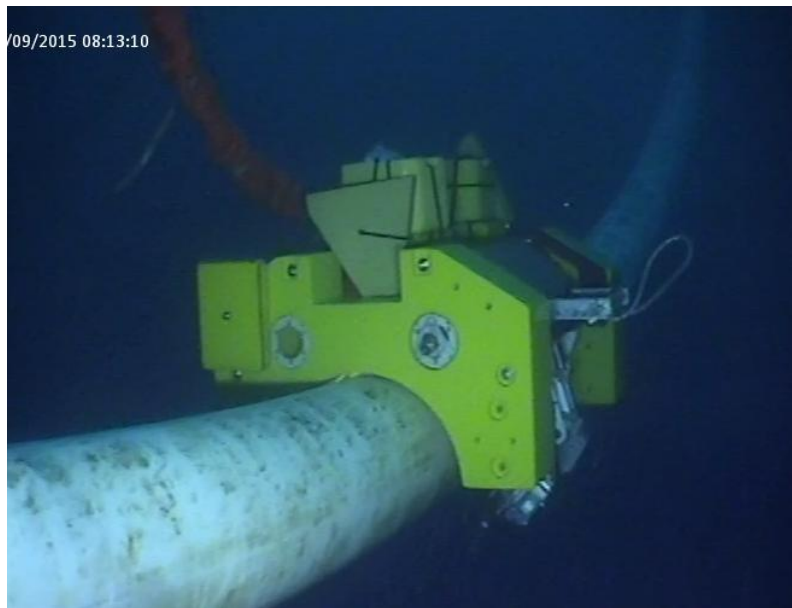
Figure 4: The MEC™-Pipe Crawler tool attached onto the 13" Flexible Riser. The position is near the low point of the arc.

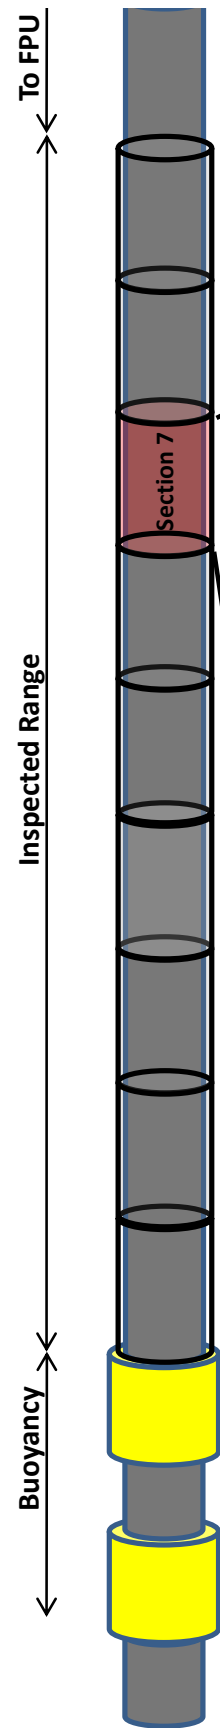
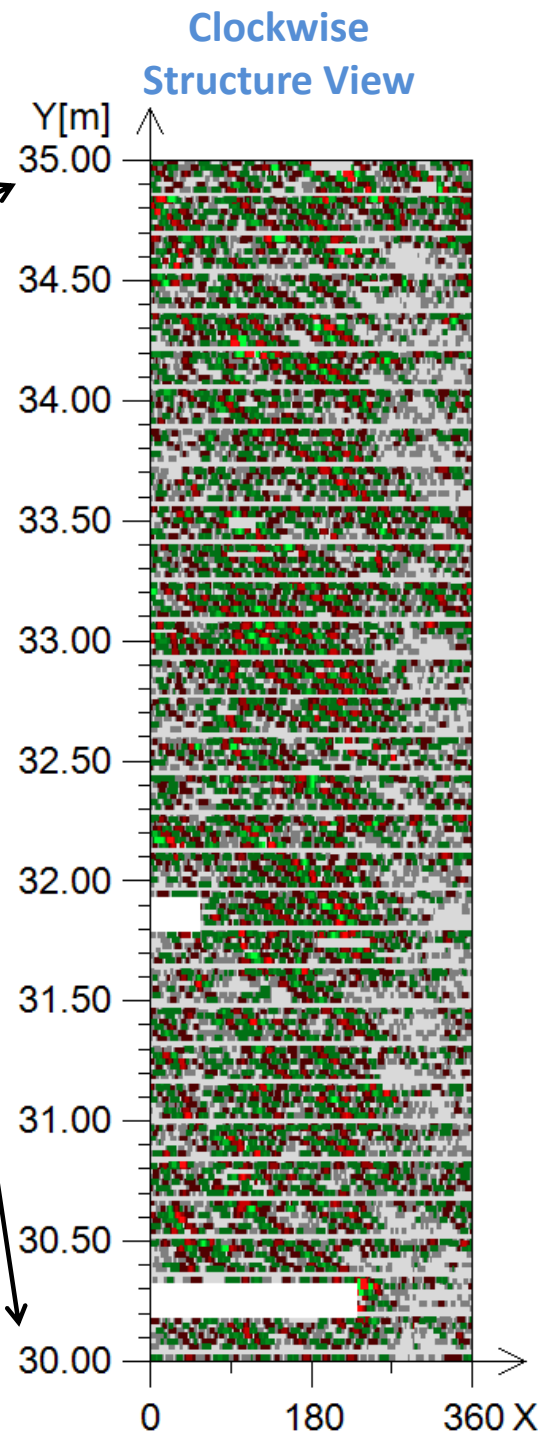
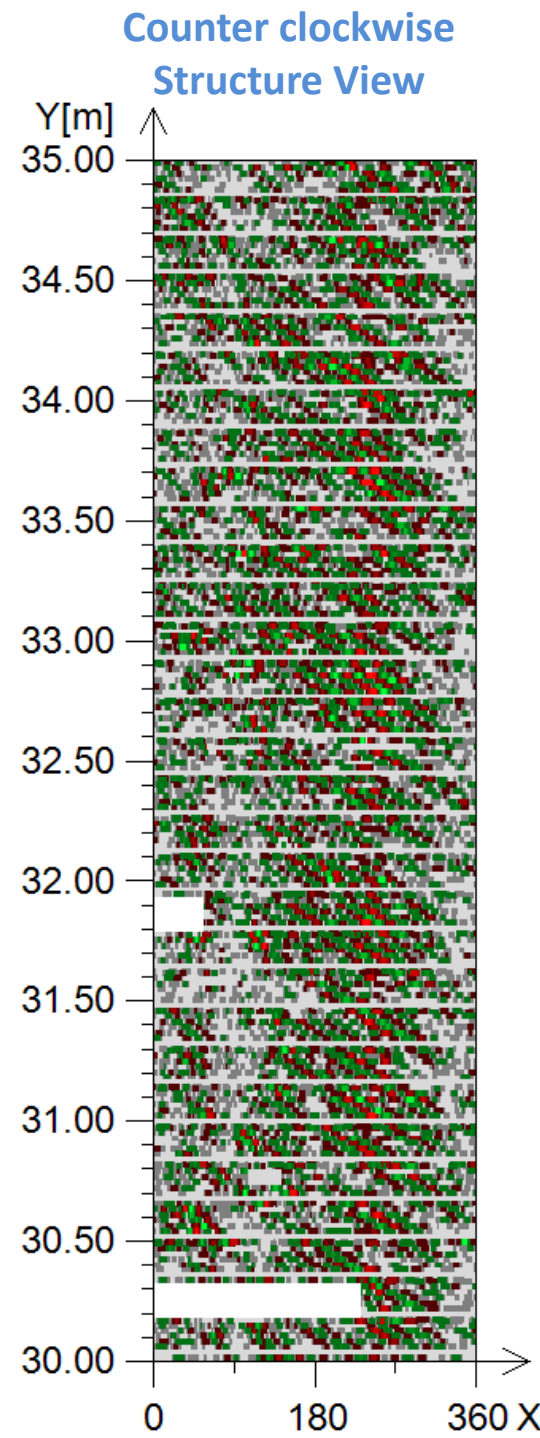
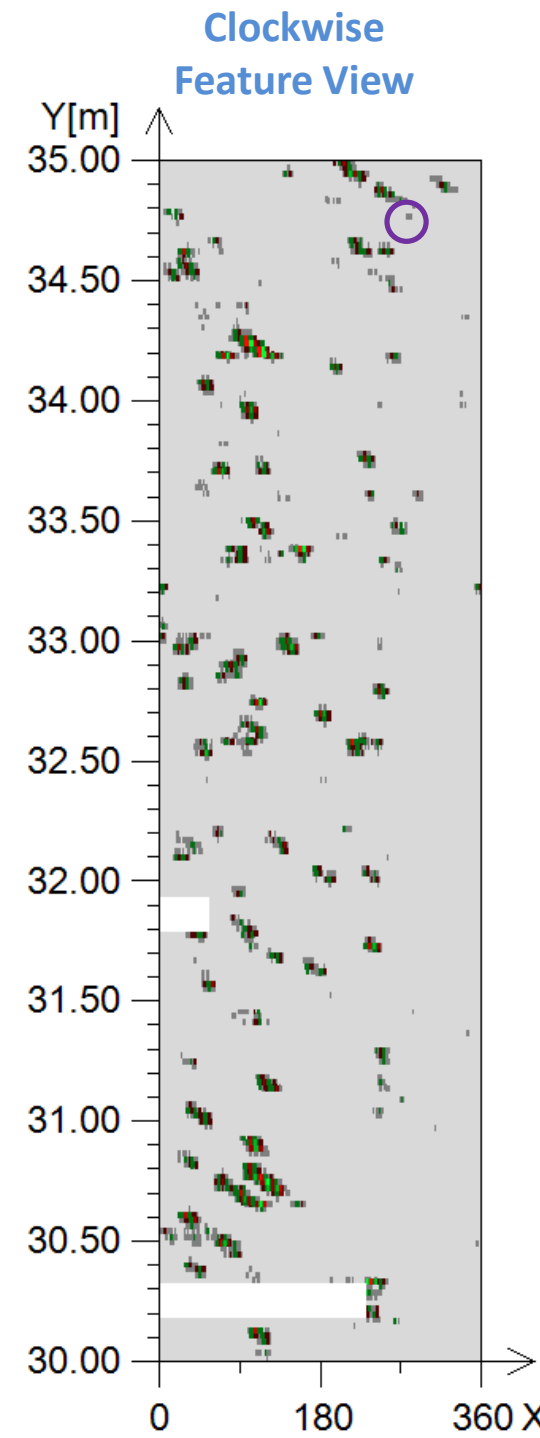
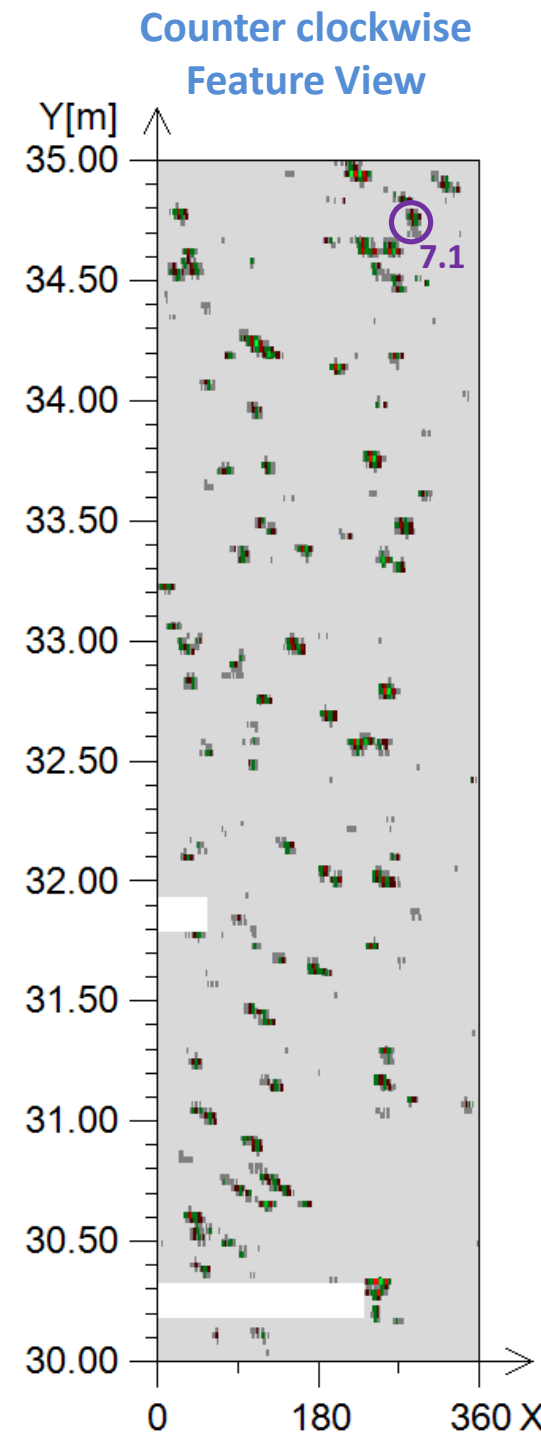
Scan #1 Section 7 (30 m – 35 m)

Results: 55°-structure visible in the structure view. Slower motion at 3 o'clock for counter clockwise motion. Two portions of track missing. Stress induced marks are found in feature view. One indication has been selected for detailed analysis.
Colour Code represents signal amplitude with red and green showing opposite phase.

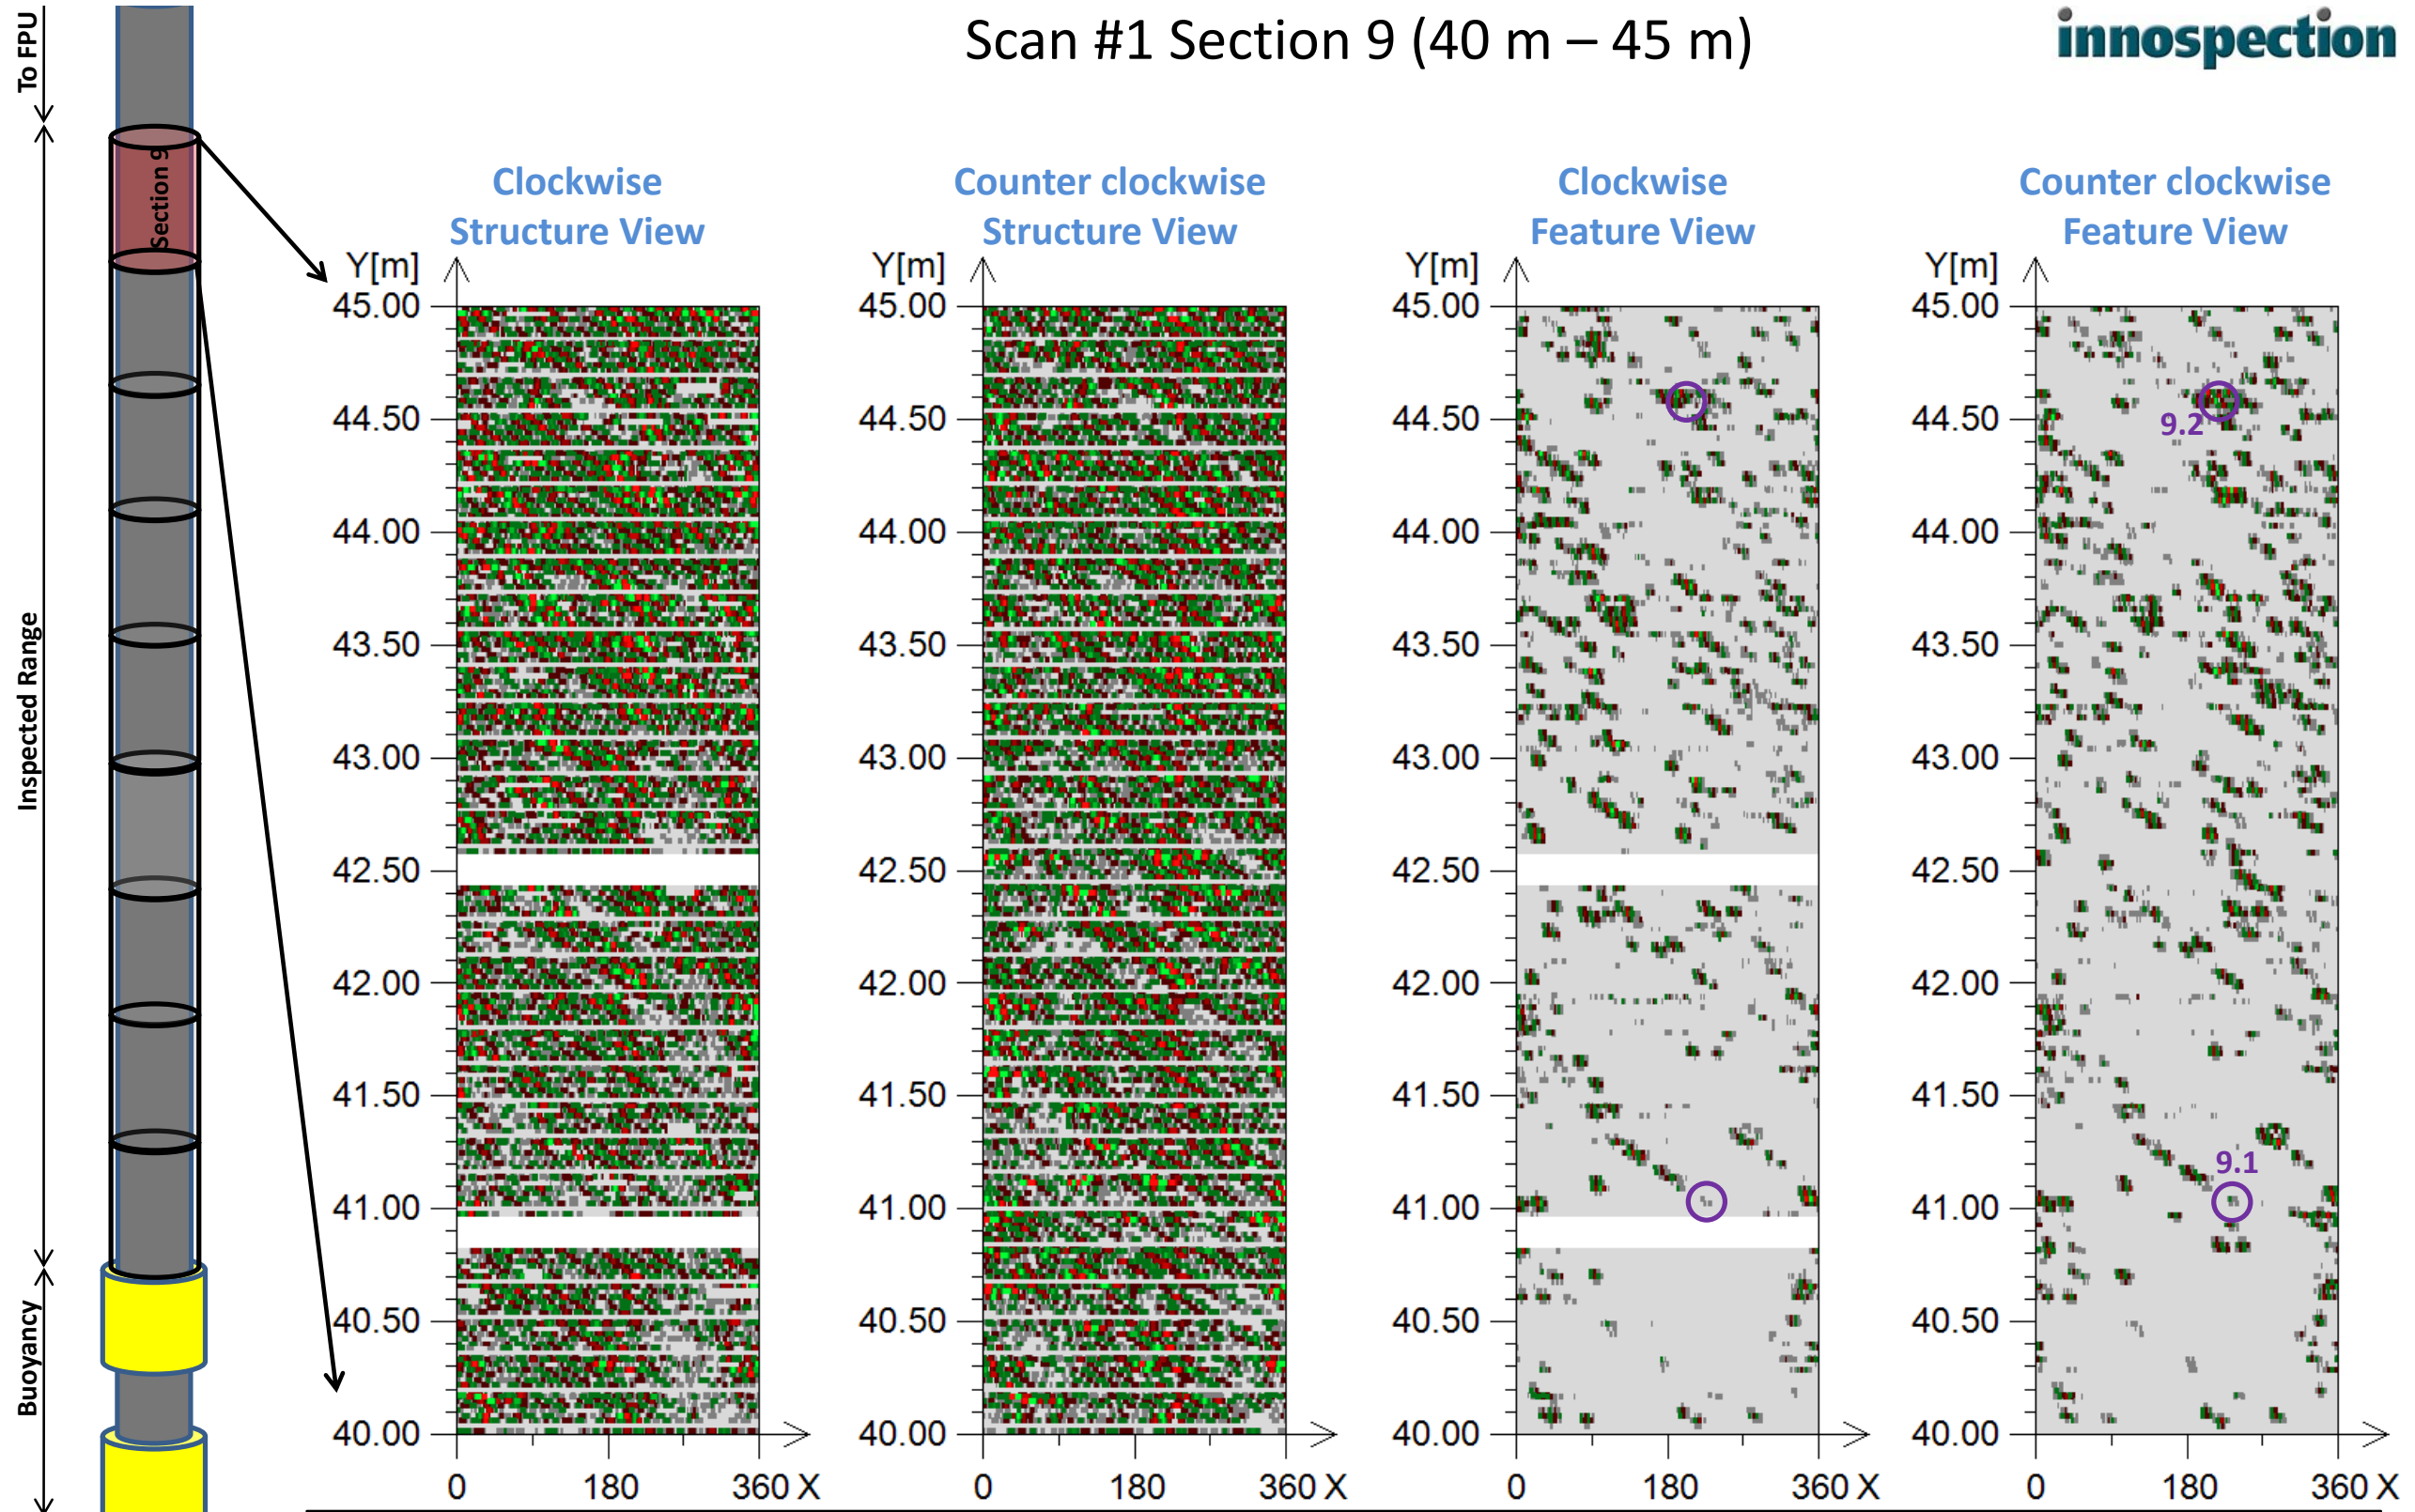
Scan #1 Section 9 (40 m – 45 m)

Results: 55°-structure visible in the structure view. One tracks on clockwise motion not saved. Stress induced marks are found in feature view especially dense towards the end of the scan. Two indications have been selected for detailed analysis. Colour Code represents signal amplitude with red and green showing opposite phase.

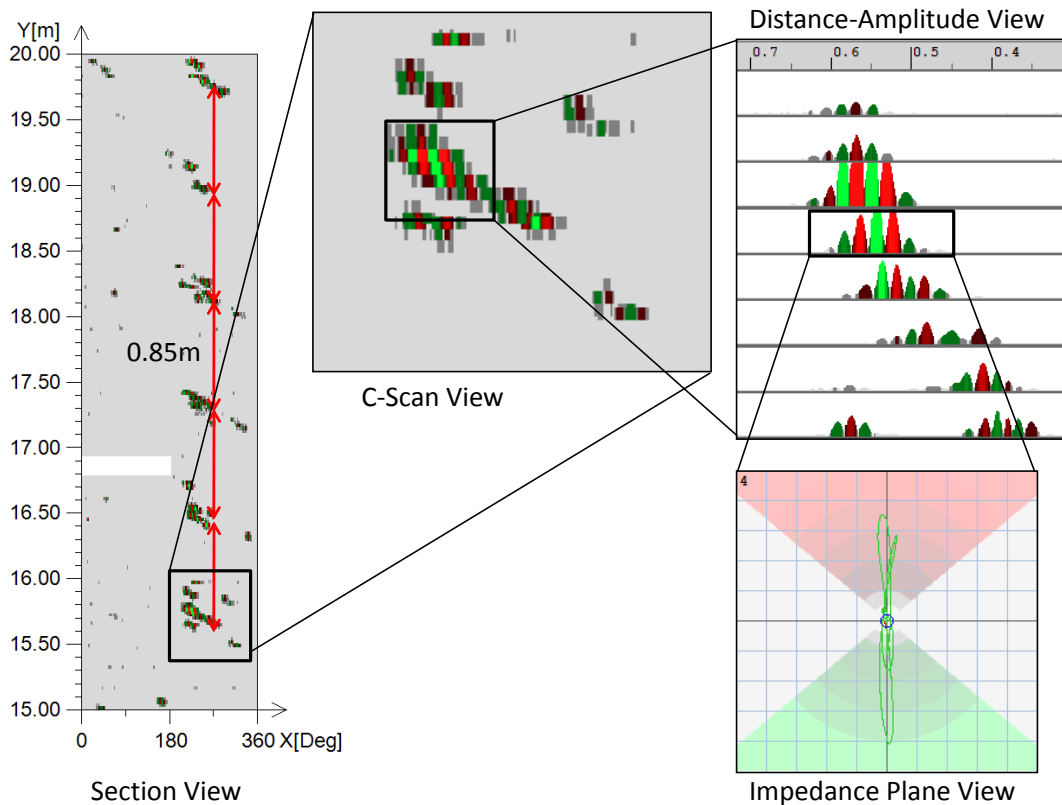
In the features view there is an abundance of indications. They are more pronounced in the start and the end of the scan. In the sag bend the density of these features is smaller. As these features can be exactly reproduced between clockwise and counter clockwise movement and also between the two scans for the overlapping sections they definitely stem from the armour wire layers. They tend to show an anisotropy comparable to the outer wire structure. In section 4 the pattern is less dense. Here the spots are exactly 0.85 m apart. This happens to be the pitch of one wire at full circumference. Hence the same wire is affected at the same orientation. Refer to Figure 6 for a sample signal of this kind.

Figure 6: A sample Data section with different views. Data is taken from Section 4 Scan2 counter clockwise motion.

From their appearance the signals are attributed to residual stresses (see 3.3).
