Platform / Riser	Flexible Riser Inspection Report	Report: No Kxxxx-xx

FLEXIBLE RISER EXTERNAL INSPECTION REPORT

Using MEC-FIT™

Final Report: Kxxx-xx

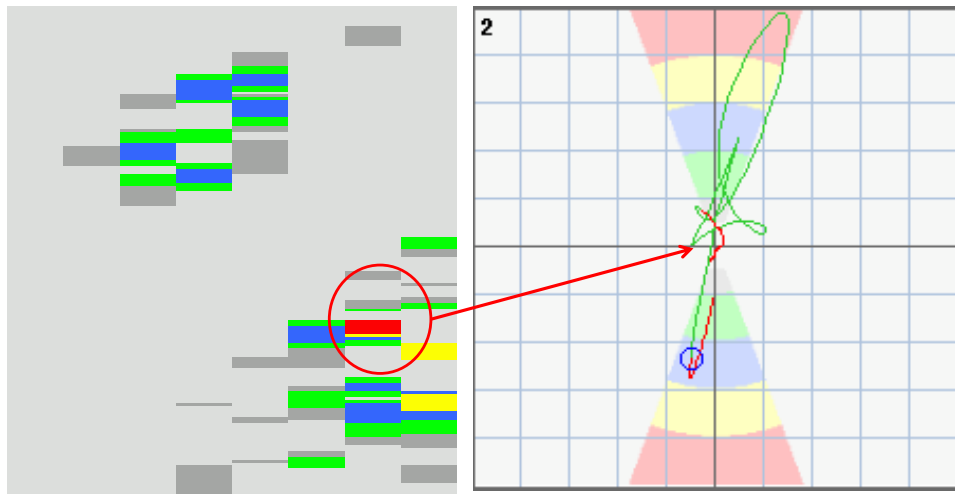
Figure 6: Signal of indication 1

Indication 1:

Indication is found at +0.2 m slightly above LAT. The signal corresponds to a surface corrosion. The depth of the deepest point is in the range of 30% wall loss of the thickness of a wire. The signals were captured by tracks 3 and 7. The screenshots depicted in Figure 6 are taken from Track 7 with magnet on. It is close to indication 2 and of the same kind.

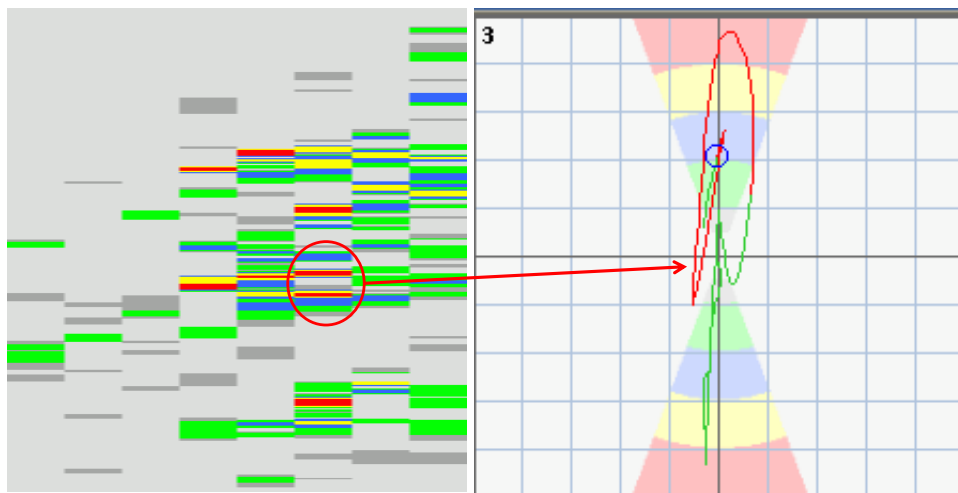
Figure 7: Indication 2; a larger area of surface corrosion

Indication 2:

The second indication is shown in Figure 7. It consists of a larger area of surface corrosion. The loop-signal is shown for a deeper part of the area. The deeper spots should be in a range of 30% wall loss of the outer armoured wire (2nd tensile armour).

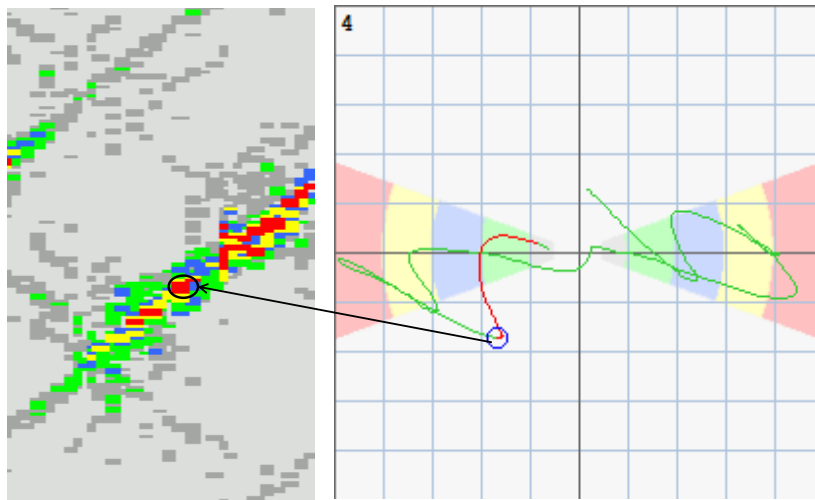
Figure 8: Signal of Indication 3

Indication 3:

Indication 3 runs parallel to the outer wire structure. The signal is shown in Figure 8. The width indicates that one wire is affected. The signal shows that this one wire is not in the regular position, but is running on top of the neighbouring wire for a length of about one meter. The signal stems from the edge of the wire and the corresponding void in the remaining structure.

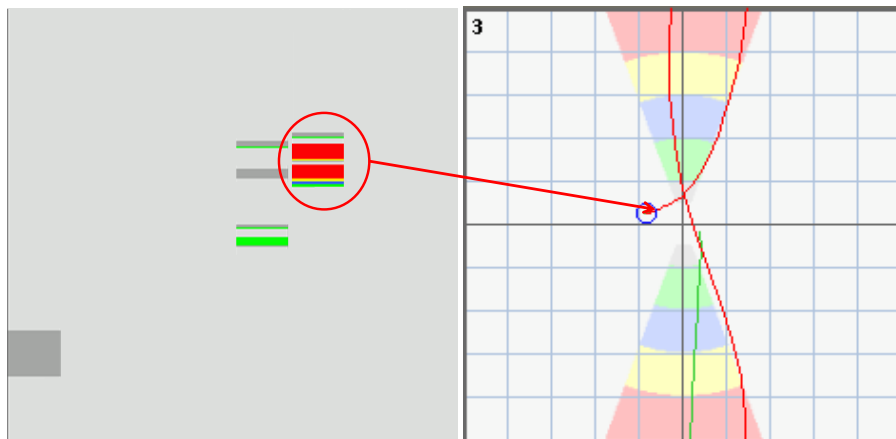
Figure 9: Signal of Indication 4

Indication 4:

The signal of indication 3 is shown in Figure 9. It is a very localised indication. The appearance indicates a crack in a single wire. The signal is only seen on a single sensor. The crack is likely to be at least 50% through the thickness of the outer armour layer. The signal remains with the magnet off. Hence it grows from the outside. A completely snapped wire would produce a larger signal.
