Client	Combined MEC™ Inspection with video	Page 1 of 9
Caisson	MEC™ Internal Caisson (marinised) Inspection Report	Report:J1739

Executive Summary

Innospection has carried out an internal **Magnetic Eddy Current (MEC)** inspection on the client's caisson. MEC is the next generation and improved version of **Saturation Low Frequency Eddy Current (SLOFEC™)**. This report details the inspections which were carried out during the inspection campaign.

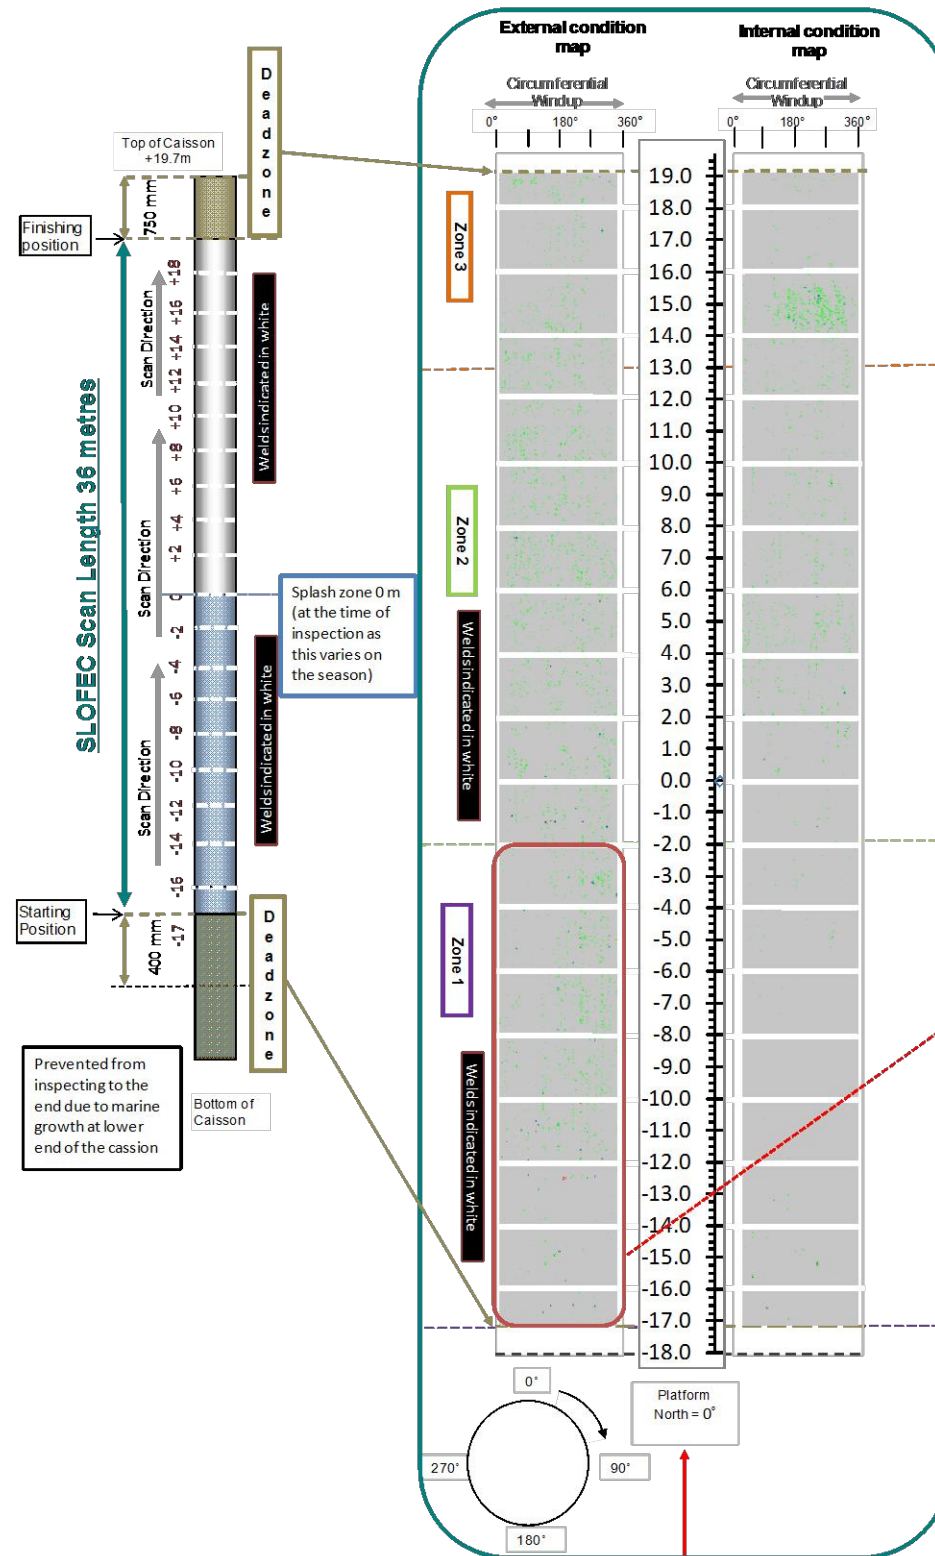
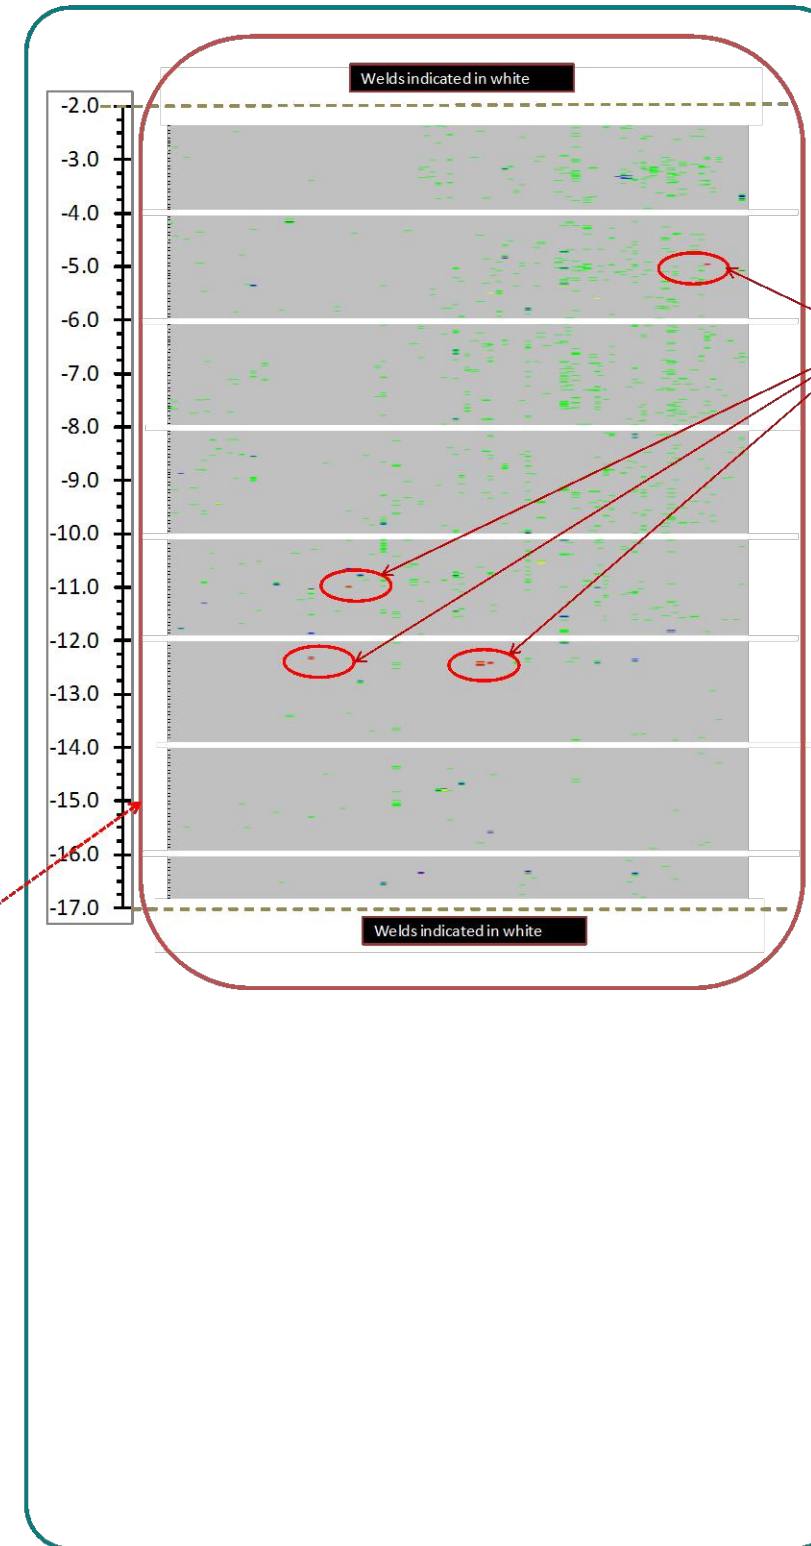
External Scan Report Zone 1

No severe wall losses:
Maximum wall loss up to 30%. Very minor indications of >50% wall loss (In comparison to calibration)

Very small amount of red indications highlighted with red circles are >50% max wall loss
