Offshore Field	Pipeline Inspection Report	Report: No KXXX-15INT

SUBSEA PIPELINE EXTERNAL INSPECTION REPORT

Using MEC™ and UT

Final Report: K001-15INT-B

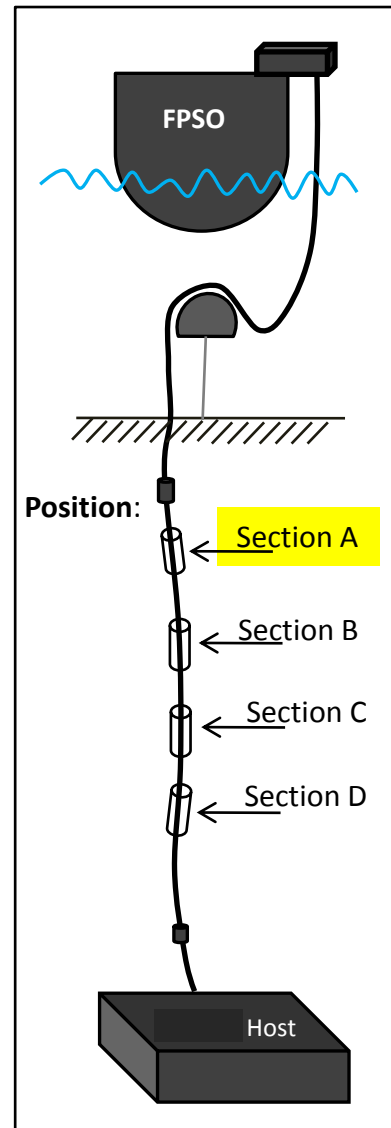
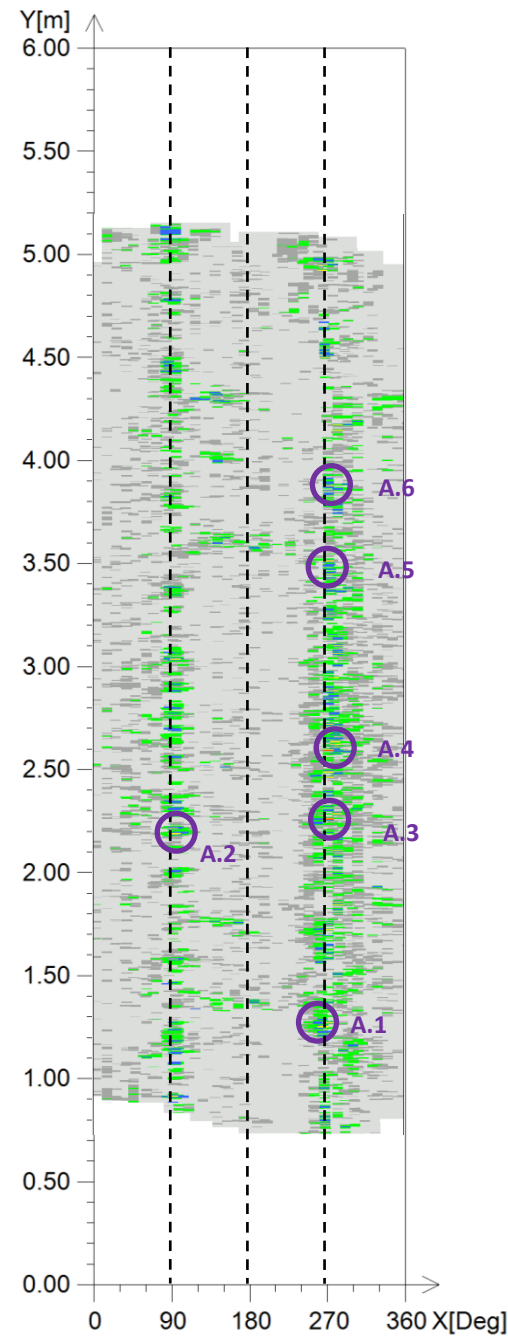
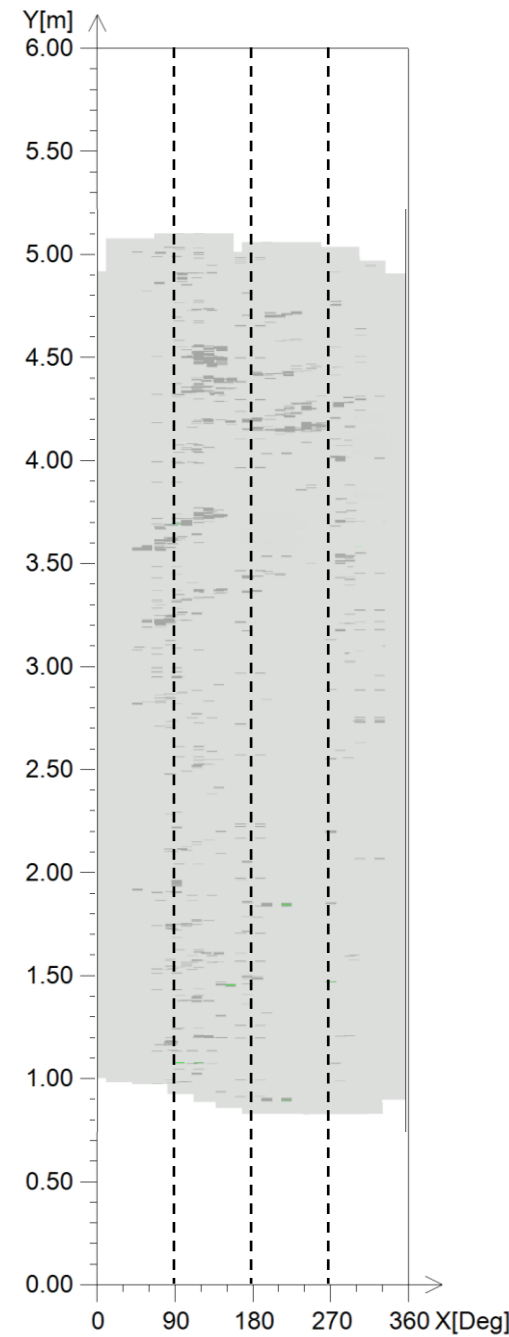
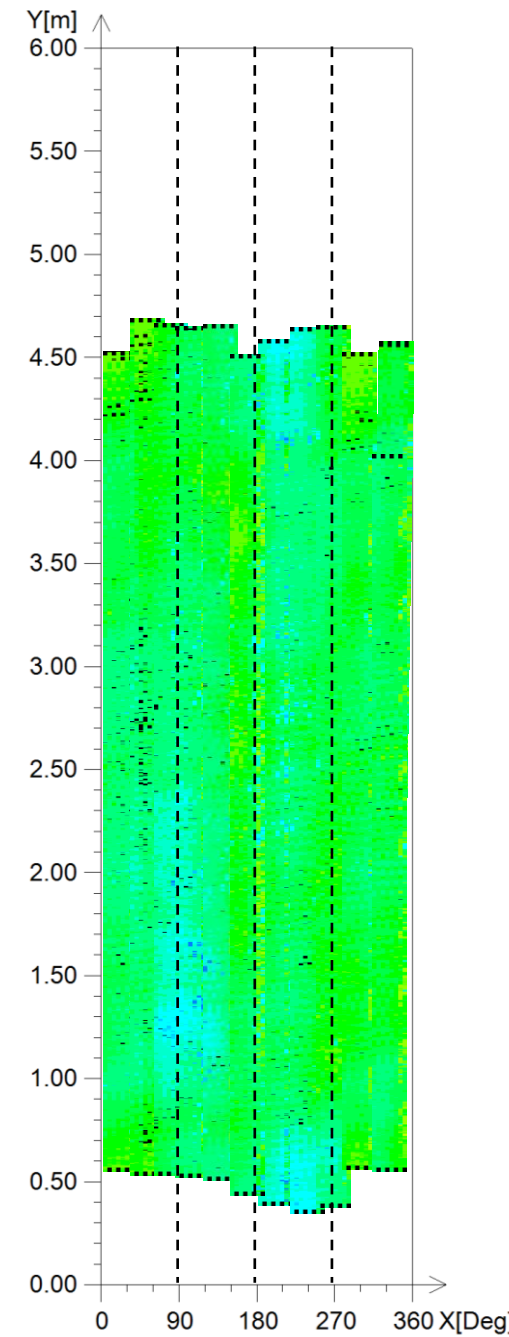
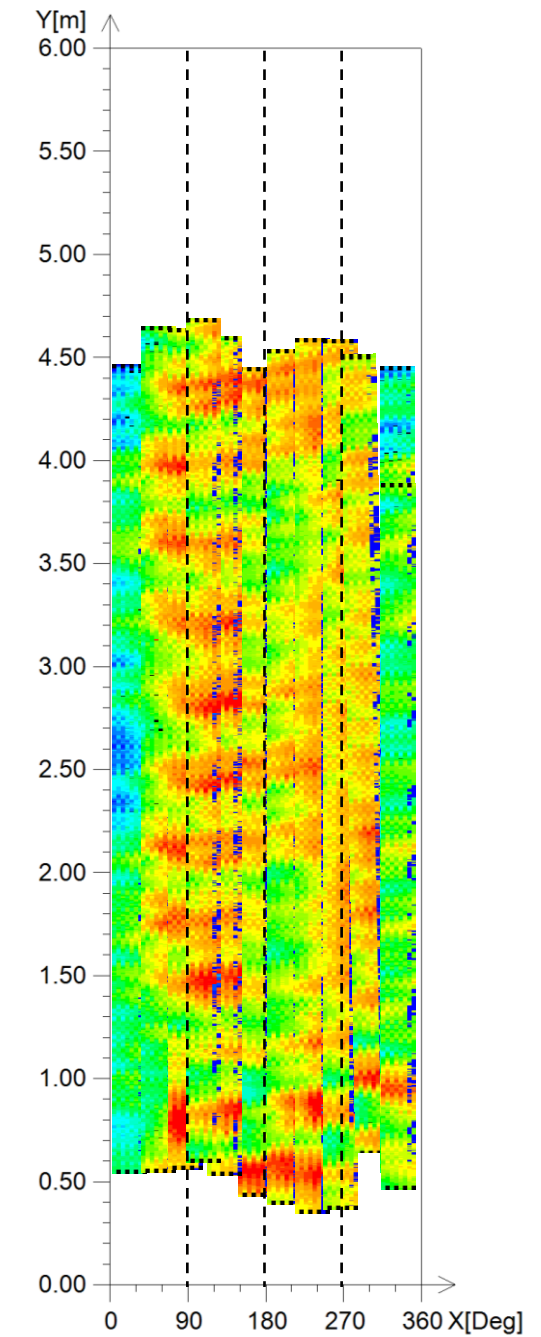
MEC and UT subsea pipeline inspection report Location (East) Section A

Results:

Two lines of pitting corrosion found at 3 and 9 o'clock. Deepest pitting about 25% loss of wall thickness (A.5).

For section A, two lines of pitting corrosion found at the 3 o'clock (90°) and 9 o'clock (270°) orientation. The deepest pitting is about 24% loss of wall thickness (A.4).

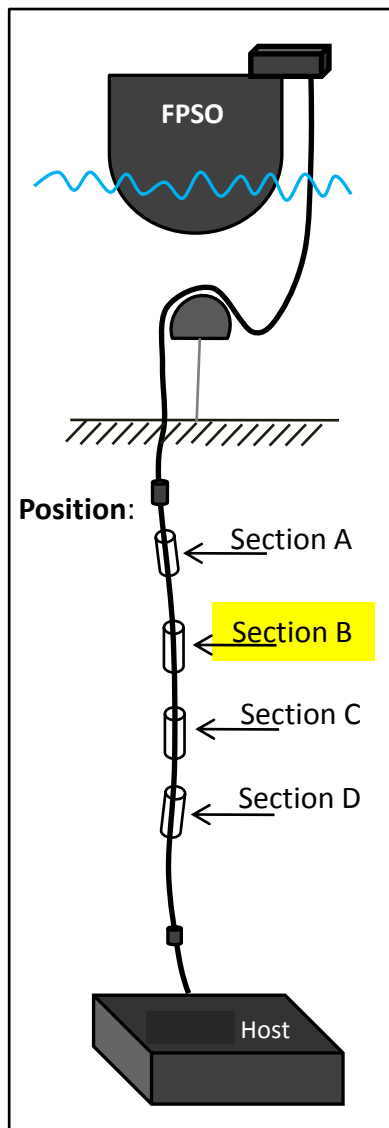
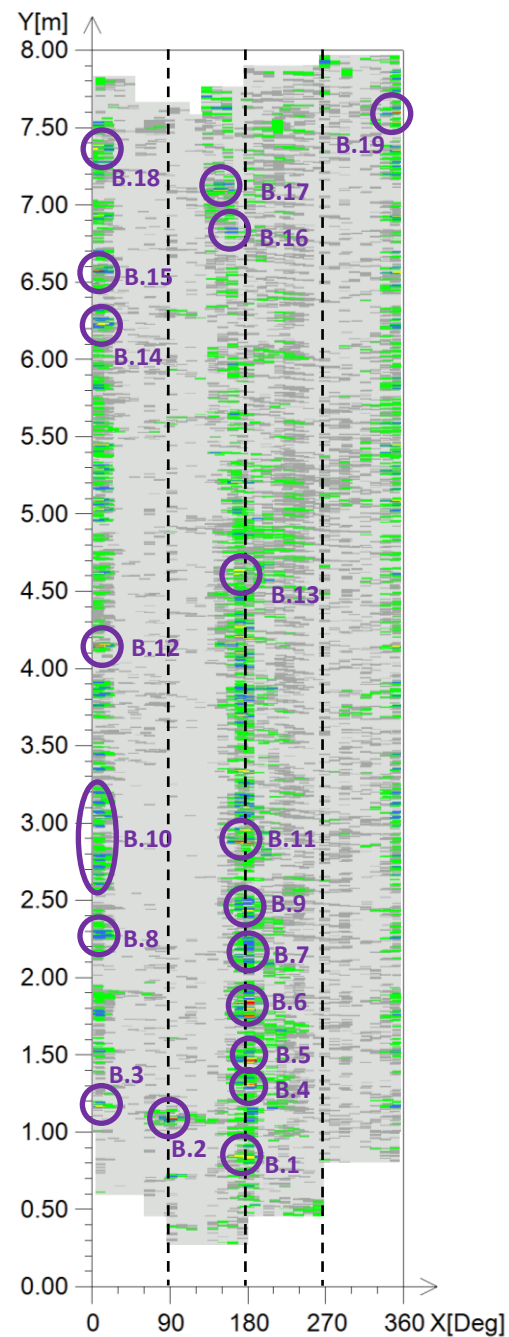
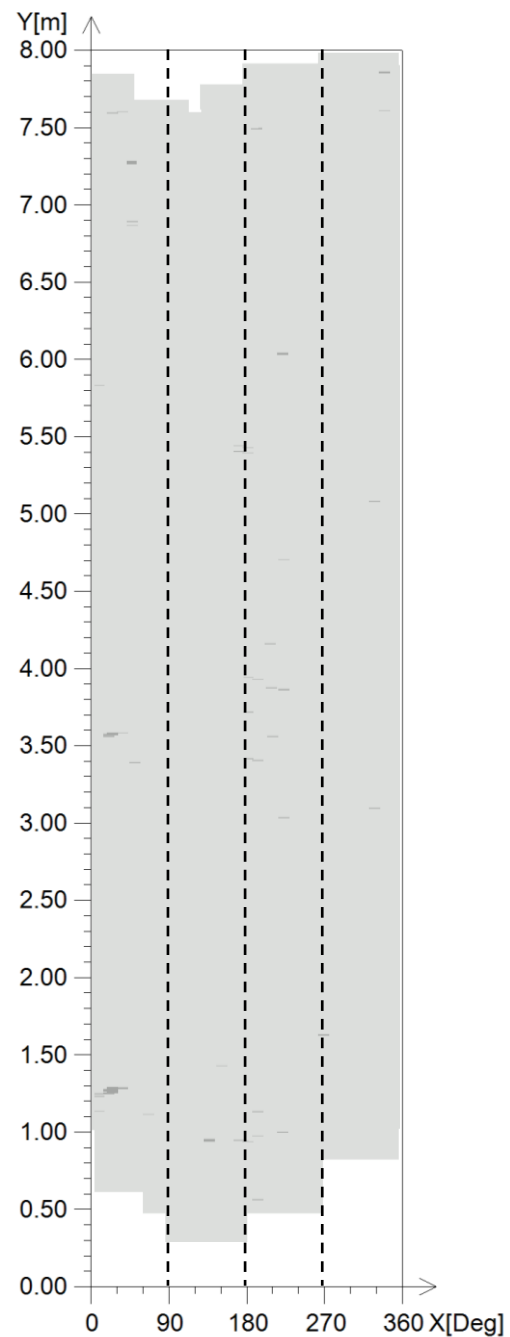
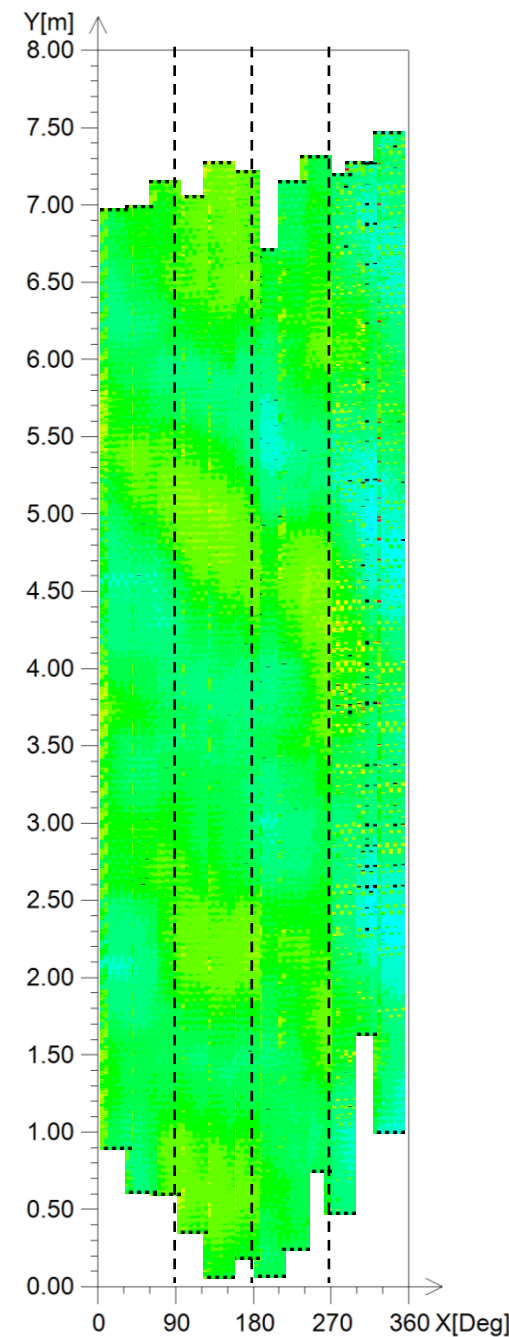
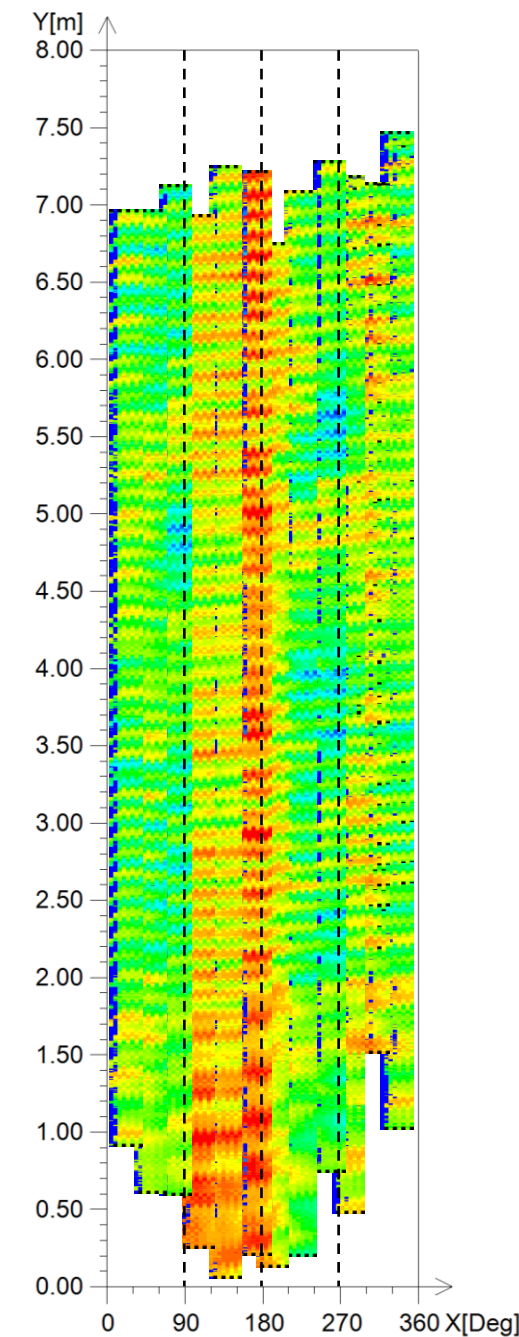
MEC and UT subsea pipeline inspection report Location (East) Section B

Results:
One line of intense pitting corrosion found at 6 o'clock with deepest pits above 25% wall loss. Another line found at 12 o'clock.

In Section B, one line of intense pitting corrosion found at 6 o'clock with deepest pits about 25% deep (B.11). Another line found at 12 o'clock. The number and density is the highest in this section compared to other sections.

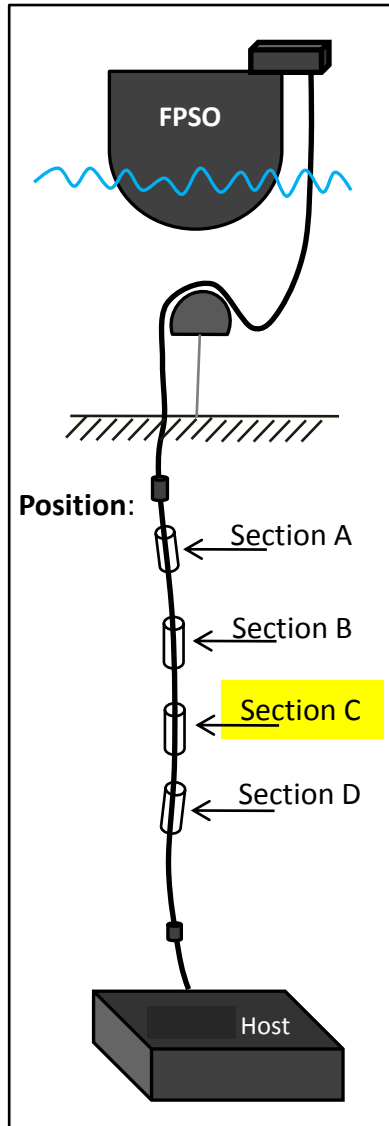
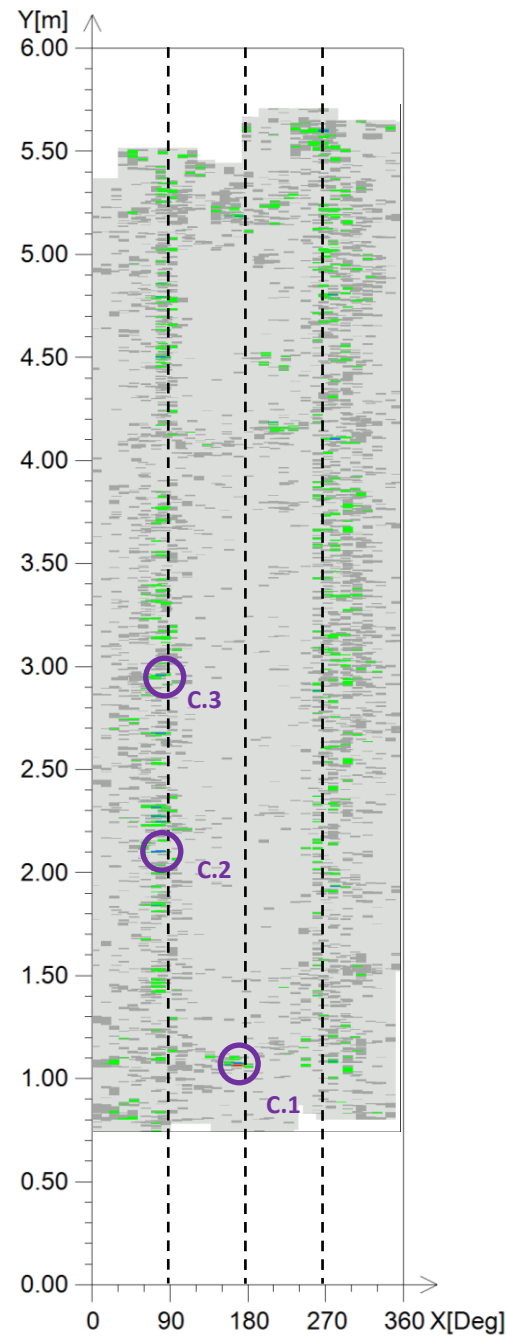
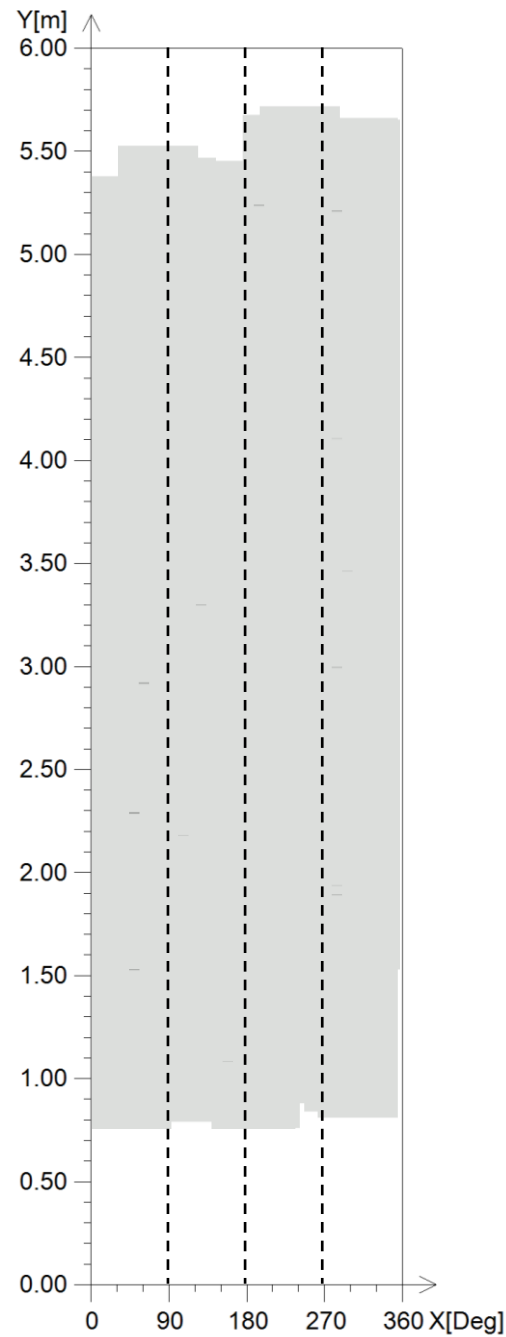
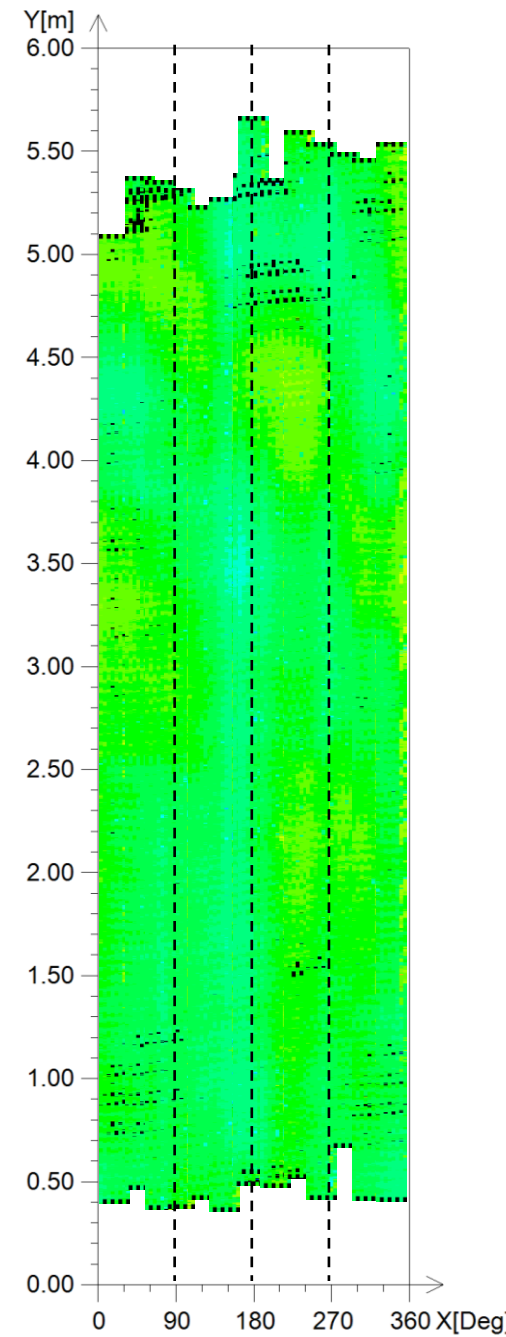
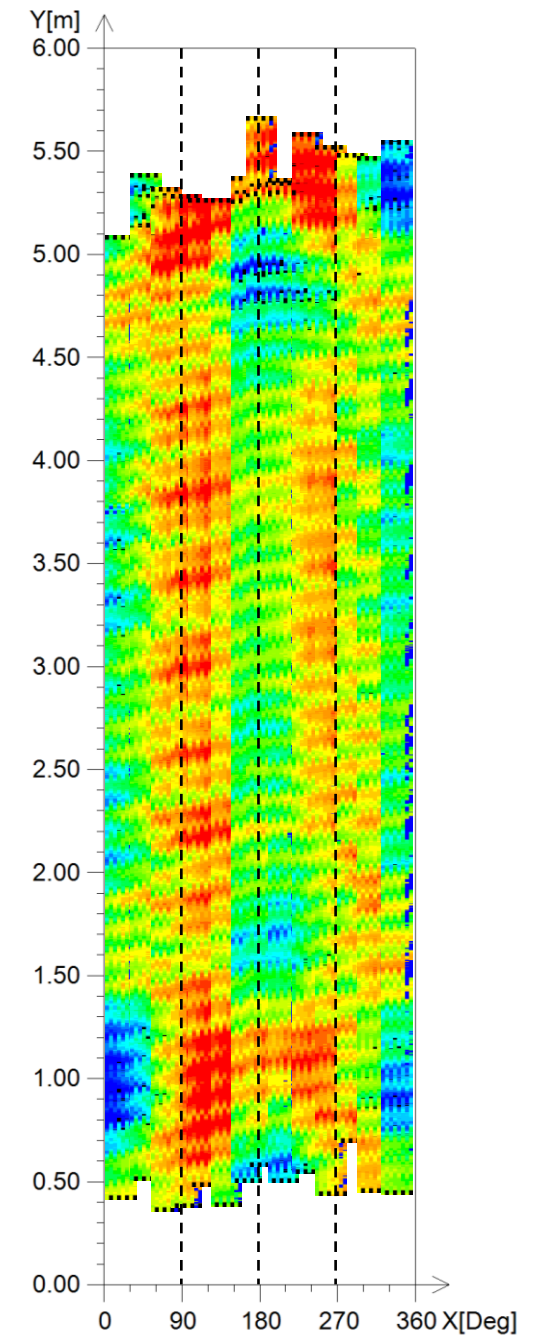
MEC and UT subsea pipeline inspection report Location (East) Section C

Results:

Two lines of minor pitting corrosion found at 3 and 9 o'clock. One isolated deeper pit found in 6 o'clock orientation (C.1).

Section C shows two lines of minor pitting corrosion found at 3 and 9 o'clock. One isolated deeper pit found in 6 o'clock orientation (C.1).

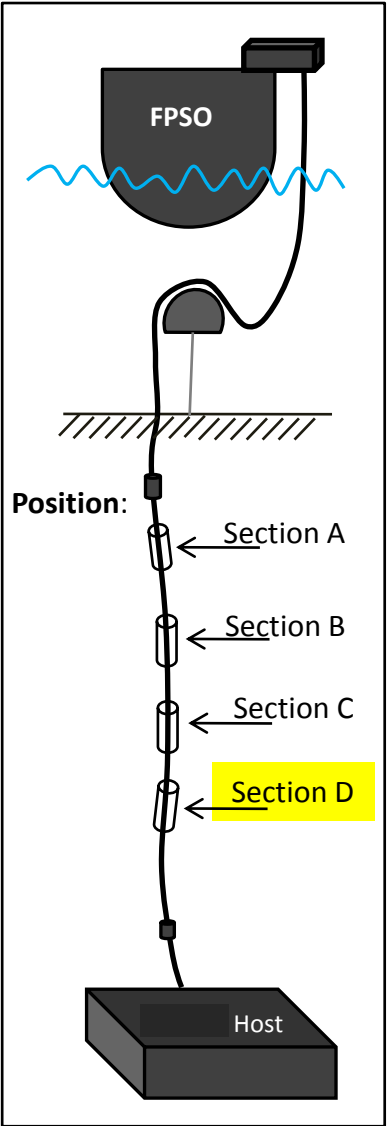
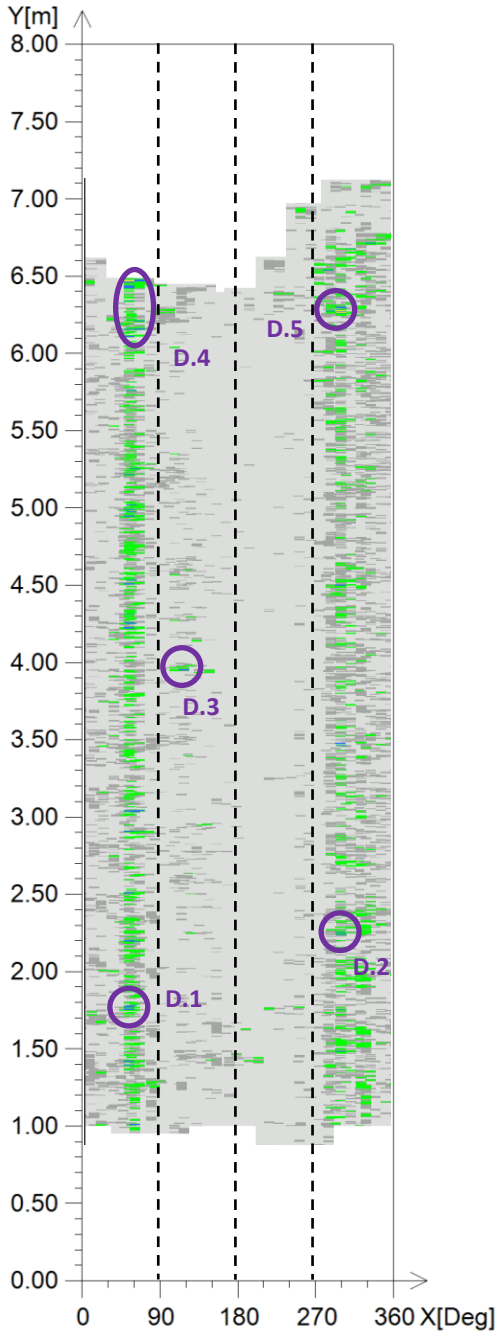
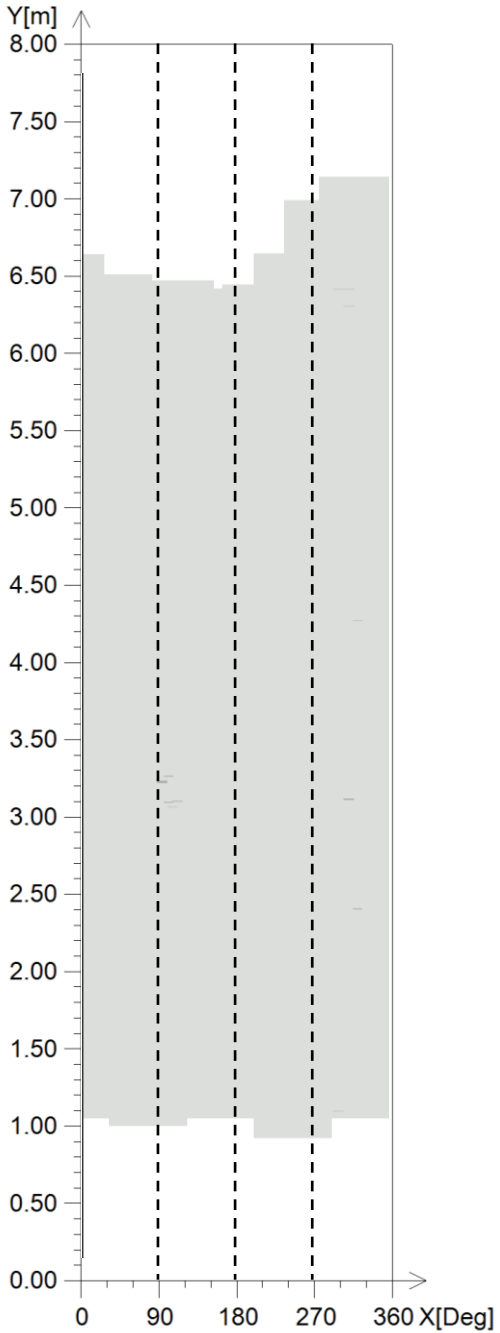
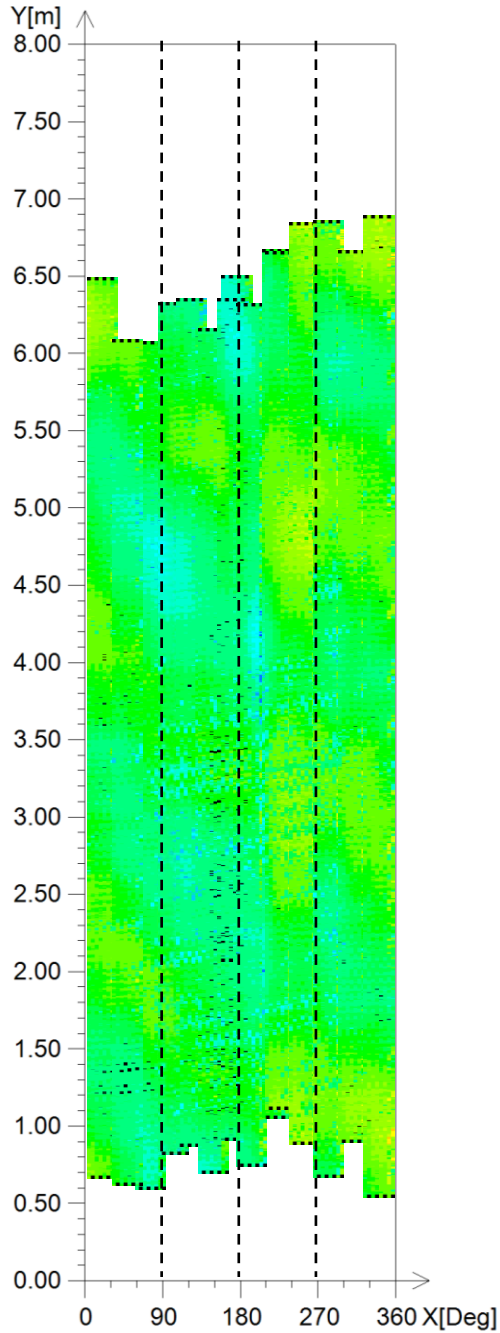
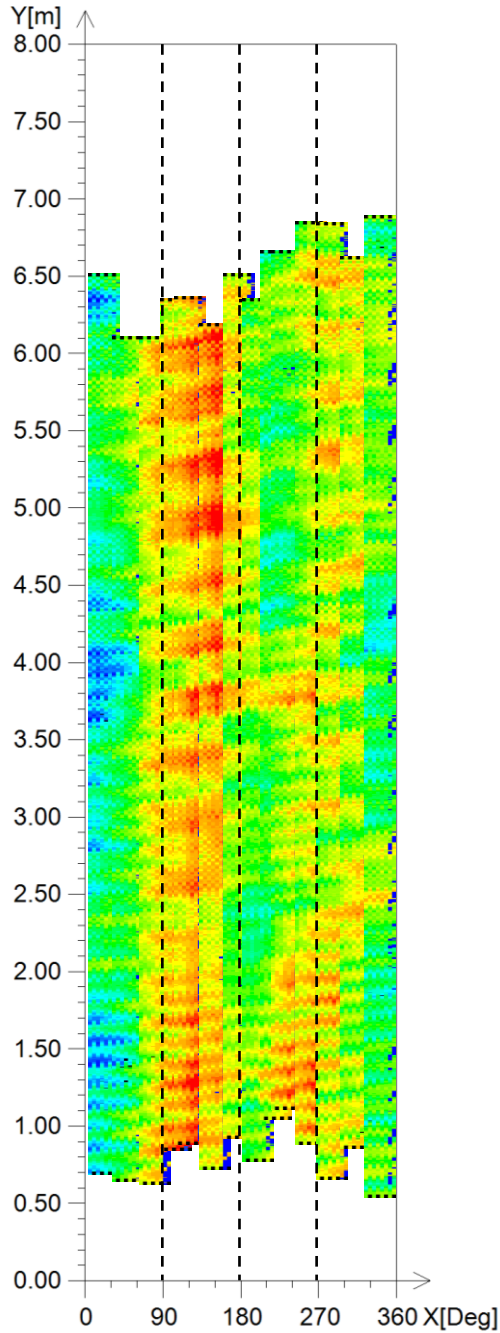
MEC and UT subsea pipeline inspection report Location (East) Section D

Results:

Two lines of pitting corrosion found at 10 and 2 o'clock orientation.

Section D shows two lines of pitting corrosion found at 10 and 2 o'clock orientation.

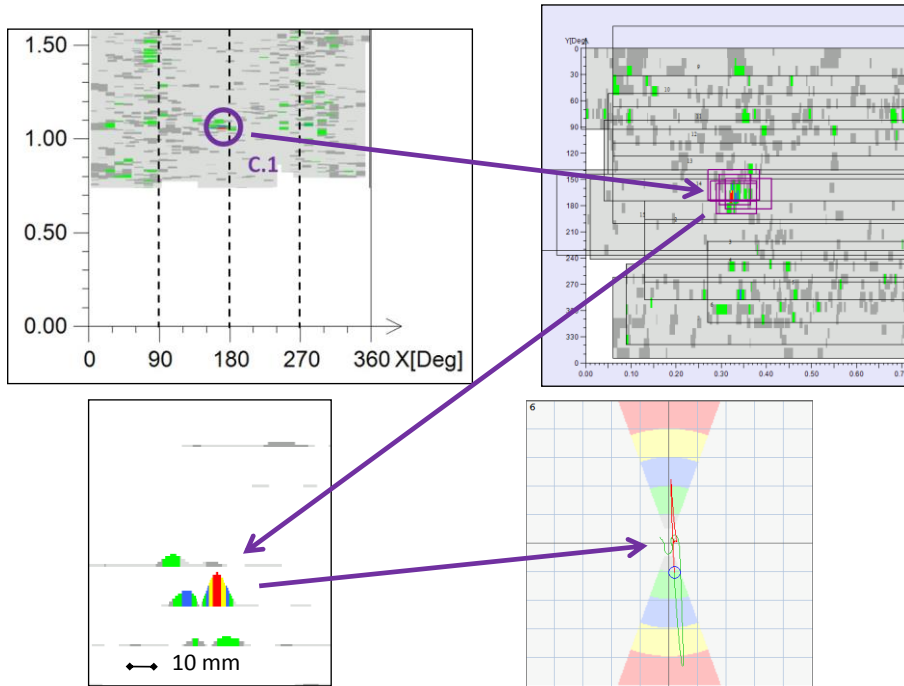
A significant indication is found in Section C with item C.1. It is not embedded in the channelling but rather isolated. It is scanned in five different scans.

Figure 5: Detailed view of the indication C.1

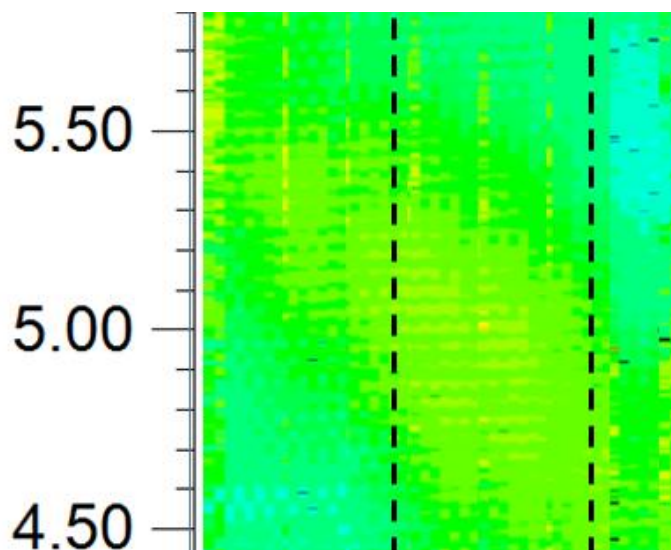
The UT wall thickness mapping does not show any degradation of the wall thickness. Instead manufacturing related gradual variations of the wall thickness are visible. Even certain patterns are visible in particular in Section B. They show a typical pattern of seamless pipe. Figure 6 shows such a fine pattern with near horizontal stripes and a larger helical pattern.

Figure 6: Manufacturing related wall thickness variations visible in the UT data in section B.
