SLOFEC TANK FLOOR INSPECTION REPORT

Items Inspected: Tank123

Inspection Method: SLOFEC

Report Number: K0xx-16

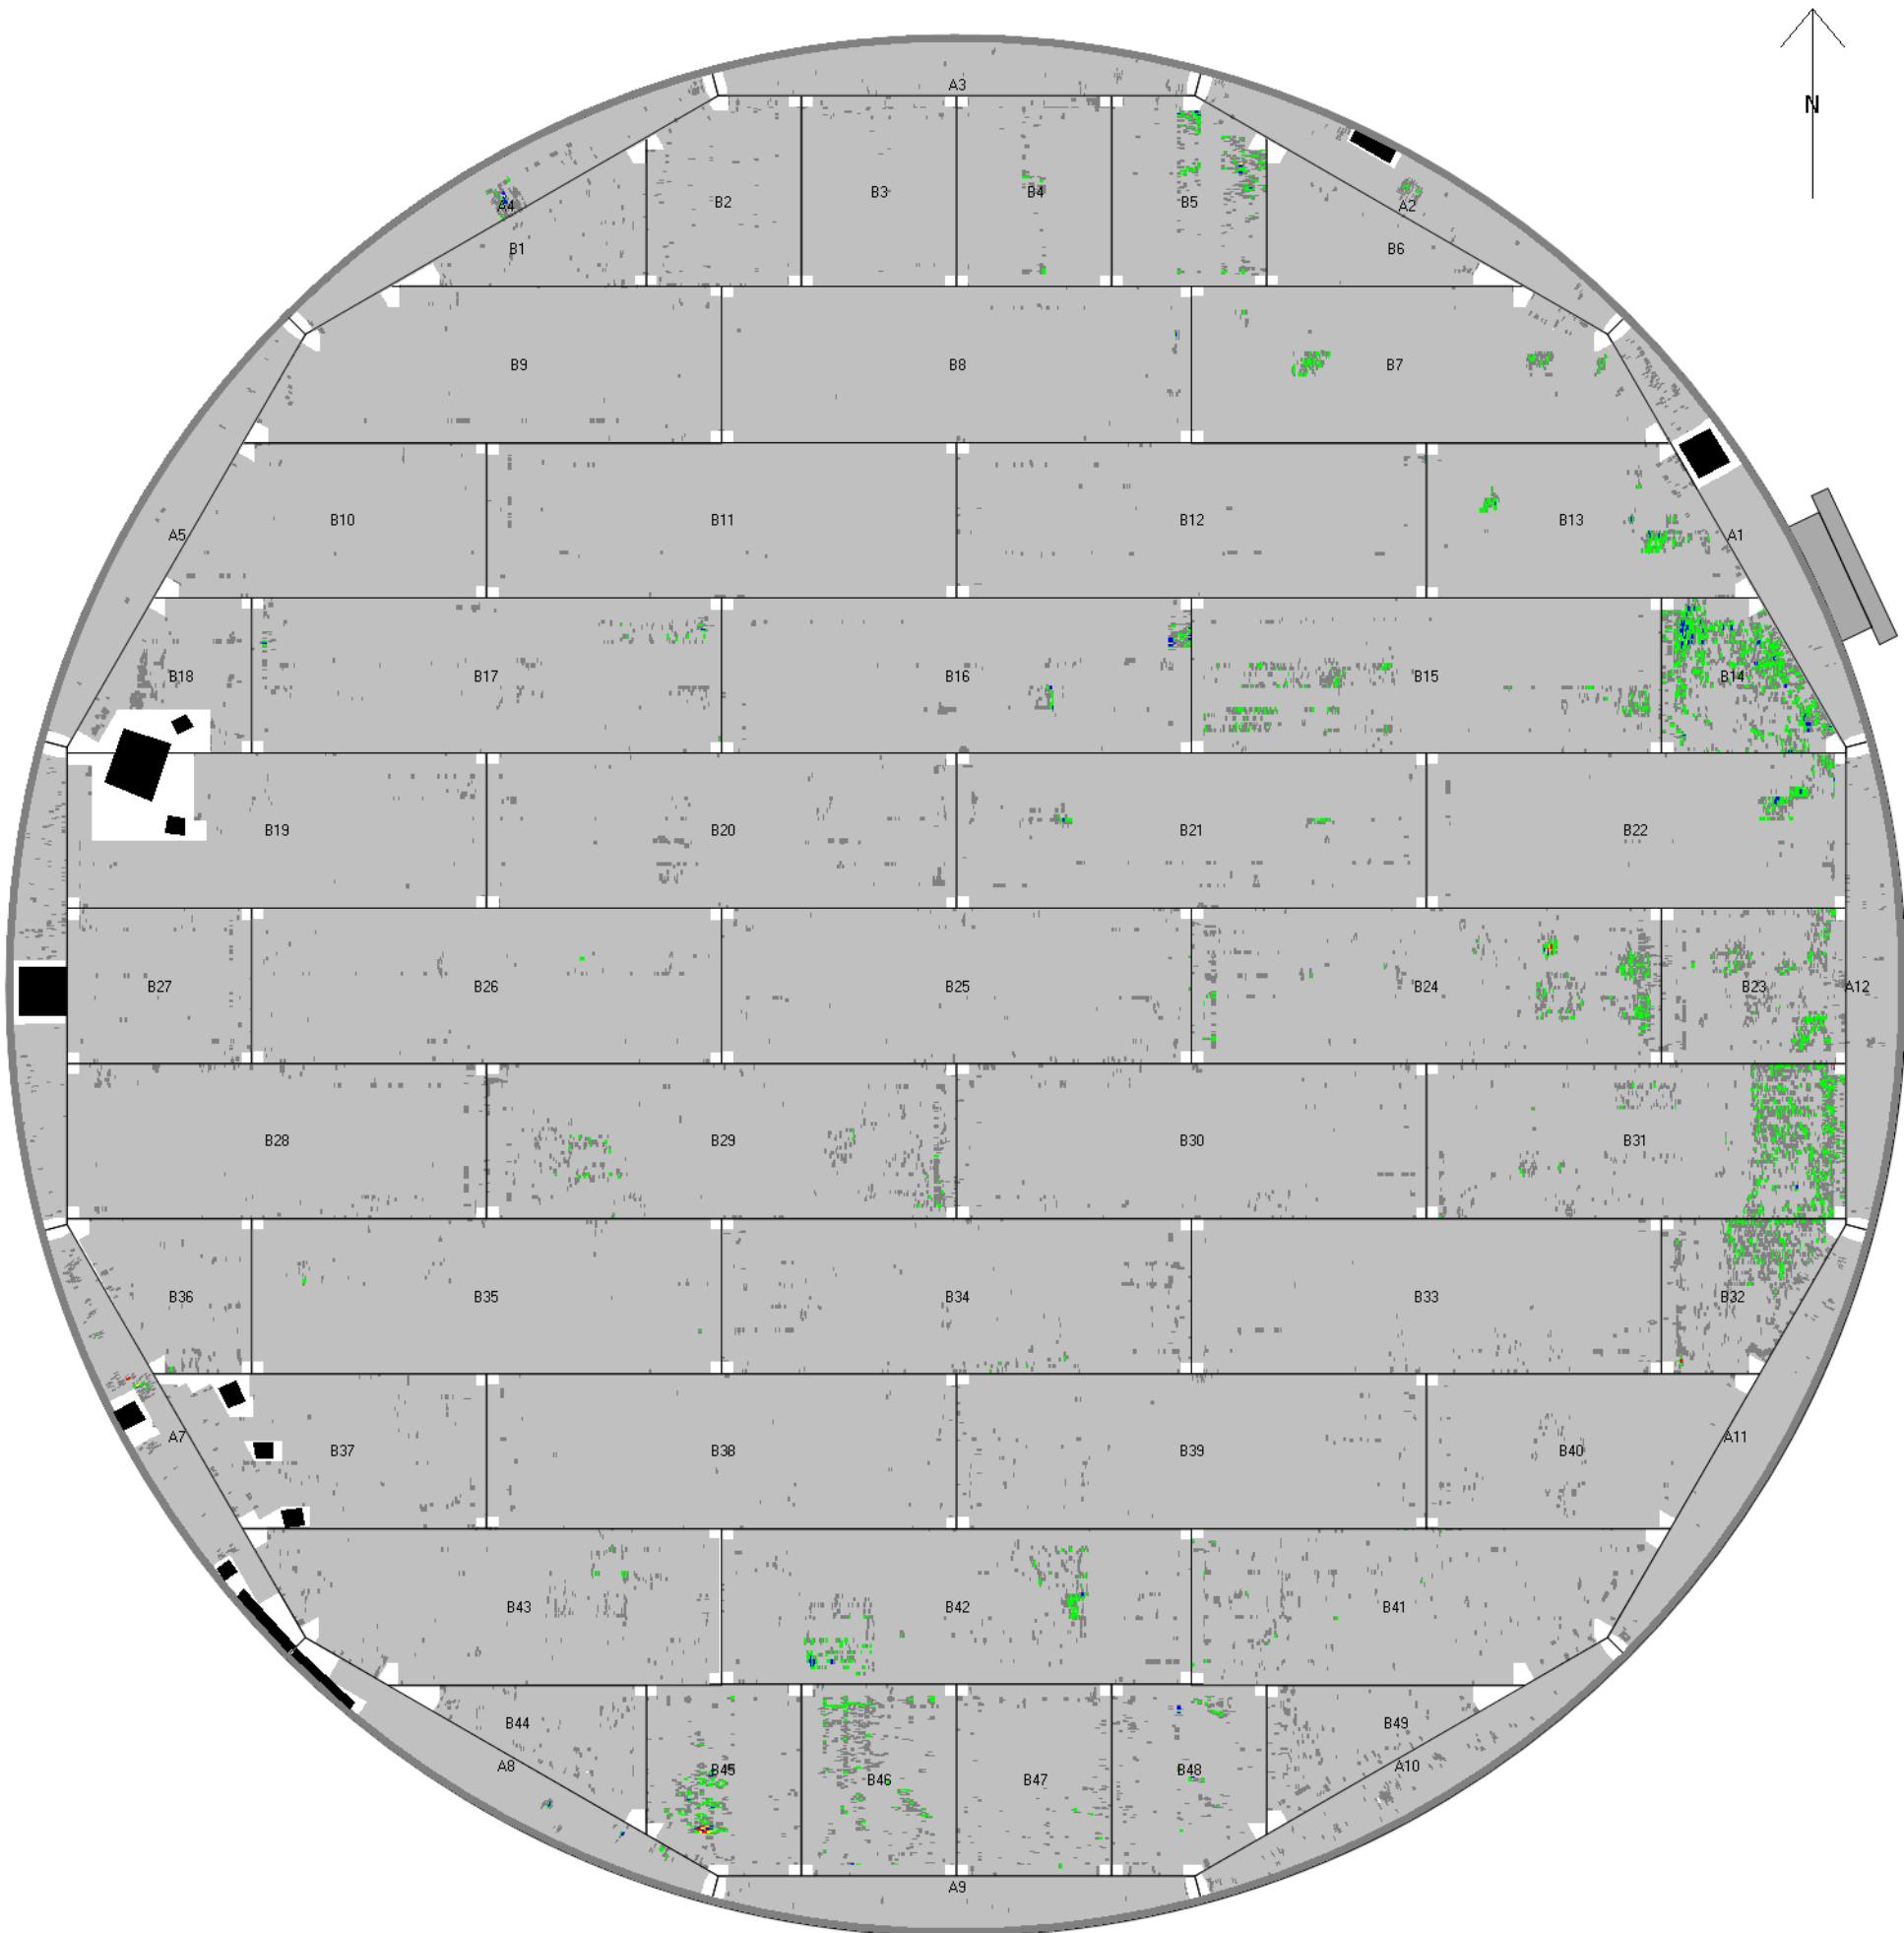
General Tank Floor Overview

Number of plates identified with main indications on underside of tank floor

Below 20% wall loss	: 28 plates
20% - 30% wall loss	: 14 plates
31% - 40% wall loss	: 7 plates
41% - 50% wall loss	: 4 plates
Above 50%wall loss	: 5 plates

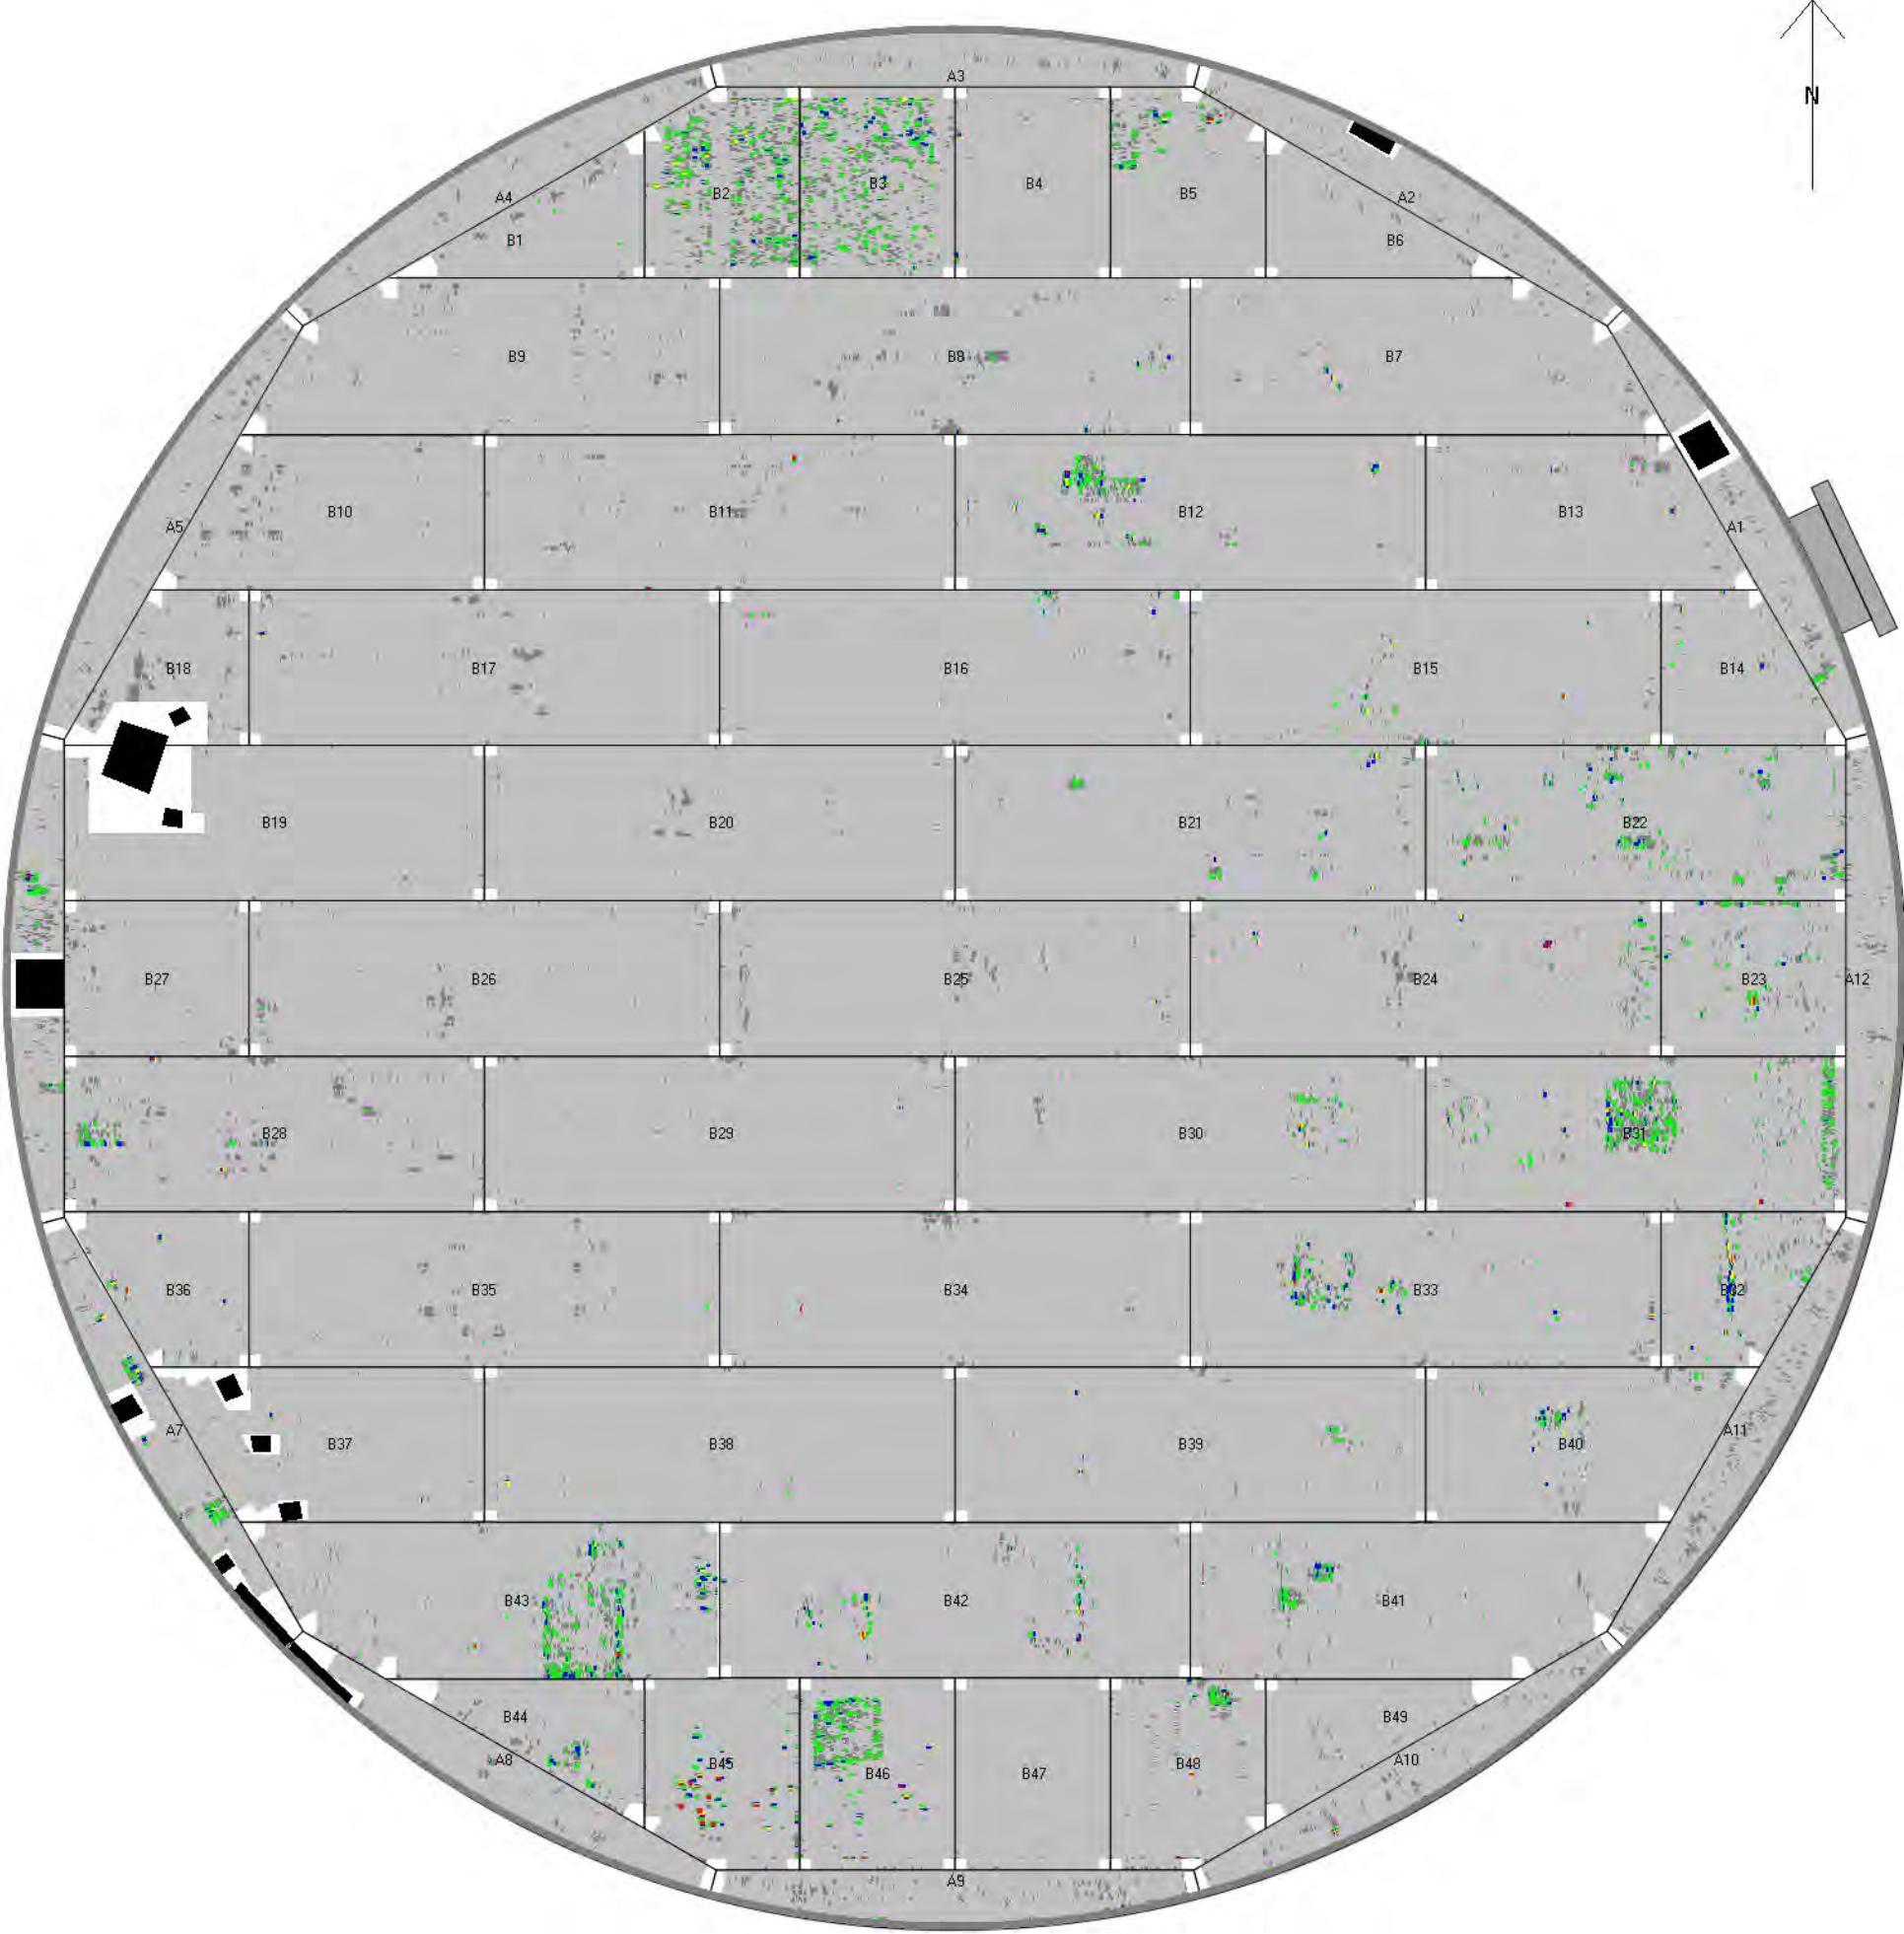
General Tank Floor Overview
Individual Plate View

Number of plates identified with main indications on topside of tank floor

Below 20% wall loss	: 13 plates
20% - 30% wall loss	: 4 plates
31% - 40% wall loss	: 5 plates
41% - 50% wall loss	: 13 plates
Above 50%wall loss	: 26 plates
