MEC™ TANK FLOOR INSPECTION

Client: Client a

Facility: site b

Items Inspected: Tank c

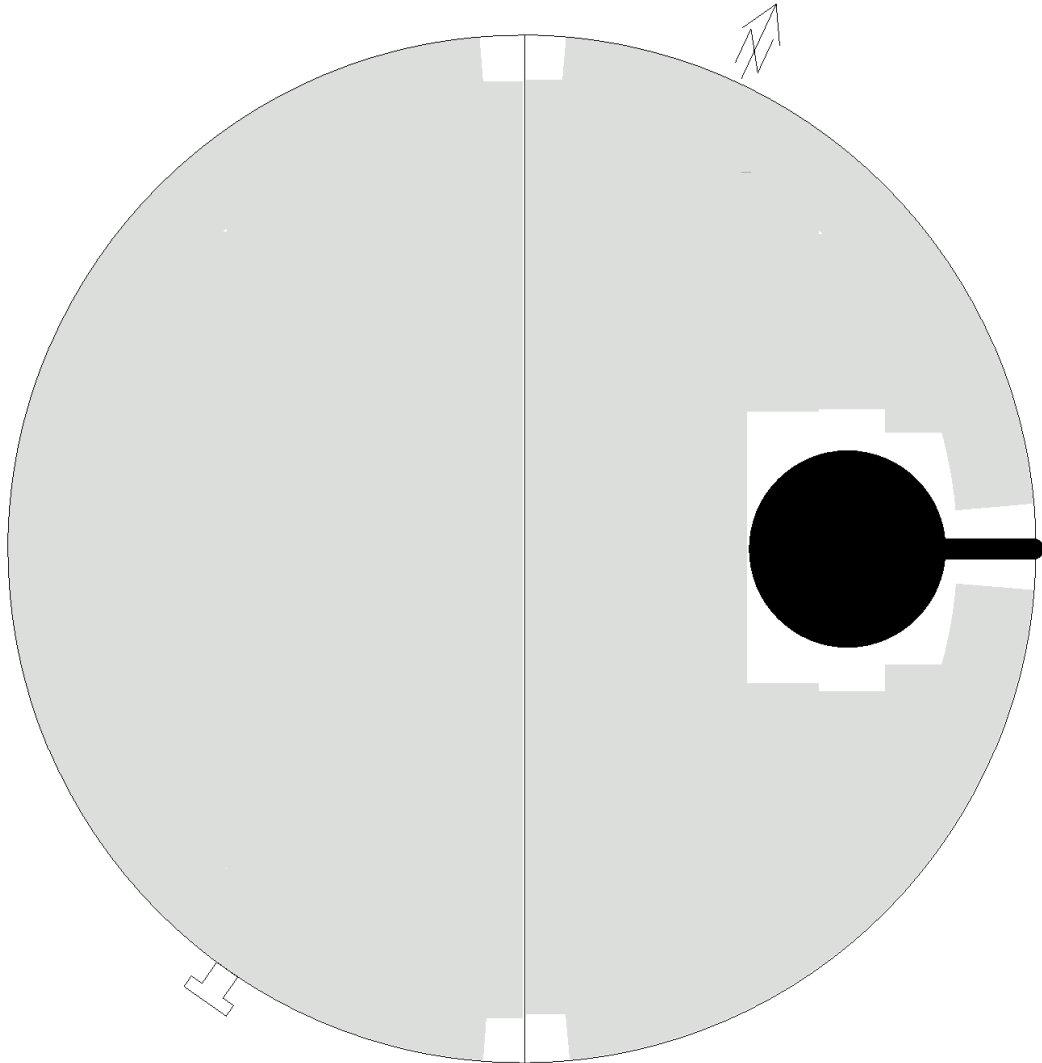
Overview of Scan Results

Minor topside, general pitting was evident; this appears to have occurred prior to the painting of the tank floor and lower shell wall.

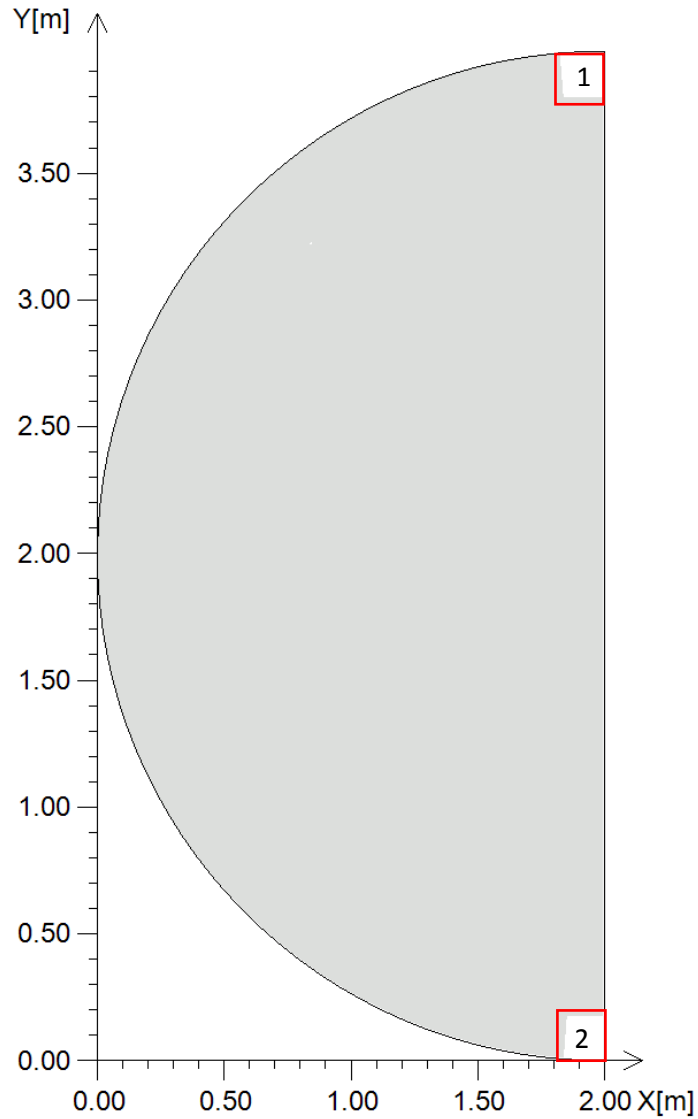
Ultrasonic Scan Results Plate B1

Remarks: 150mm x 150mm areas marked and scanned with UT. Lowest wall remaining reading in each square recorded.

No.	Pos. x [m]	Pos. y [m]	Depth [mm]	Type
1			8.2	Nominal wall
2			8.1	Nominal wall

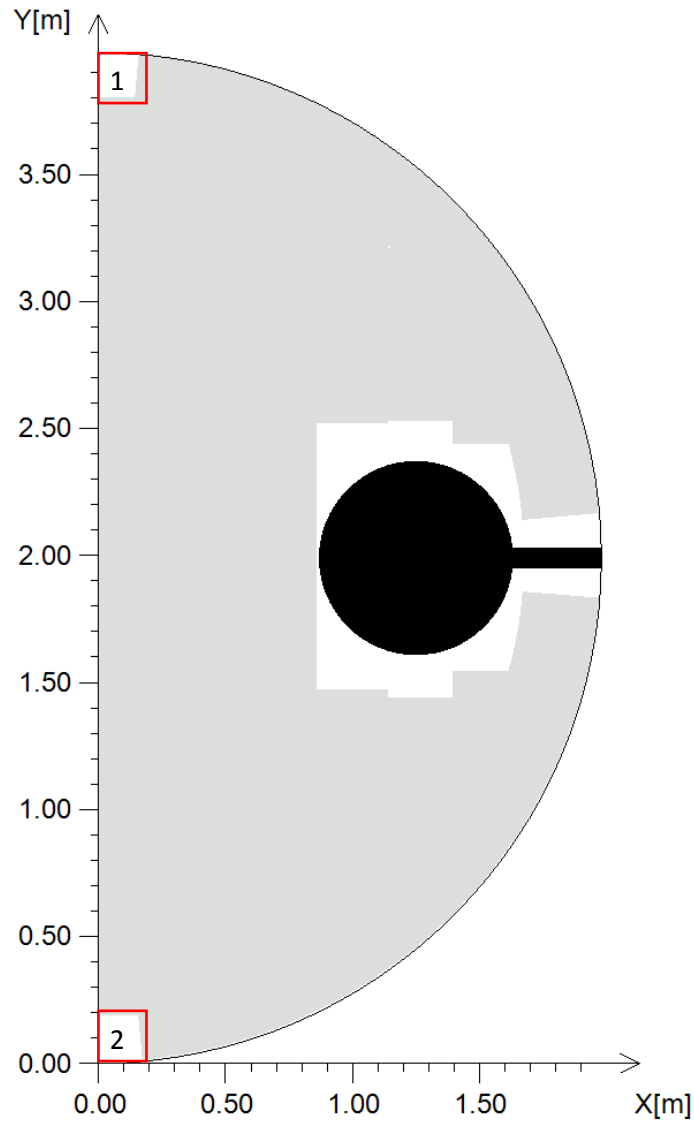
Scan Results Plate B2

Remarks: a Maximum area of 150mm x 150mm was marked and scanned with UT. Lowest wall remaining reading in each square recorded.

No.	Pos. x [m]	Pos. y [m]	Depth [mm]	Type
1	0	2	8	Nominal wall
2	0	0	8.1	Nominal wall

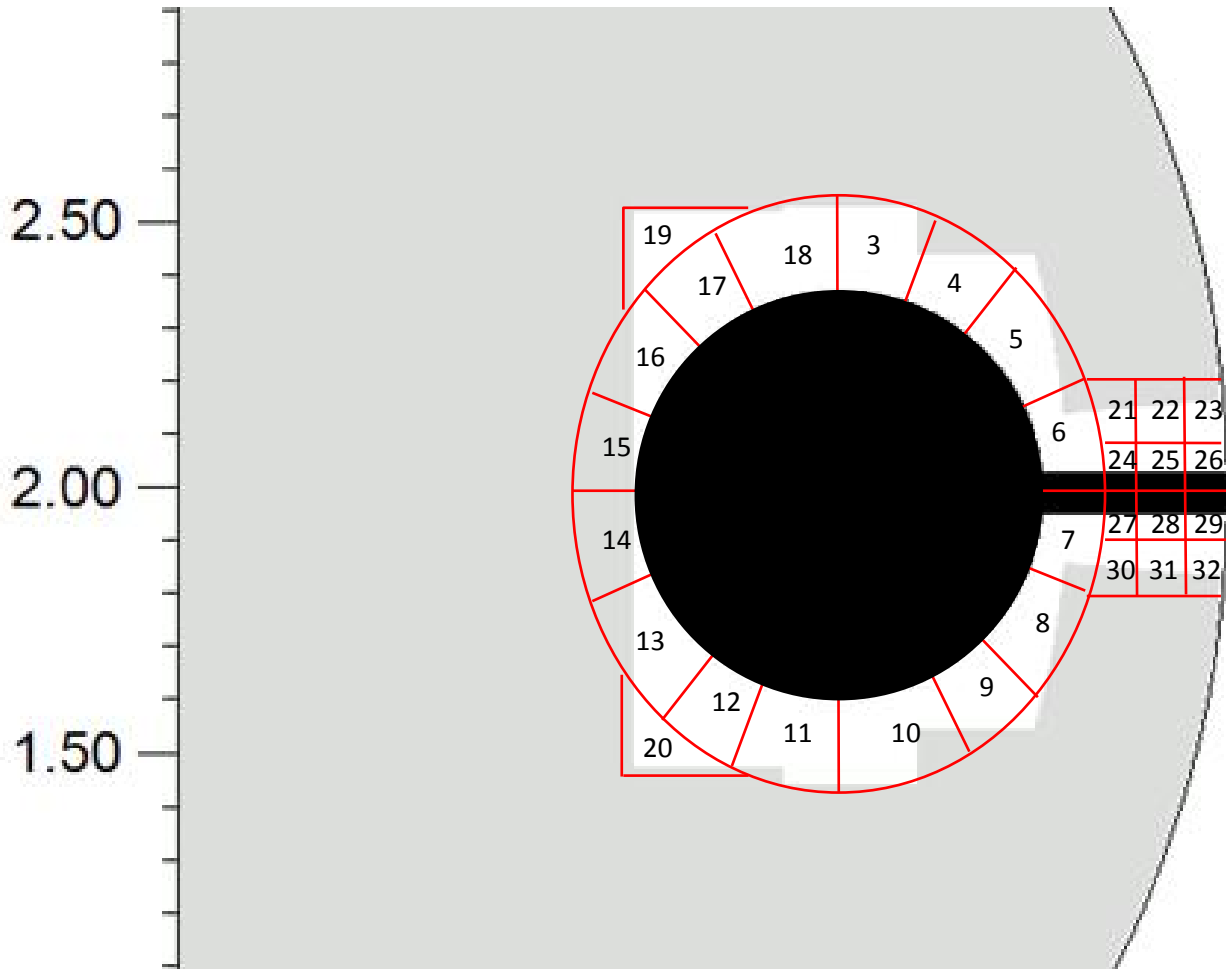
Ultrasound Scan Results Plate B2

Remarks: a Maximum area of 150mm x 150mm was marked and scanned with UT. Lowest wall remaining reading in each square recorded.

No.	Pos. x [m]	Pos. y [m]	Depth [mm]	Type
3			8	Nominal wall
4			8	Nominal wall
5			7.9	Nominal wall
6			8.1	Nominal wall
7			8.1	Nominal wall
8			7.9	Nominal wall
9			8	Nominal wall
10			8.2	Nominal wall
11			8.1	Nominal wall
