Leak / Through Hole (Worm Hole) Defect Detection with SLOFEC[™] Technology

As requested by CLIENT, Innospection has carried out a SLOFEC[™] (Saturation Low Frequency Eddy Current) inspection on a floor plate sample from Tank XXXX.

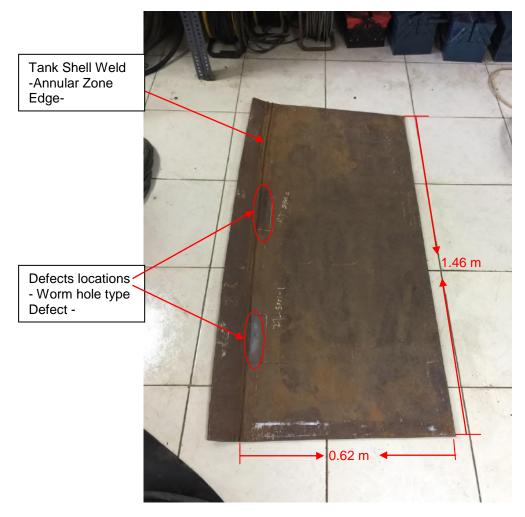
Figure 1: Cut out Sample dimensions & leak locations

The sample plate was made available for Innospection on Wednesday 1st Feb 2017 and the test was done on 2nd Feb 2017 in the presence of the CLIENT. The sample was cut out from the Tank annular zone with the bottom to shell weld still on the plate side. The plate is 10mm thick with no coating on. See **Figure 1**.

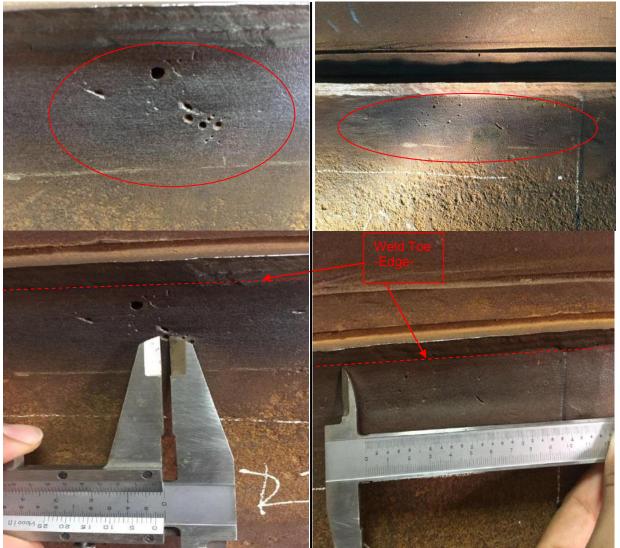
Figure 2: showing both leaked locations from topside

Two leak locations on the test plate were inspected by RT and identified by CLIENT. At the leak locations are very small pitting on the topside of the plate and small pits on the underside.

As seen in the pictures in Figure 2, the defect locations are very close to the weld toe; with a distance of 5mm to 10mm between the defects and the bottom to shell weld toe.

Defect 1 is small pitting which can be seen from top; the largest pit is around 4mm in diameter; at the second leak area, Defect 2 is the pitting of around 1mm in diameter.

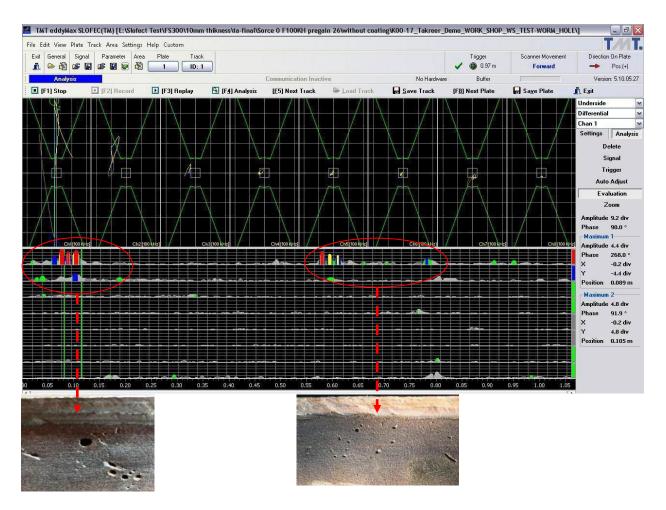
Figure 5: Showing the SLOFEC[™] Signal response from both defect locations

The signals of the defects of concern were clearly detected with amplitude of more than 50% wall loss and the signal phase tends towards the underside signal.

However, a part of the indication can also be seen on the topside signal.

A further few indications at the test plate were also detected in other locations, however those reached a signal amplitude mainly on topside reaching around 20% wall loss maximum.
