INSPECTION REPORT

Facility: Platform Legs

Item Inspected: B2, K2 and K3

SLOFEC™/UT Inspection of Platform Legs

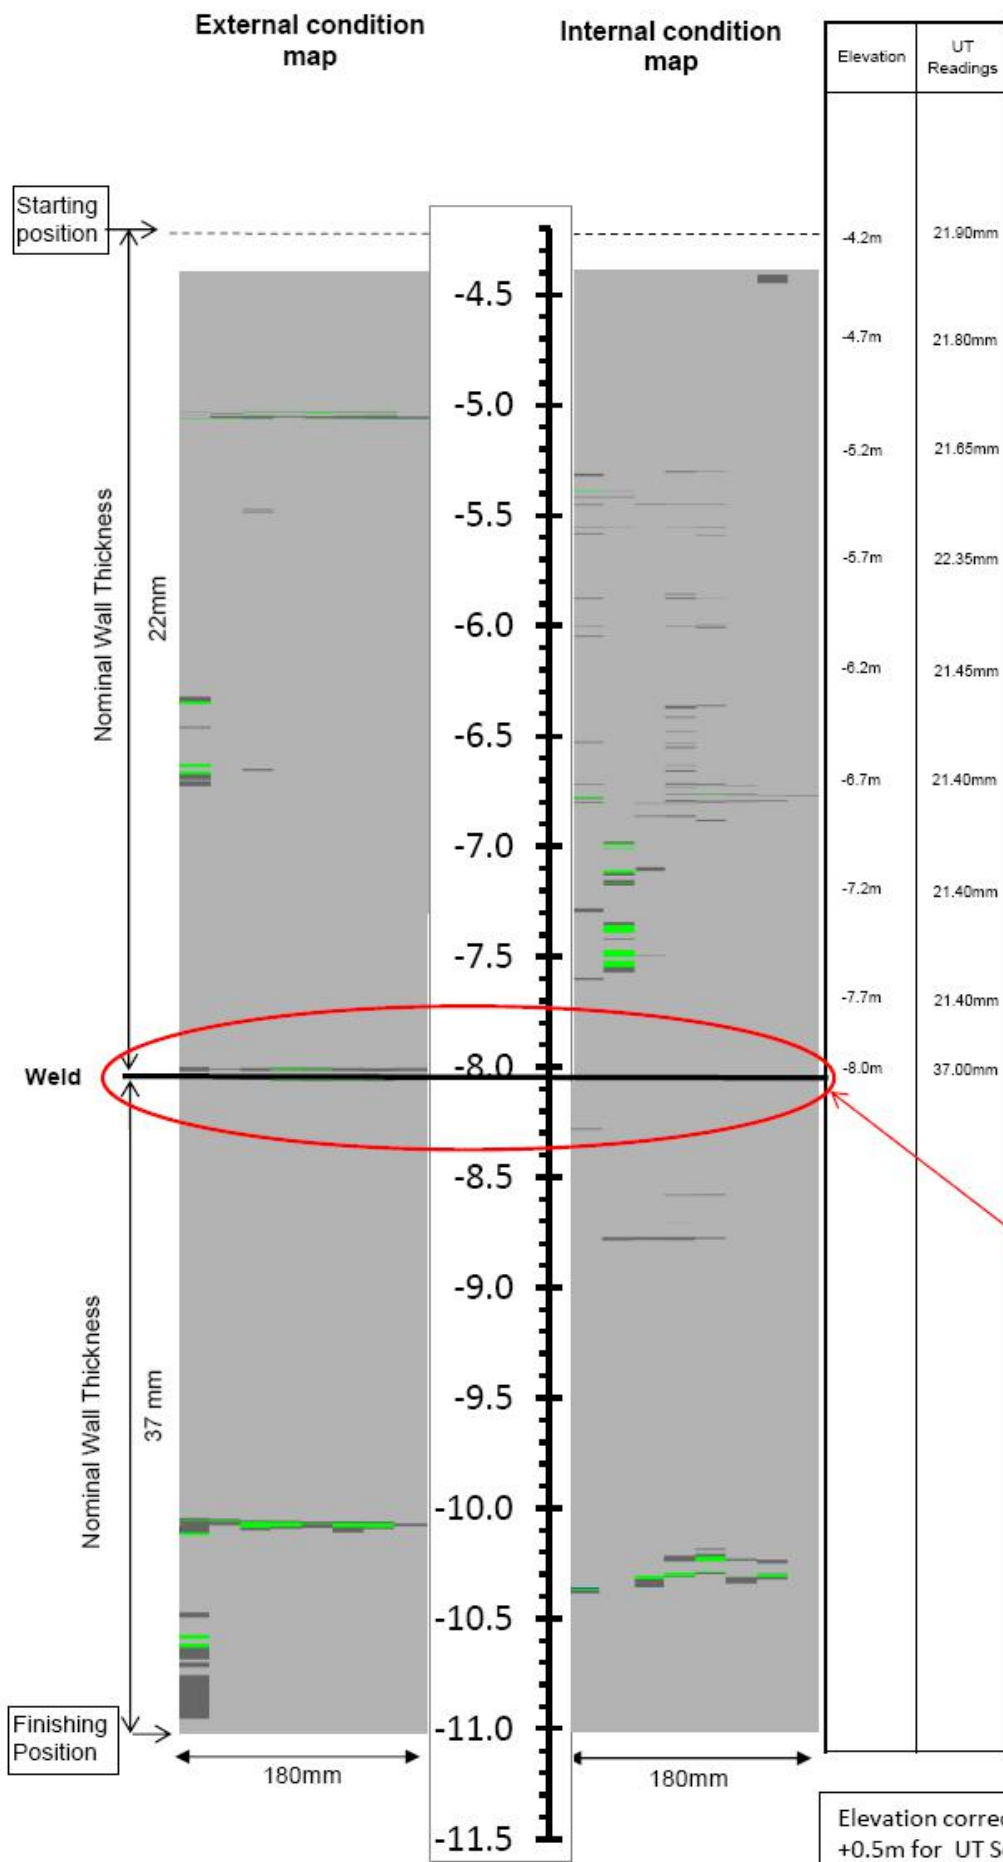
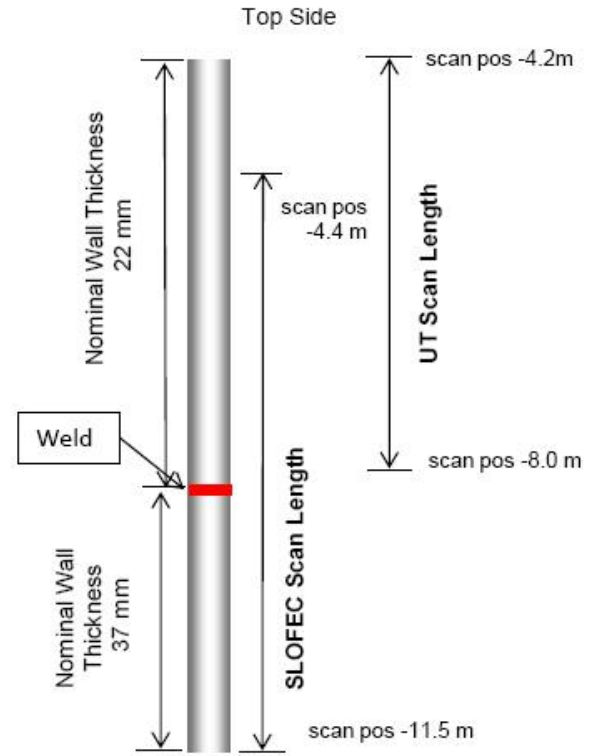
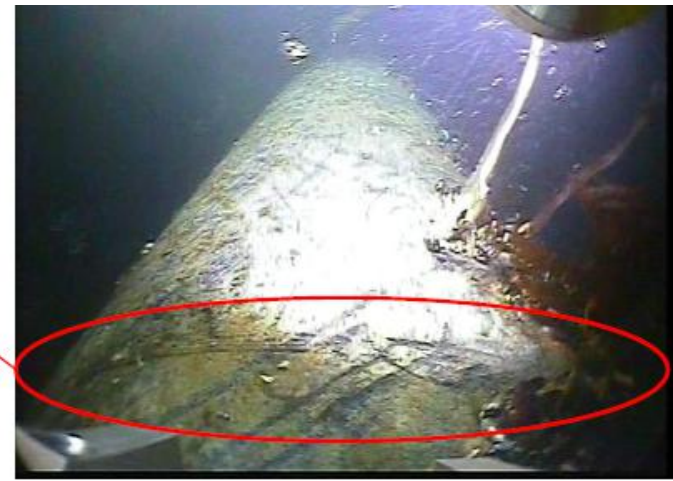
SLOFEC and UT - Scan Report Leg B2 Track 1

Above image is from the ROV during the inspection of Leg B2. Note the weld is clearly displayed

Signals were analysed and no defects were detected. No severe wall loss detected as the indicated signals were above tolerance levels.

No severe external or internal wall losses detected.

Elevation corrected +0.5m for UT Sensor

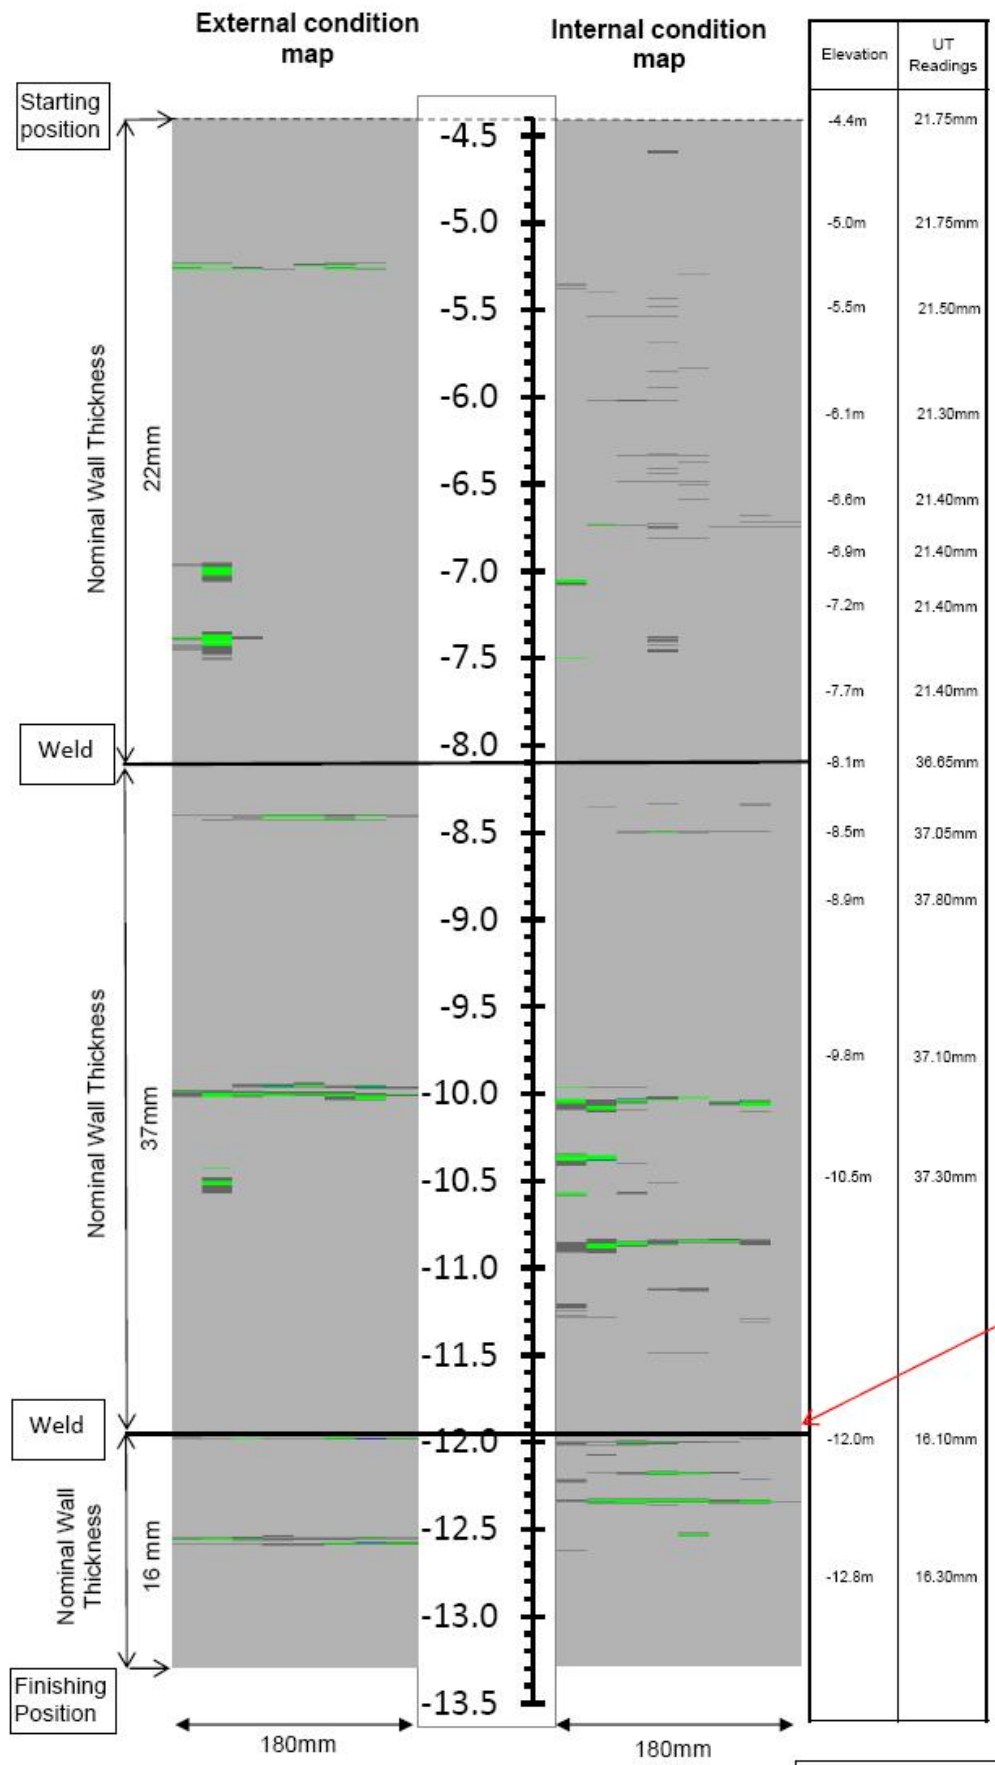
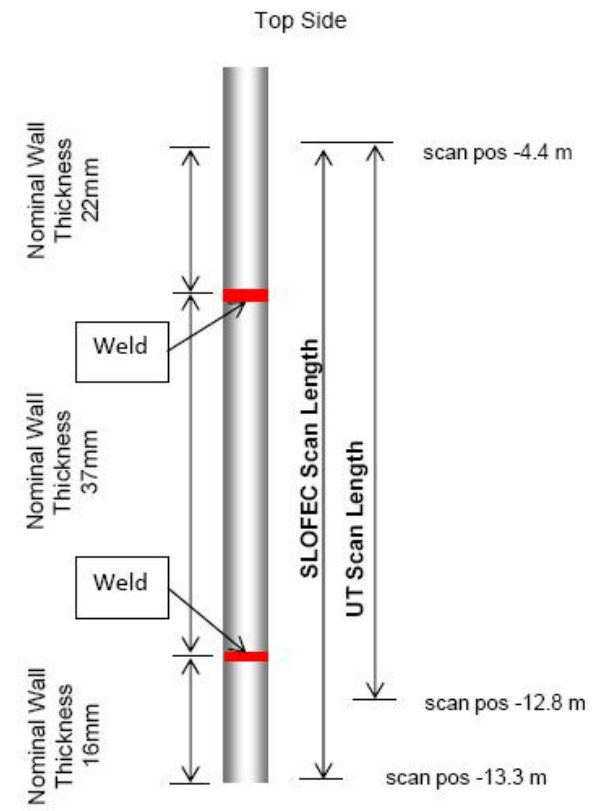
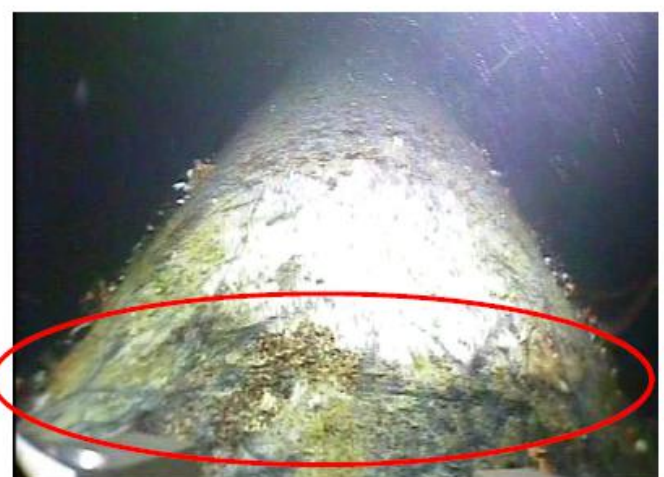
SLOFEC and UT- Scan Report Leg B2 Track 2

Above image is from the ROV during the inspection of Leg B2. Note the weld is clearly displayed

REMARKS:
 Signals were analysed and no defects were detected. No severe wall loss detected as the indicated signals were above tolerance levels.

Elevation corrected +0.5m for UT Sensor offset

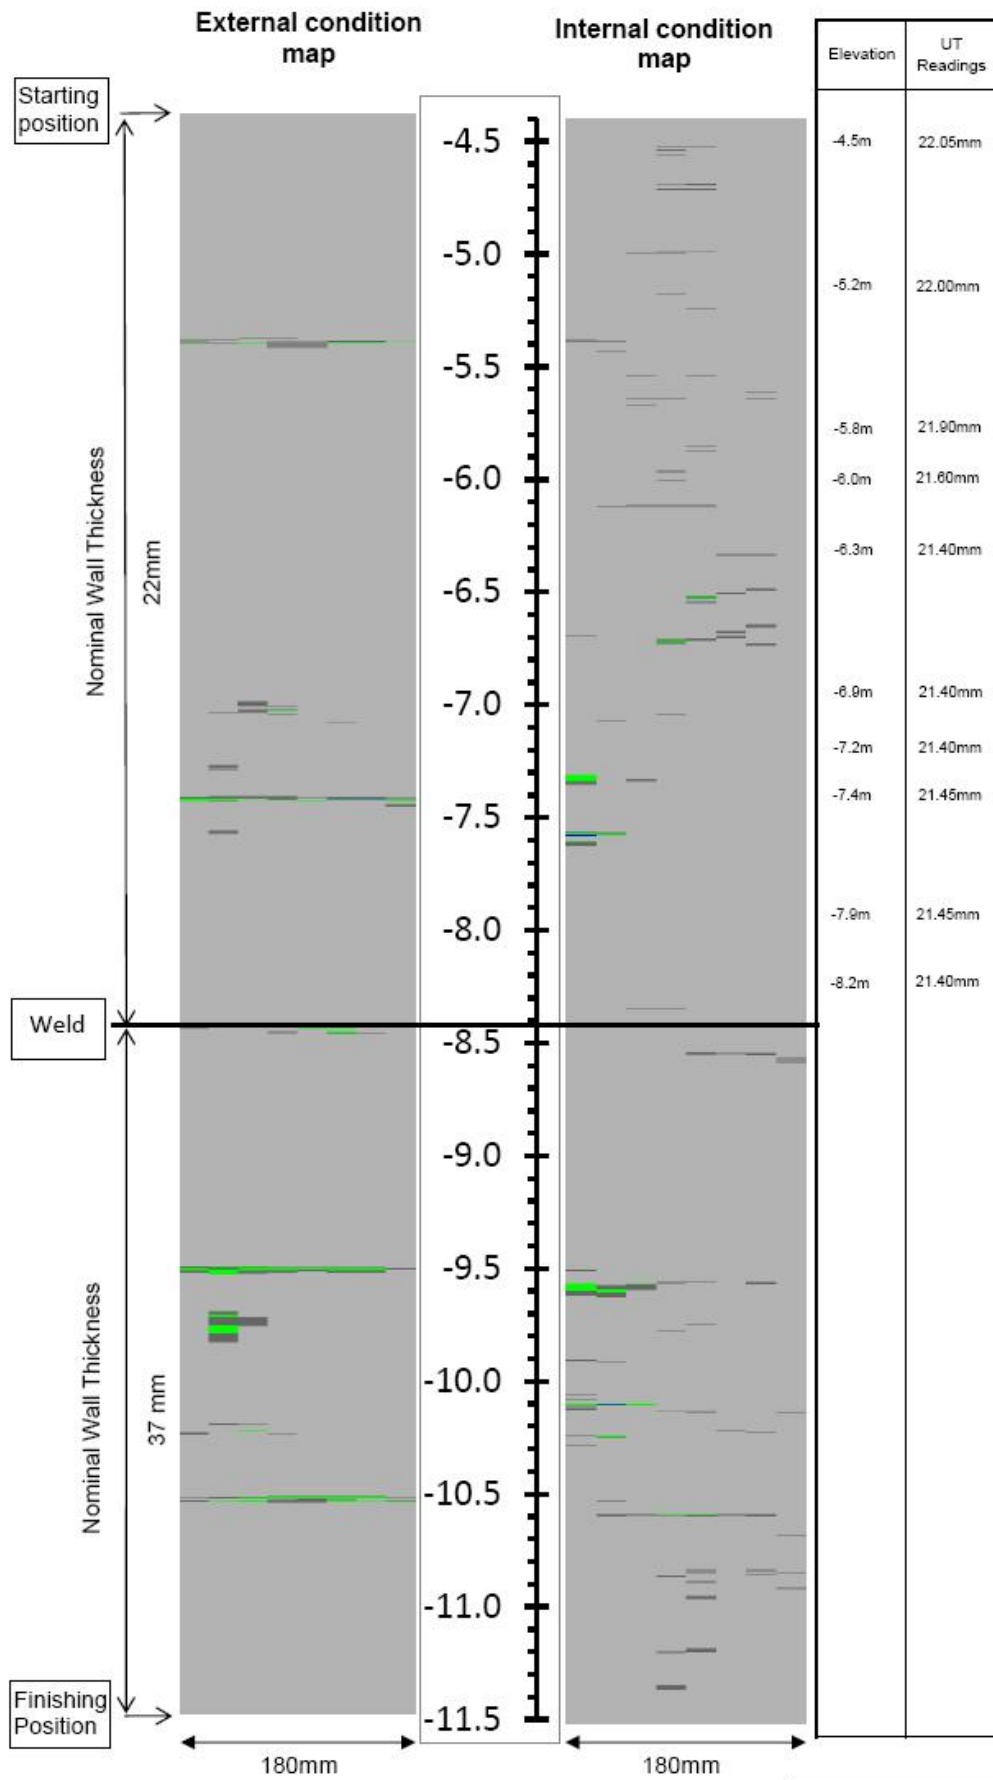
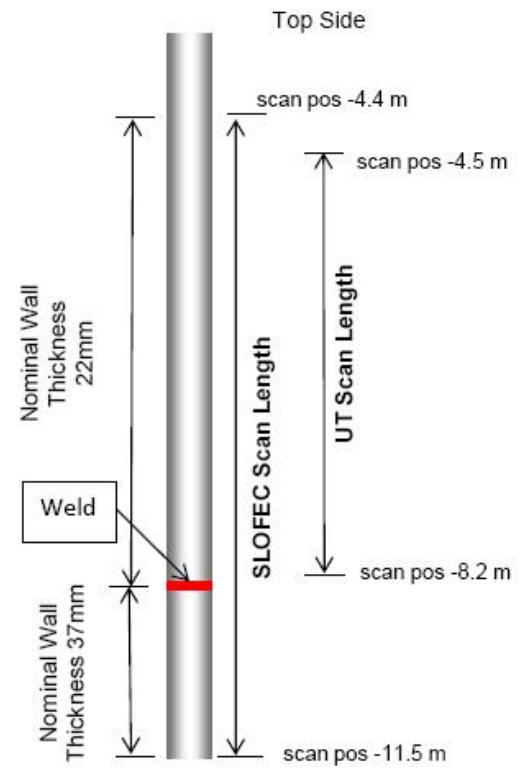
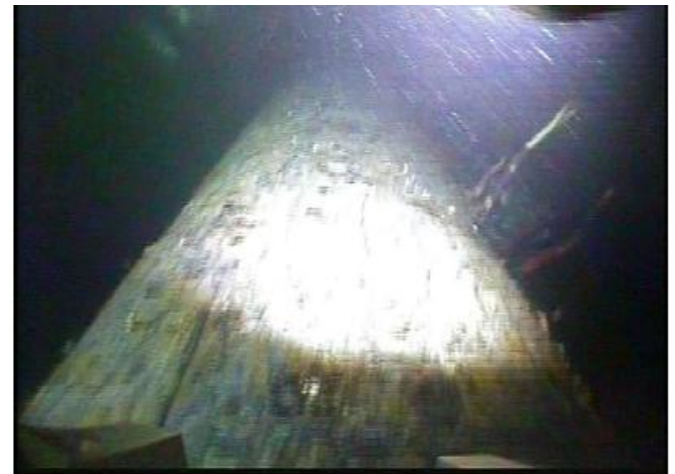
SLOFEC and UT- Scan Report Leg B2 Track 3

Elevation corrected +0.5m UT Sensor offset

Above image is from the crawler during the inspection of Leg B2.

Signals were analysed and no defects were detected. No severe wall loss detected as the indicated signals were above tolerance levels.

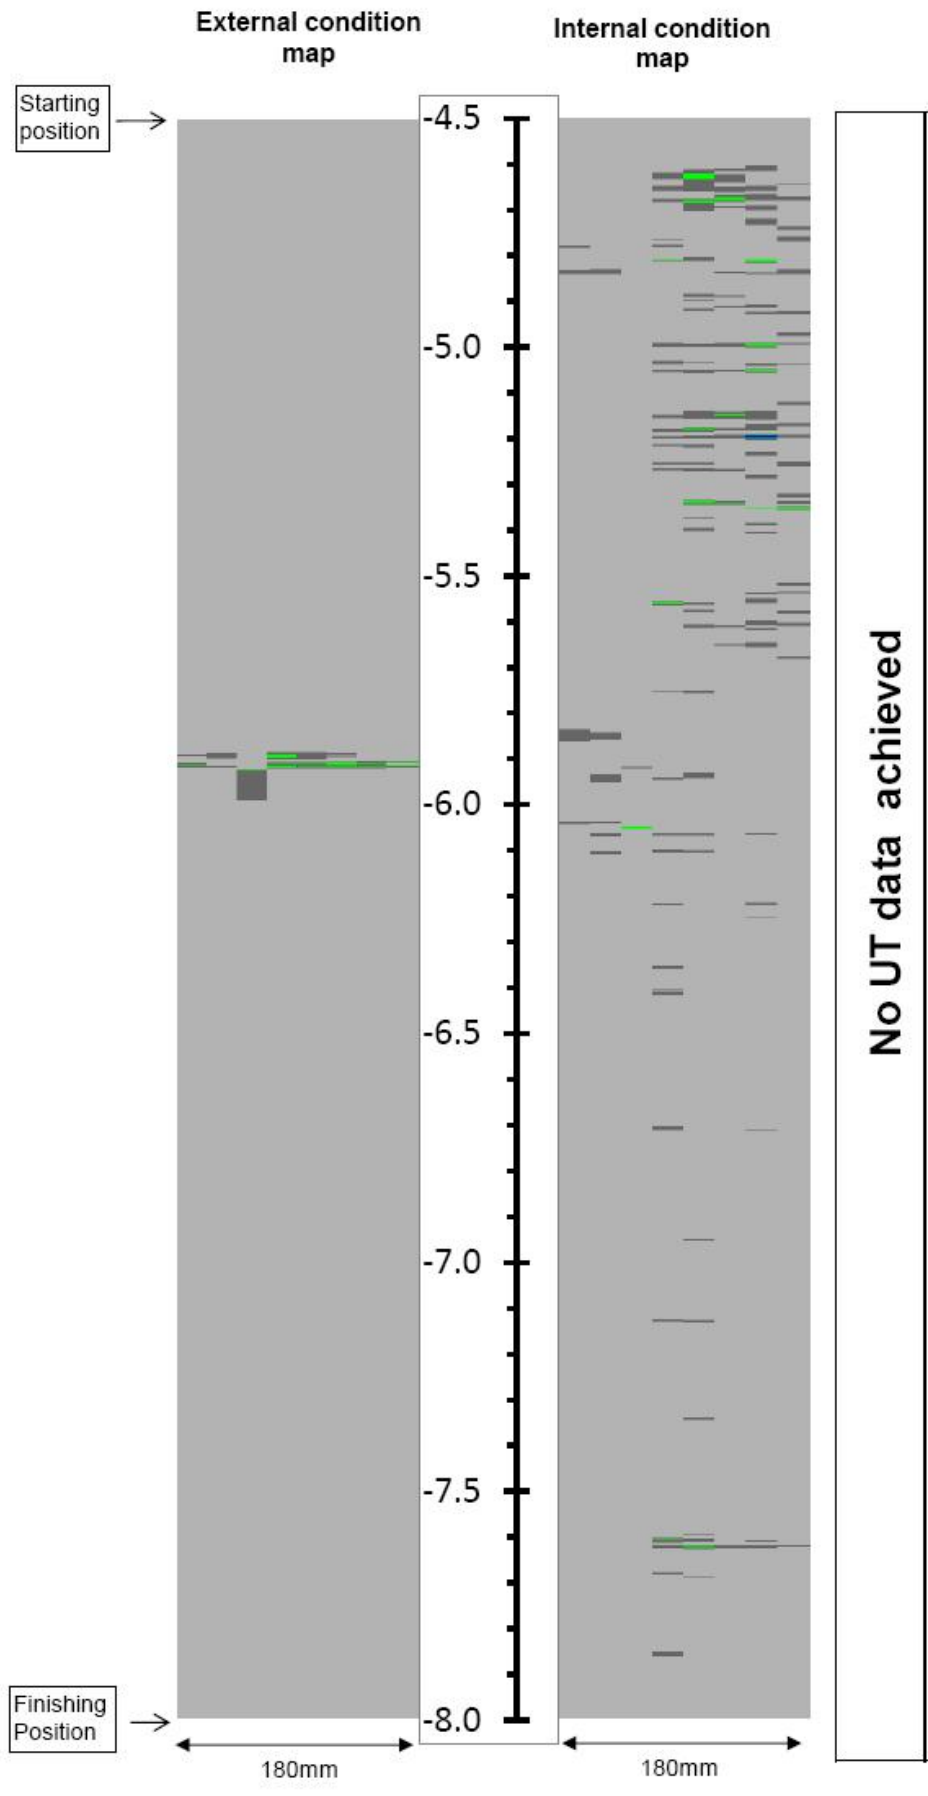
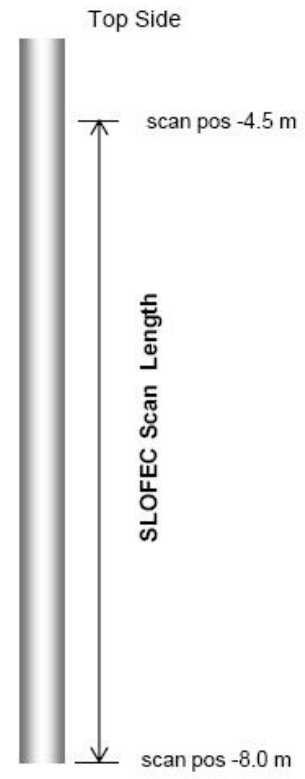
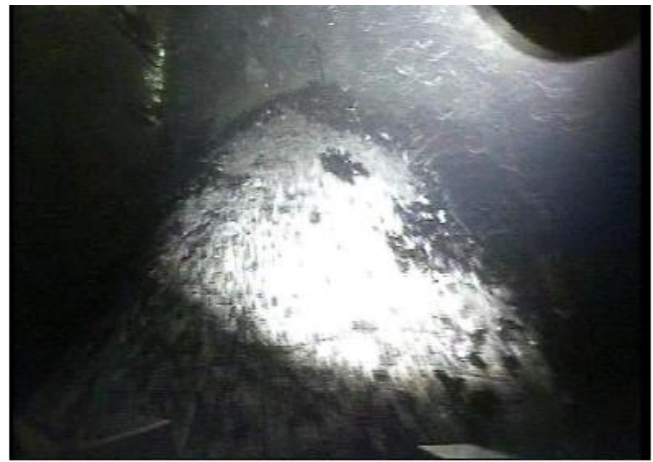
SLOFEC and UT- Scan Report Leg B2 Track 4

Above image is from the crawler during the inspection of Leg B2.

Signals were analysed and no defects were detected. No severe wall loss detected as the indicated signals were above tolerance levels.

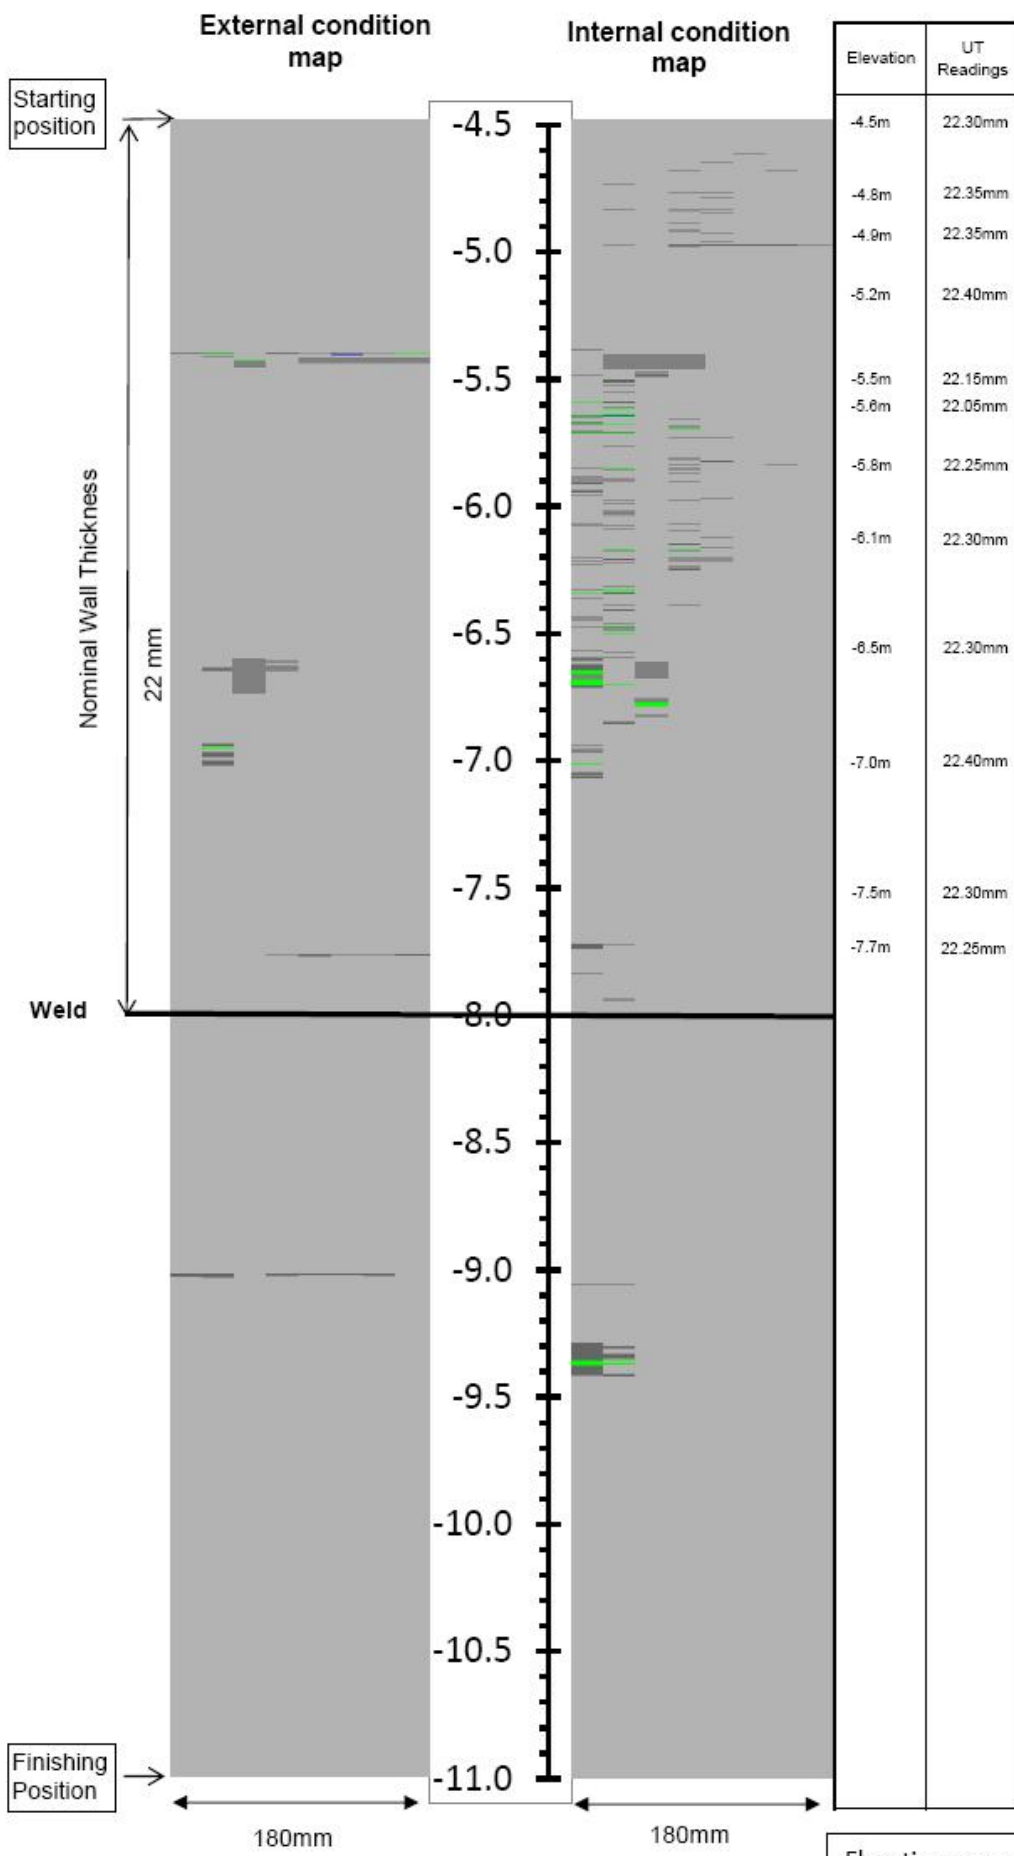
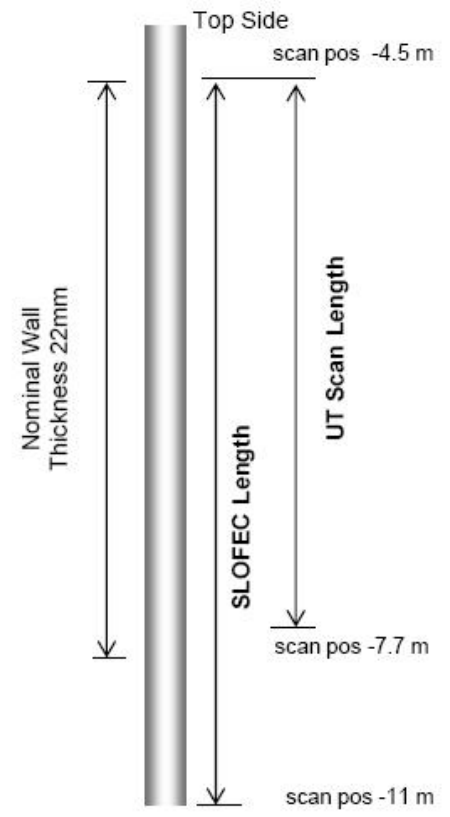
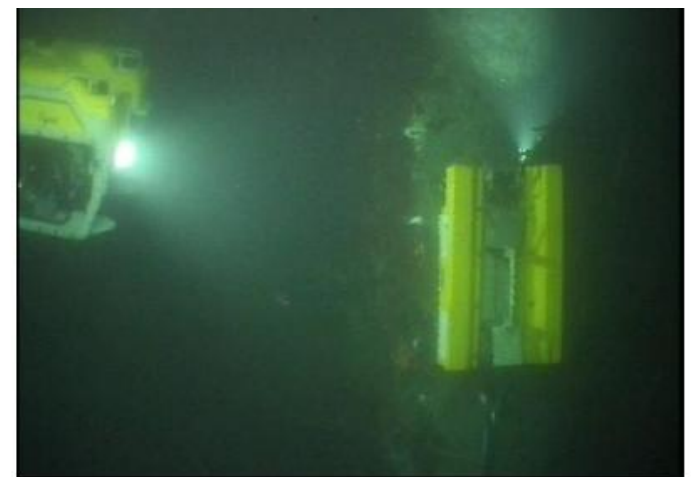
SLOFEC and UT - Scan Report Leg K2 Track 1

Elevation corrected +0.5m for UT Sensor offset

Above image is from the ROV during the inspection of Leg K2.

REMARKS:
 Signals were analysed and no defects were detected. No severe wall loss detected as the indicated signals were above tolerance levels.

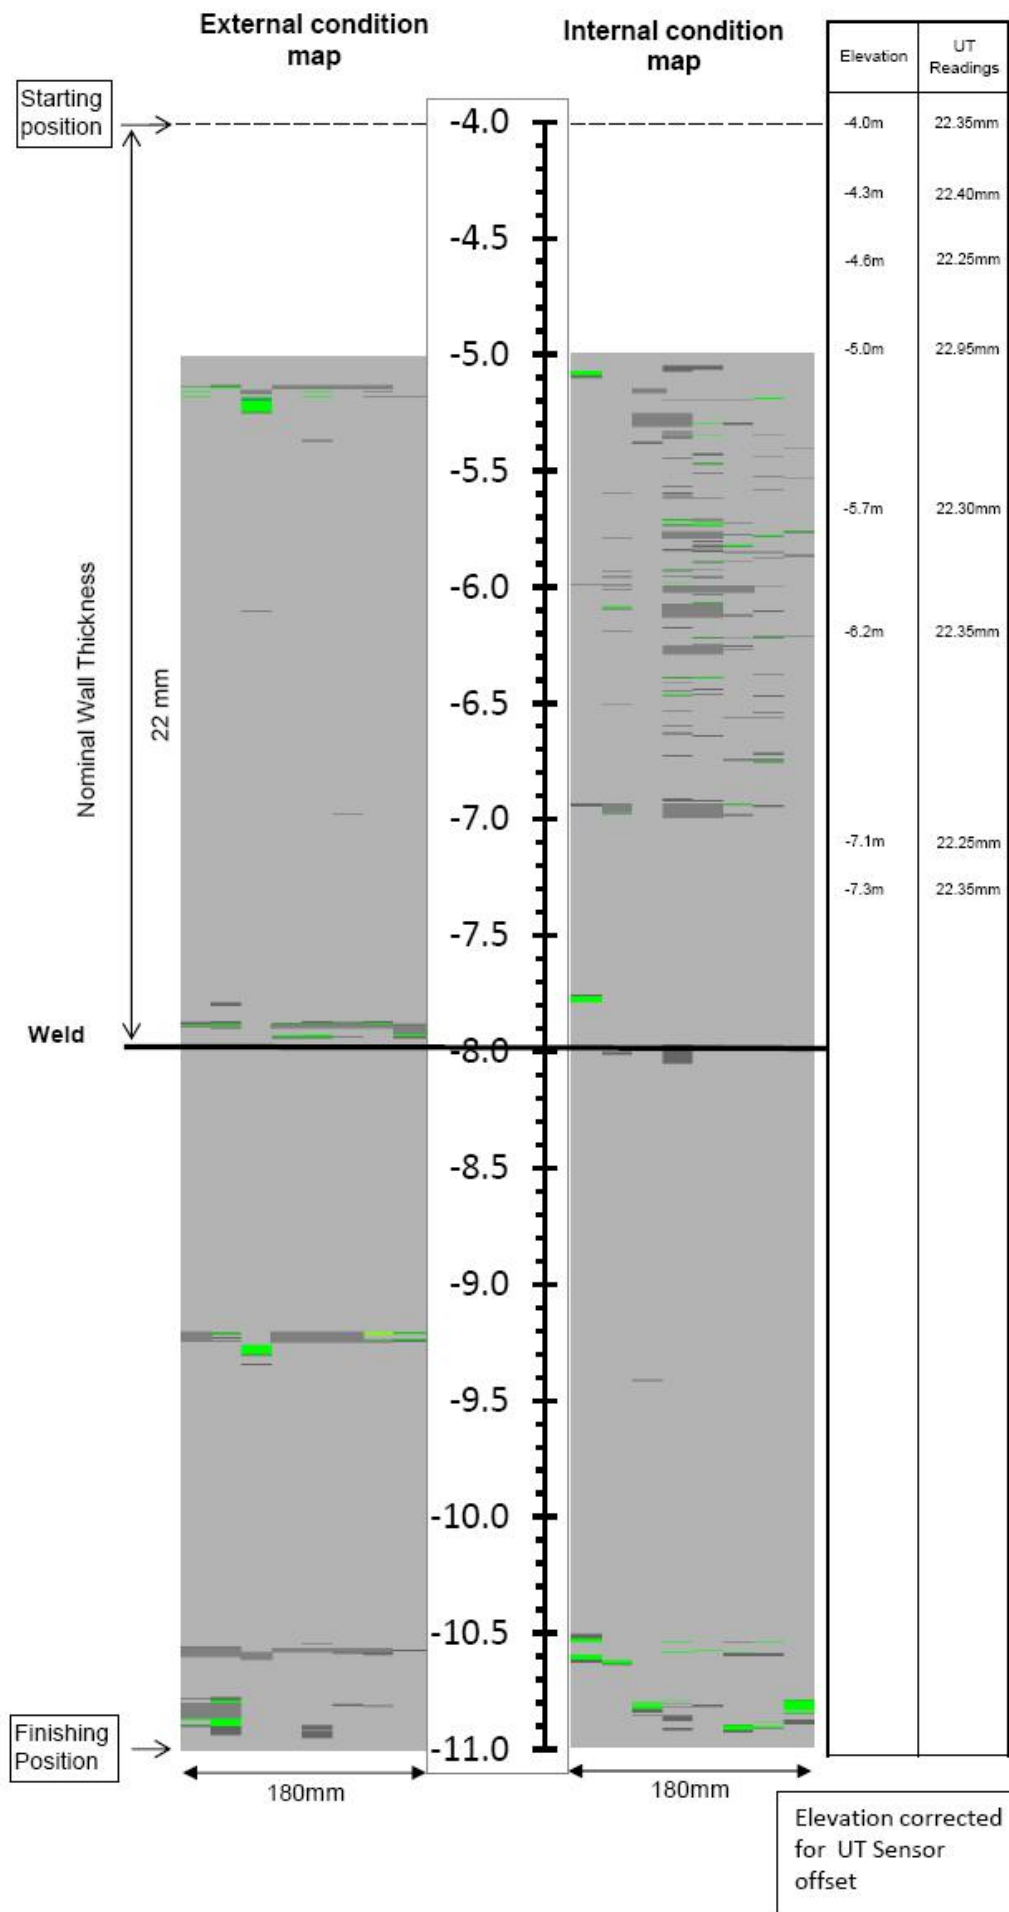
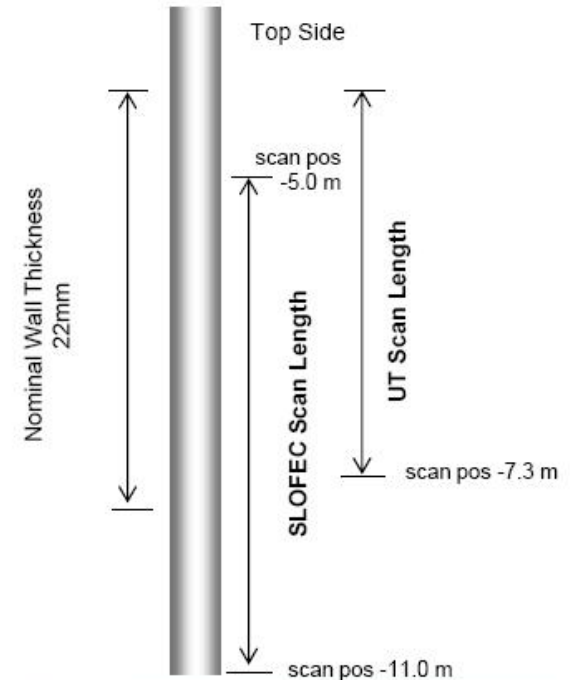
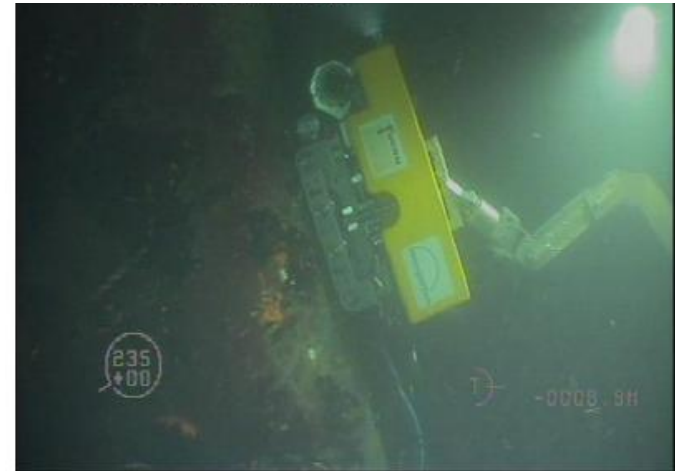
SLOFEC and UT- Scan Report Leg K2 Track 2

Above image is the crawler about to be deployed on Leg K2 for inspection.

Signals were analysed and no defects were detected. No severe wall loss detected as the indicated signals were above tolerance levels.

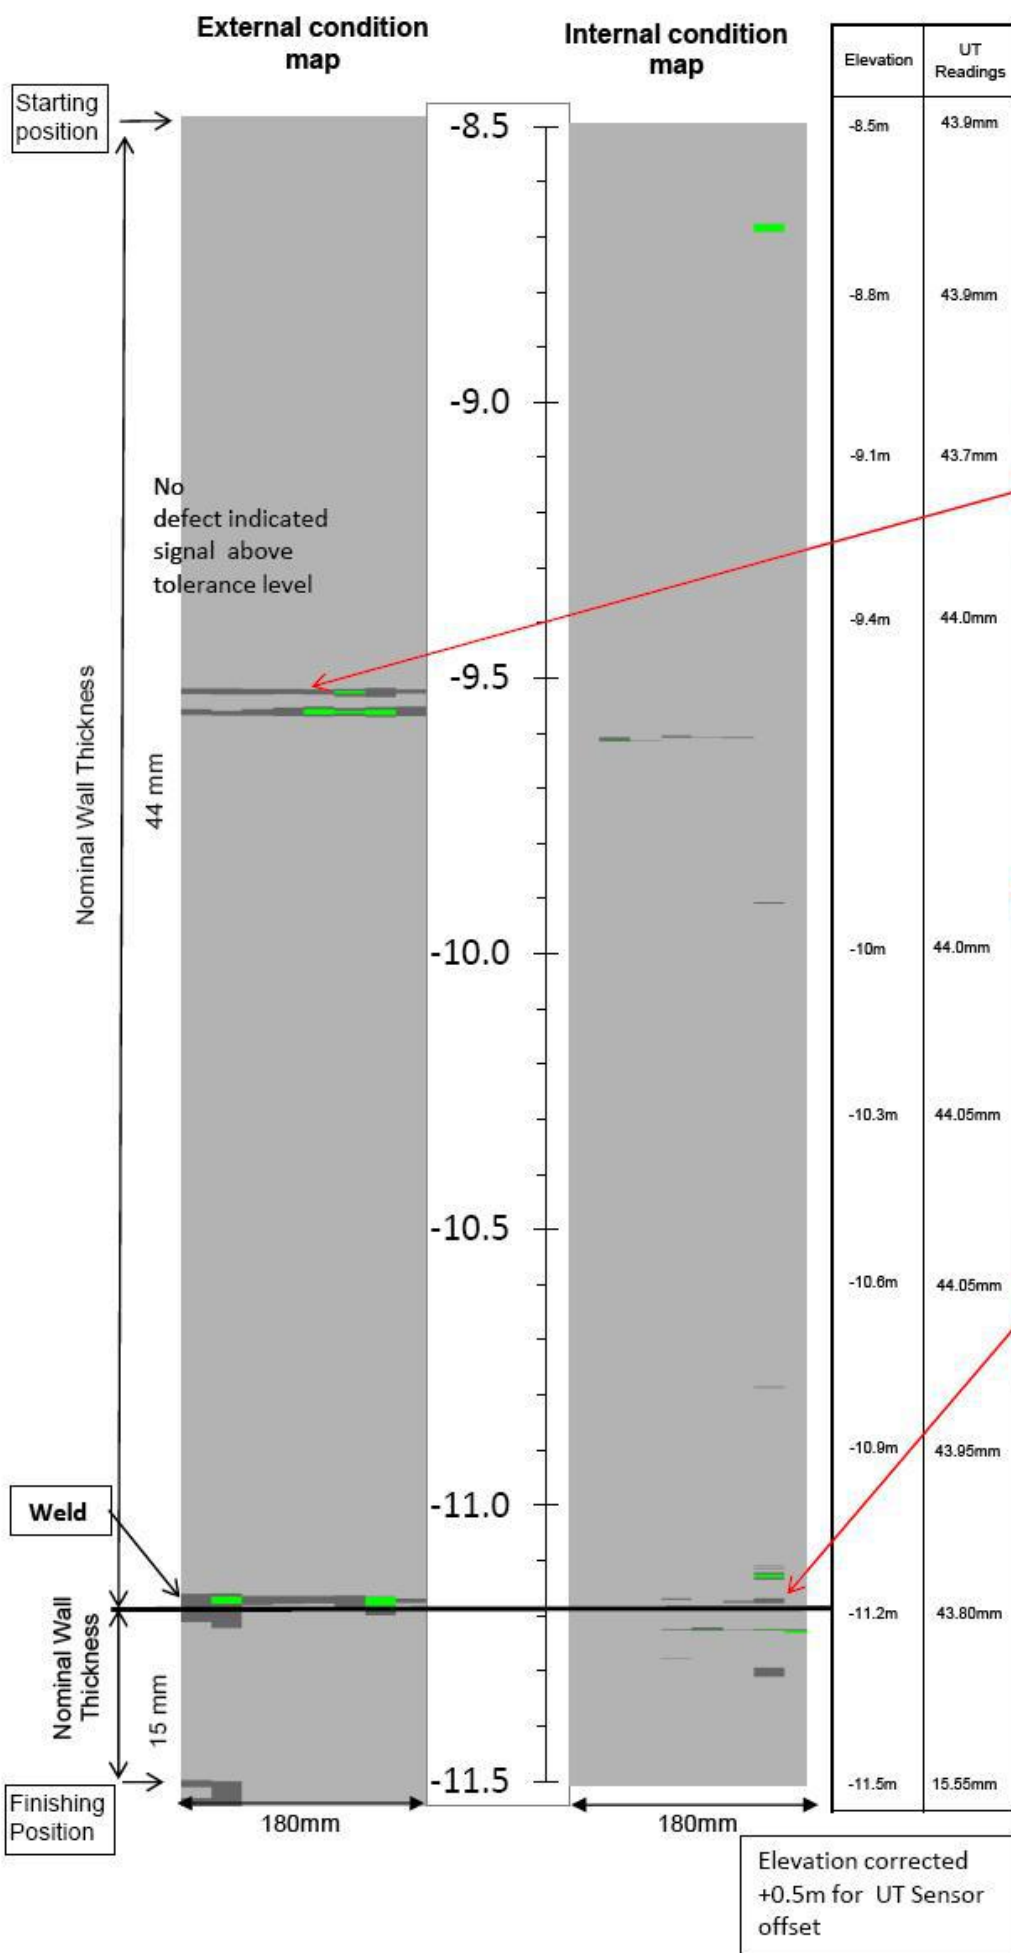
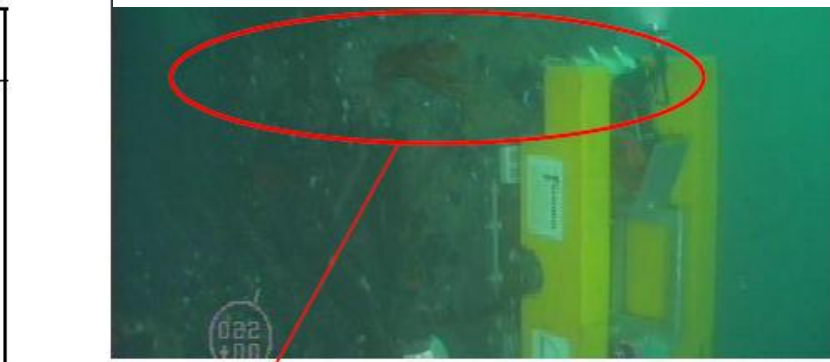
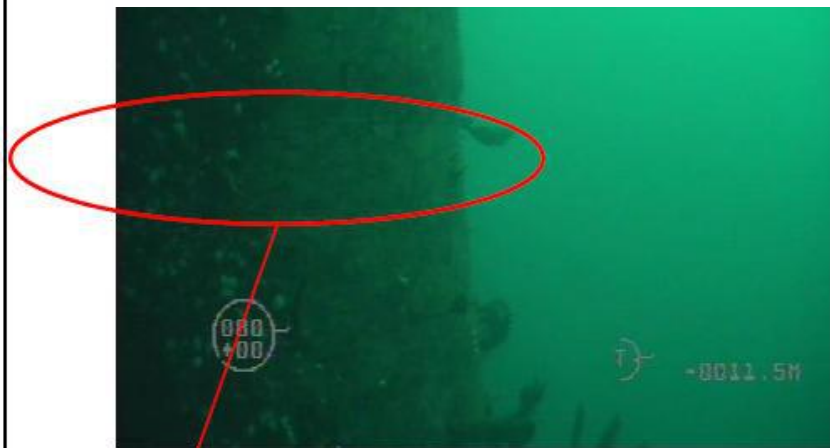
SLOFEC and UT- Scan Report Leg K3 Track 1

Signals were analysed and no defects were detected. No severe wall loss detected as the indicated signals were above tolerance levels. No severe external or internal wall losses detected. Area scanned is approx 3 m long. The scan starts at minus 8.5 m to minus 11.5 m. The nominal wall thickness in the scanned area is 44 mm. The area scanned was the cleanest part of the run. Unable to scan higher as surface not clean enough. Area was jet cleaned by Lynx and not by the Fugro crawler as this was unsuccessful. We will not be doing anything above the splash zone at this time.

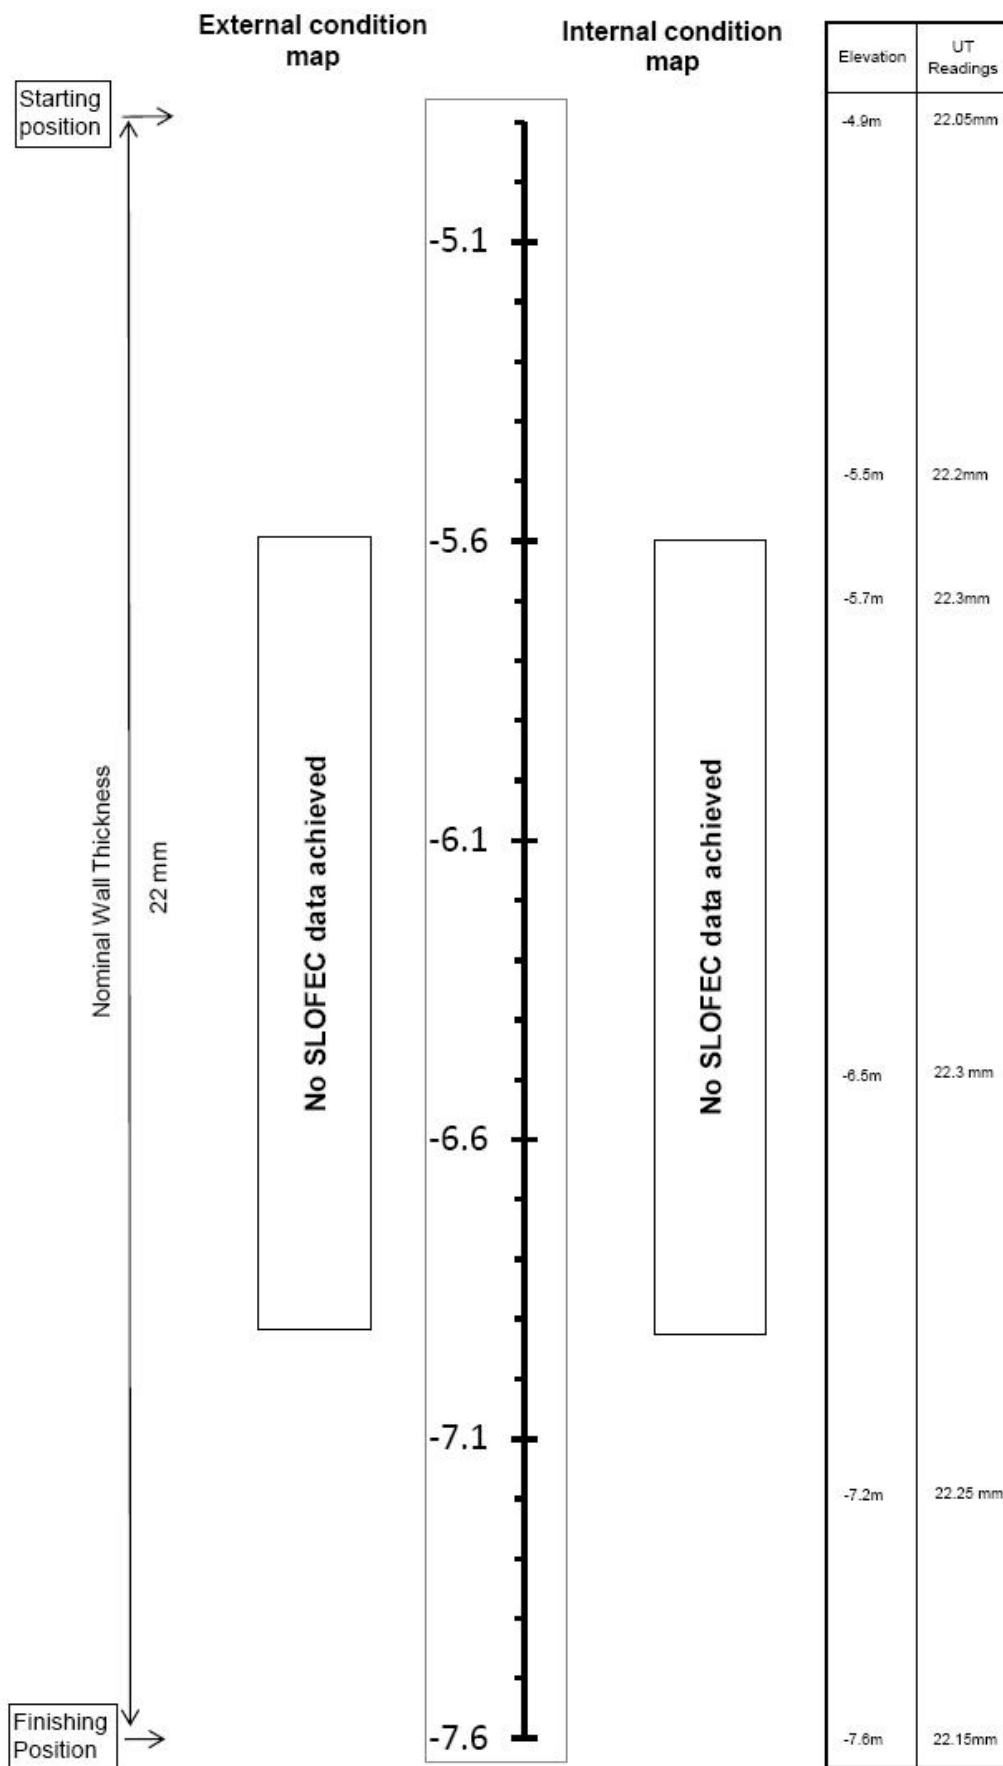
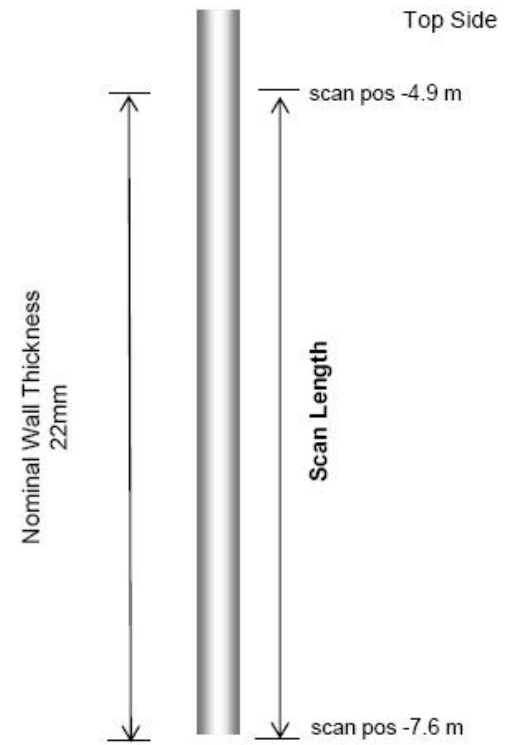
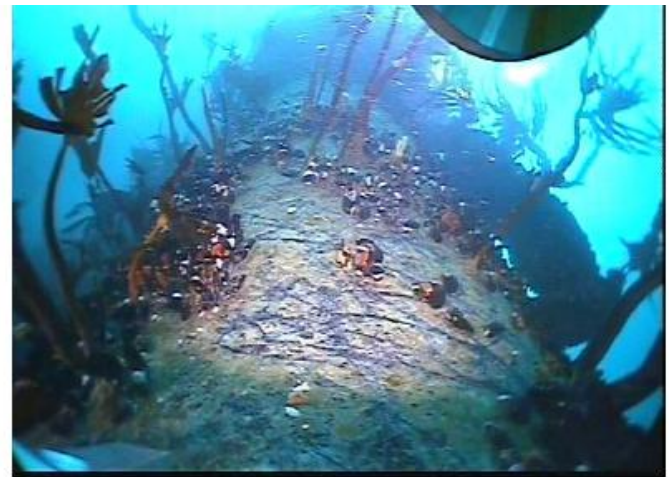
SLOFEC and UT - Scan Report Leg K3 Track 1a

Elevation corrected +0.5m for UT Sensor offset

Above image is the crawler deployed on Leg K3 for inspection.

Signals were analysed on other tracks and no defects were detected.
No severe wall loss detected as the indicated signals were above tolerance levels.
