INSPECTION REPORT

Facility: Platform Legs

Item Inspected: B2, K2 and K3

SLOFEC™/UT Inspection of Platform Legs

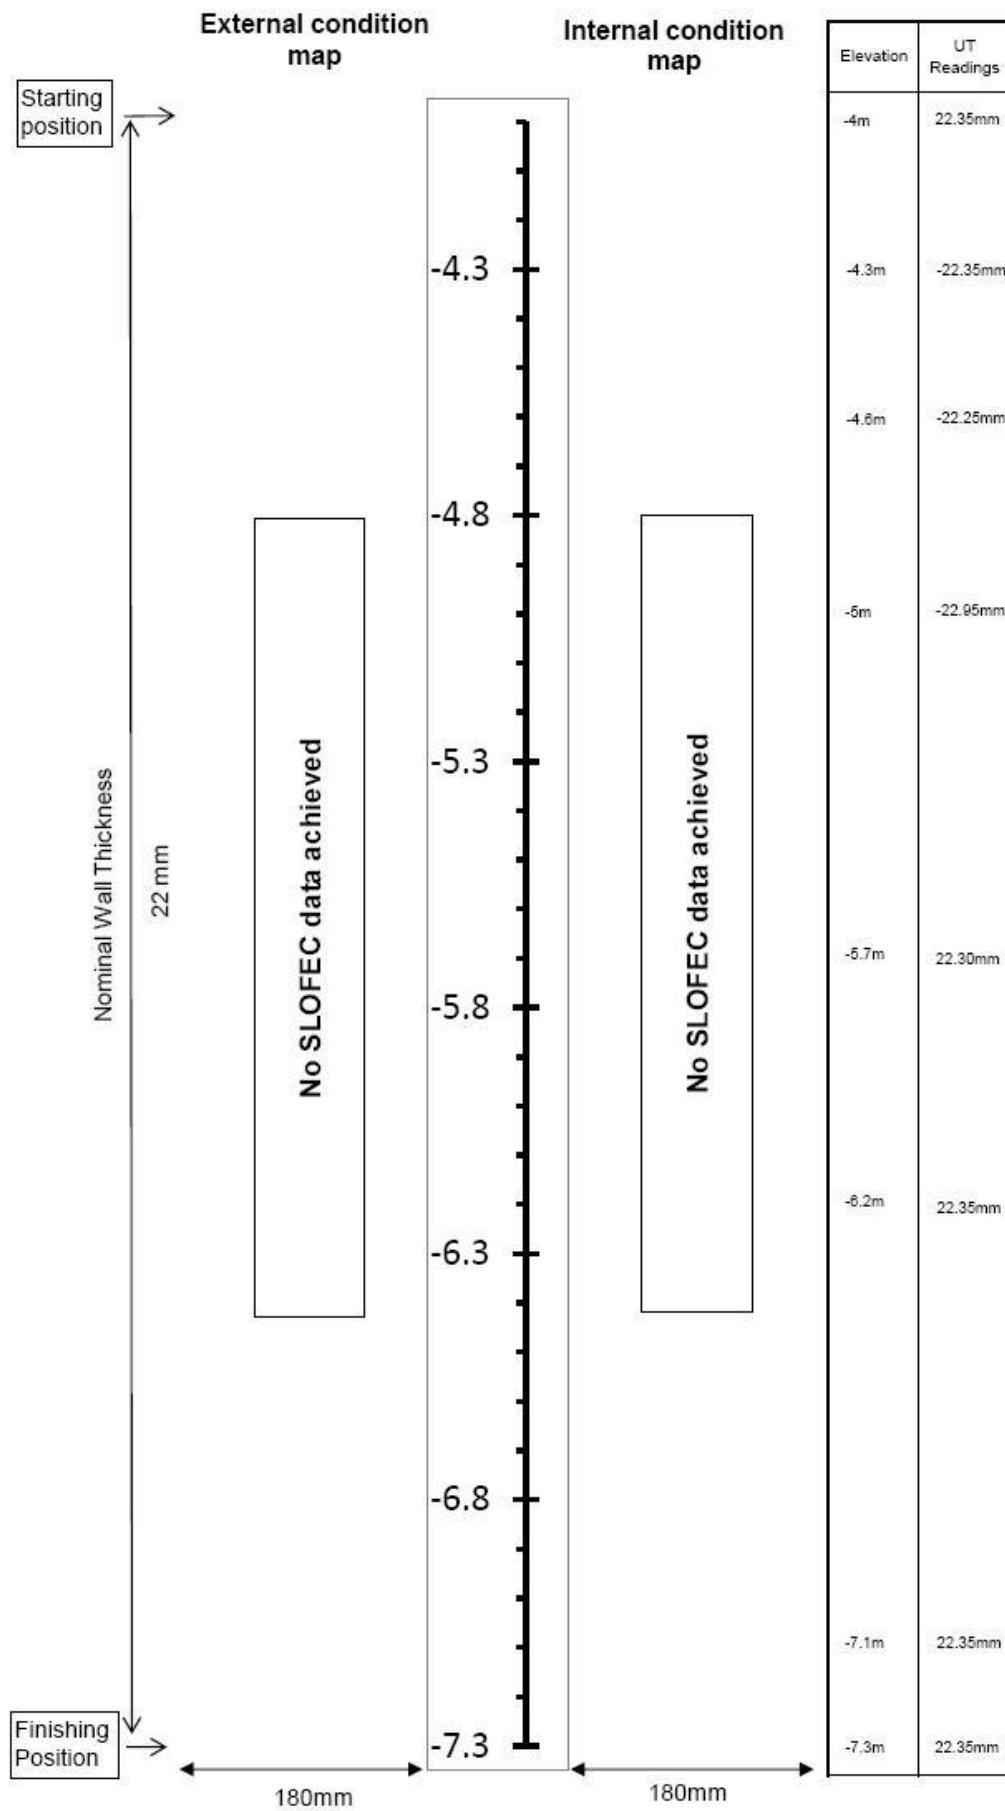
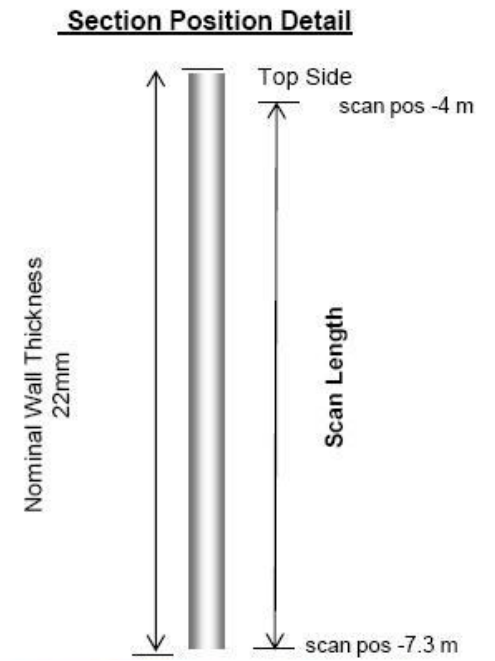
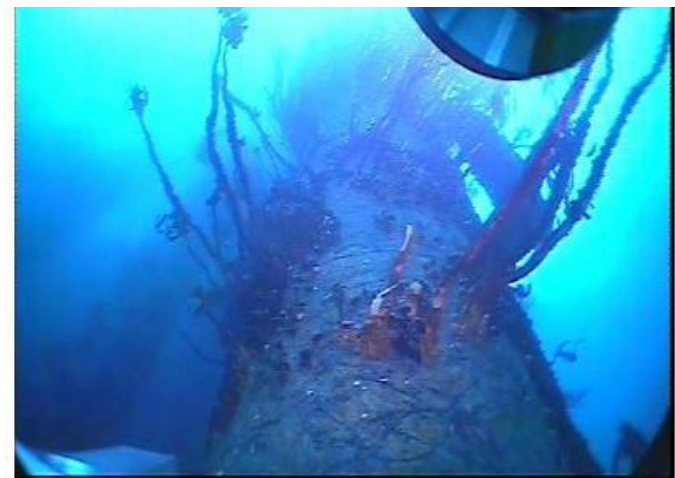
SLOFEC and UT - Scan Report Leg K3 Track 2

Above image is the crawler deployed on Leg K3 for inspection.

Signals were analysed on other tracks and no defects were detected.
No severe wall loss detected as the indicated signals were above tolerance levels.

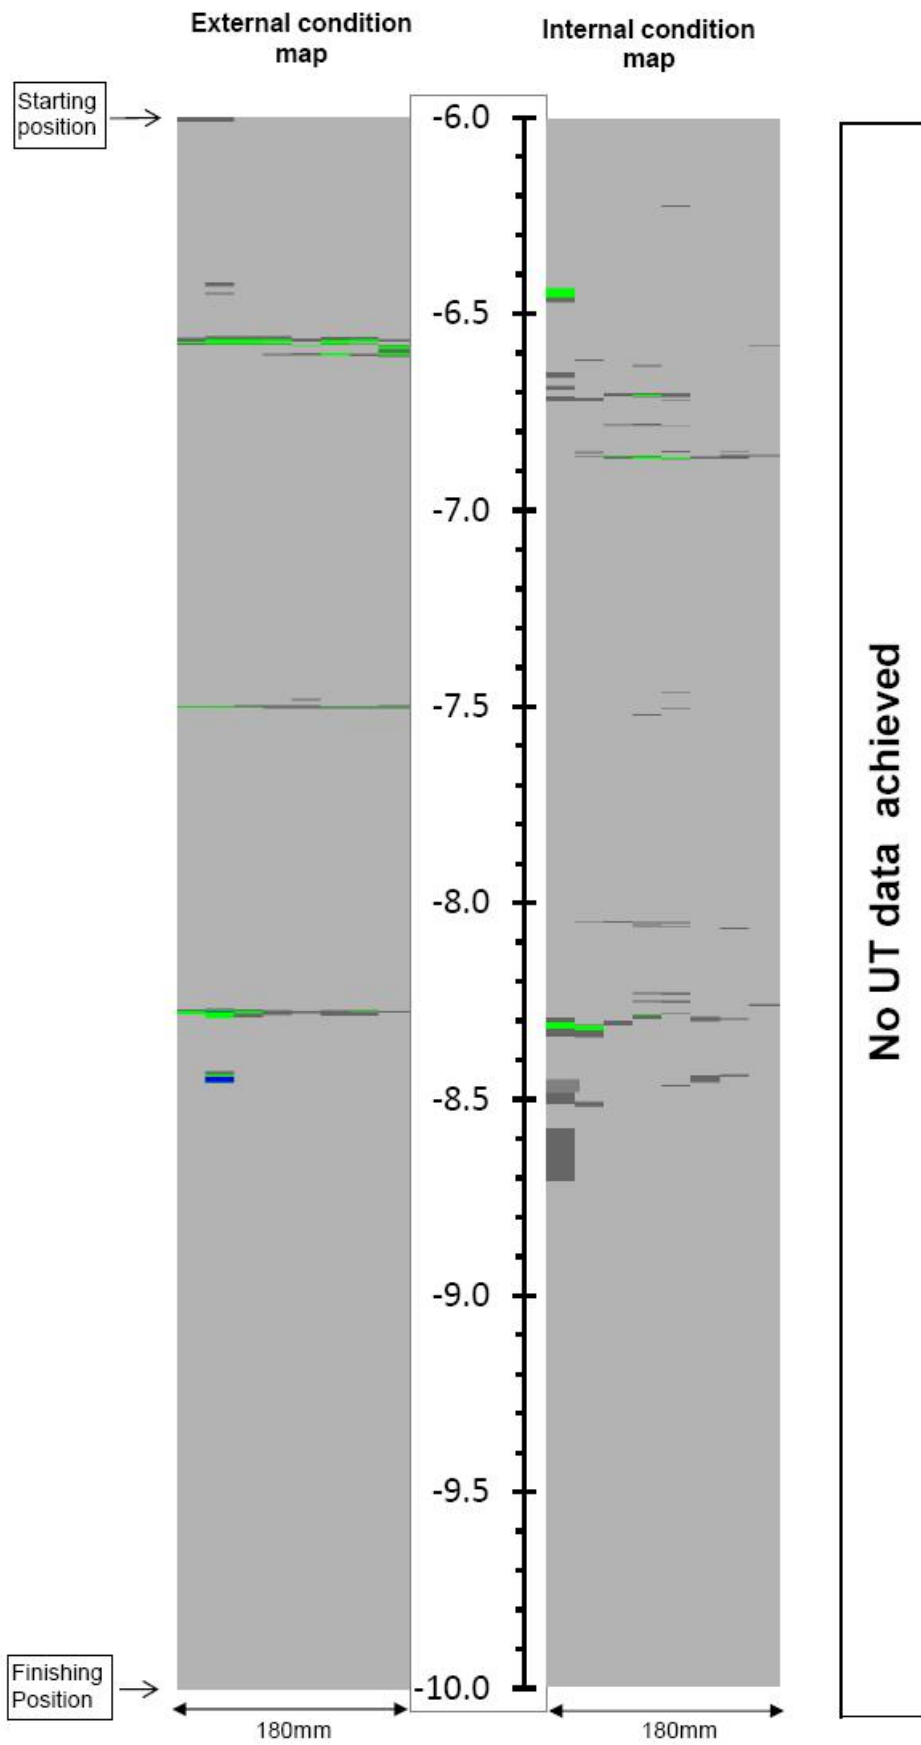
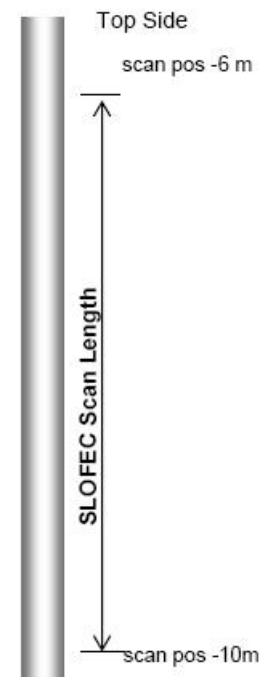
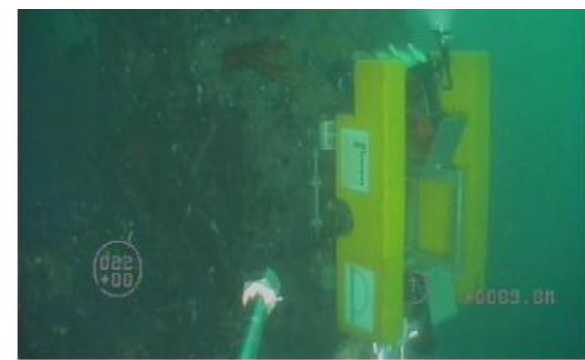
SLOFEC and UT - Scan Report Leg K3 Track 3

Above image is from the ROV during the inspection of Leg K3.

Signals were analysed and no defects were detected. No severe wall loss detected as the indicated signals were above tolerance levels.

No severe external or internal wall losses detected.

No UT readings, Tool fell off after -10 m
