# MEC (Extended SLOFEC) and UT External Pipeline Inspection Report

<b>Client</b>	<b>Client</b>
<b>Facility</b>	<b>Client's Gas Field</b>
<b>Items Inspected</b>	<b>12" and 6" Downstream Pipeline and Tie-in-Spool Sections</b>
<b>Inspection Method</b>	<b>MEC (Extended SLOFEC) and UT</b>
<b>Date Commenced</b>	<b>29<sup>th</sup> May 2013</b>
<b>Date Completed</b>	<b>1<sup>st</sup> June 2013</b>
<b>Type of Report</b>	<b>Final</b>
<b>Report Number</b>	<b>Kxxxx</b>

# PIPELINE

## EXTERNAL INSPECTION REPORT

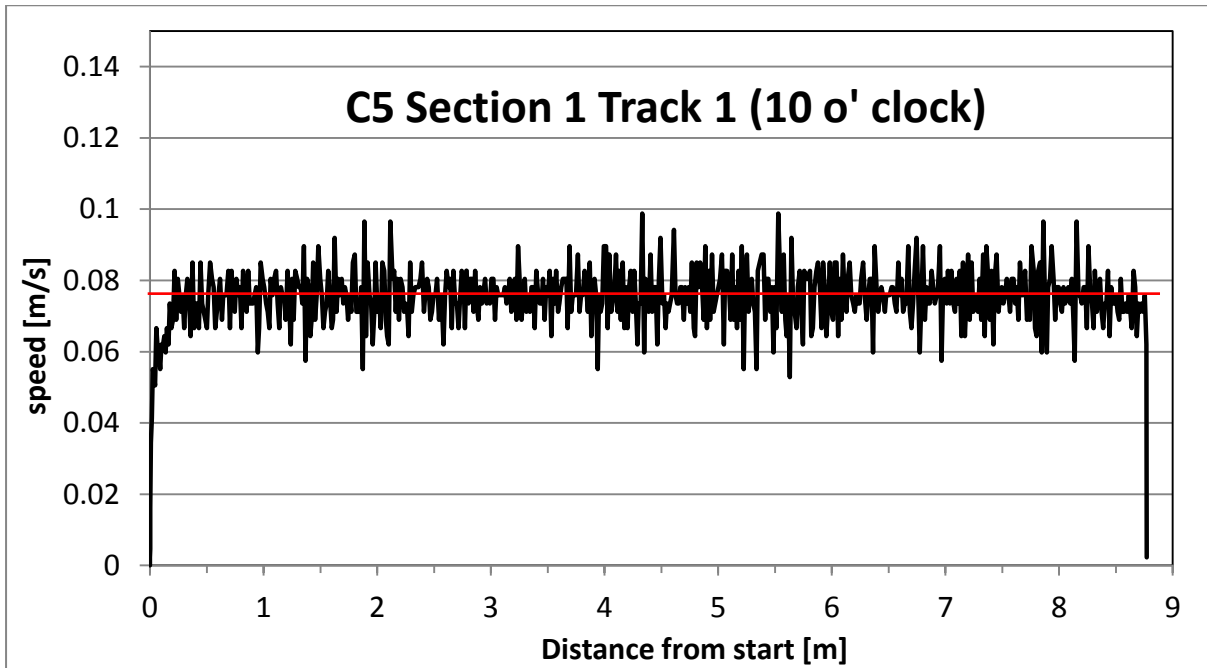
Figure 5: Speed profile of a track at XXX 5 with an orientation of 10 o' clock.

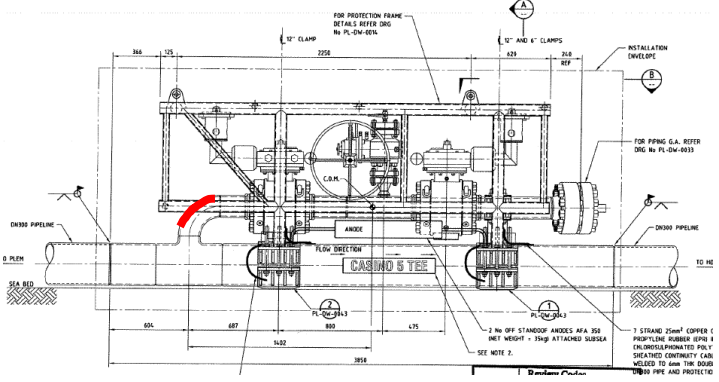
Inspection Location (marked in red)	UT Wall Thickness Measurement [mm]	Comments
XXX 5 Tee Elbow

11.1 – 11.8	Measurements performed at outside of elbow, 12 o'clock orientation
ZZZ Tee Elbow

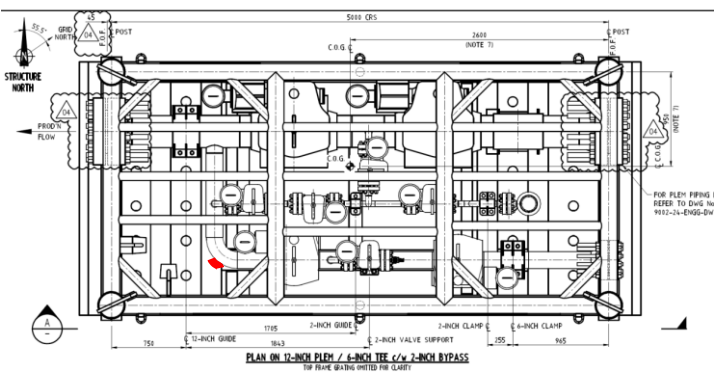
13.2 – 13.9	Measurements performed at outside of elbow, 8 to 9 o'clock orientation (12 o'clock not accessible due to obstacles)

At ZZZ tee, the inspection couldn't be performed at the 12 o'clock position due to obstacles caused by the PLEM structure and sacrificial anode. See section 3.7 for inspection locations and results of the performed measurements. At the time of inspection, no values of the corresponding nominal wall thicknesses of the elbows have been available.

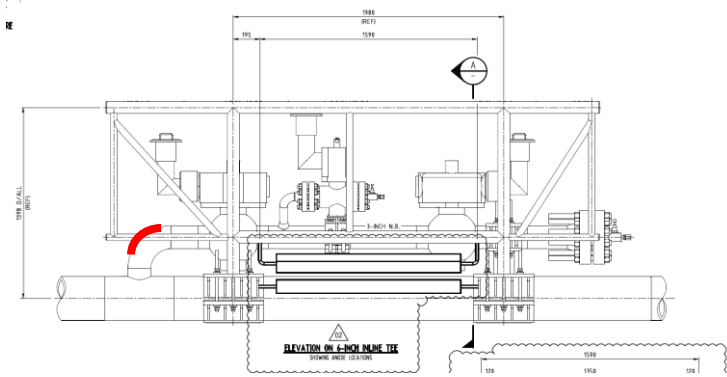
Inspection Location	UT reading of Wall Thickness [mm]	Comments
YYY 2 Tee Elbow

13.9 – 15.0	Measurements performed at outside of elbow, 12 o'clock position

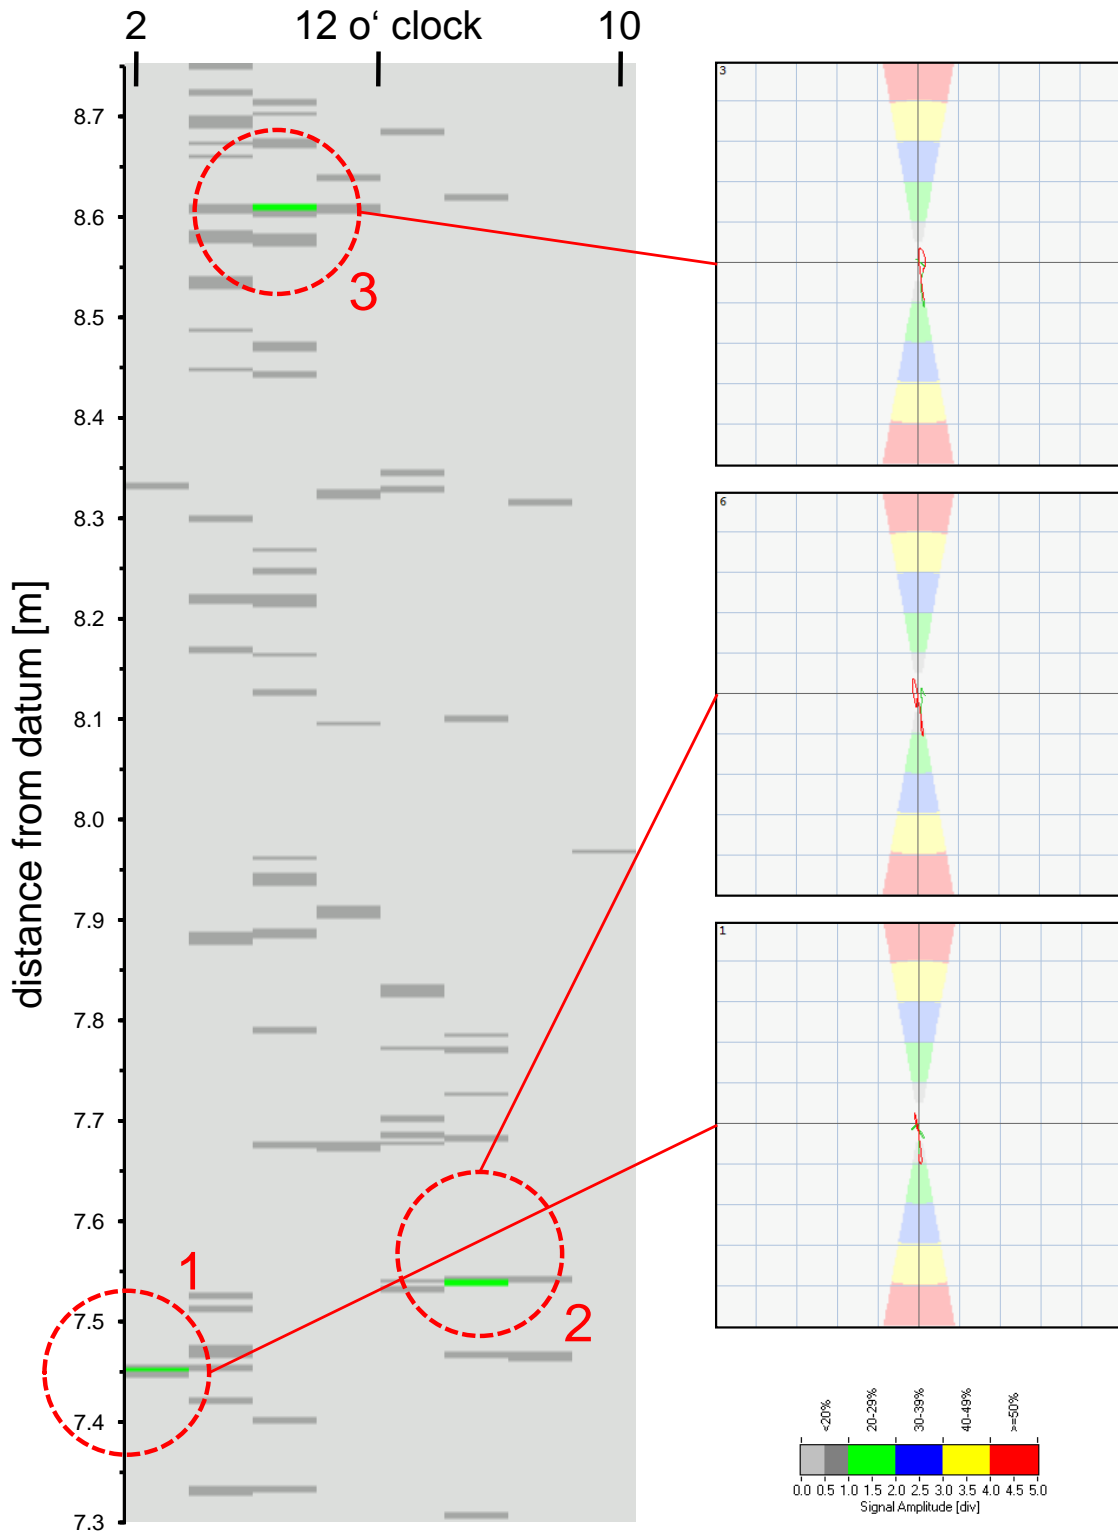
A more detailed view of the indications is depicted in Figure 7. It shows a zoomed view of track 1 (12 o'clock position) recorded at the first section of the YYY 2 6" tie-in-spool. The right-hand-side of the figure shows the corresponding phase angle diagrams of the indications. The vertical orientation of the signals indicates an internal wall loss. The amplitude in both directions barely reaches the green-marked area which highlights the wall loss region of 20 – 29%.

Figure 7: Detailed view of the positions and phase angles of the indications 1-3 detected at the YYY 2 tie-in-spool.

Three MEC-related indications have been found within the scanned areas of the individual pipelines. All of them are located at the first section of the YYY 2 6" rigid Tie-in-Spool. They are isolated and only seen on a single sensor at the internal scan, giving a size estimate of about 20 x 20 mm. The depth of the indications is close to 20% of wall loss.

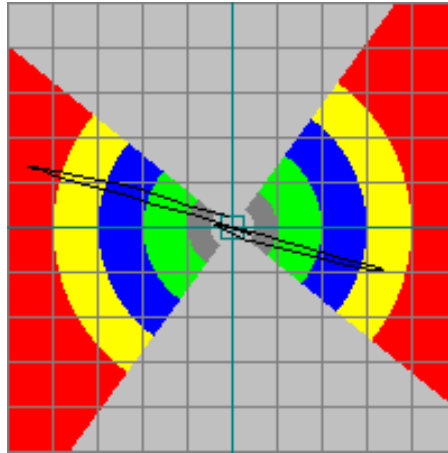
Sample signal display of external defect

Subsequently external defects are indicated in the horizontal signal phase direction as shown below. Moving the scanner in the reverse direction, the external defect signals have the first peak left followed by a right movement with the second peak right.
