EddyMax and IRIS Tube Inspection

**Glycol Contactor Inlet Trim
Cooler Tubes**

**Magnetic Biased Eddy Current
Remote Field Eddy Current
IRIS**

K-XXX-11

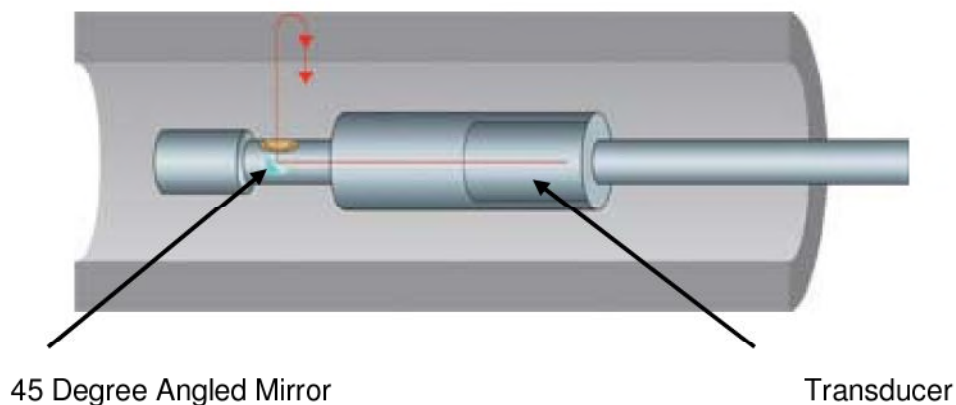
8.2) Concept of IRIS

“IRIS” is a technique based around the principle of Ultrasonic inspection. As shown in the above illustration, a sound beam is emitted from an Ultrasonic transducer and reflected off a mirror set at 45 degrees. This reflected beam impinges on the tube ID at right angles where part of the beam is reflected from the tube ID, while the remainder is further transmitted through the wall thickness and then reflected back from the tube OD. The time difference between these two reflected signals is used to measure the tube wall thickness. The mirror is mounted on a water driven turbine that can rotate at speeds of approximately 2000rpm; measurements are made around the full tube circumference of the tube as the probe is withdrawn. The ultrasonic beam maps out a spiral along the tube length, therefore if the probe pulling speed is sufficiently low enough, the scan will follow a helical overlap of each individual rotation (taking into account the inspection parameters), giving a 100% coverage of the tube surface.

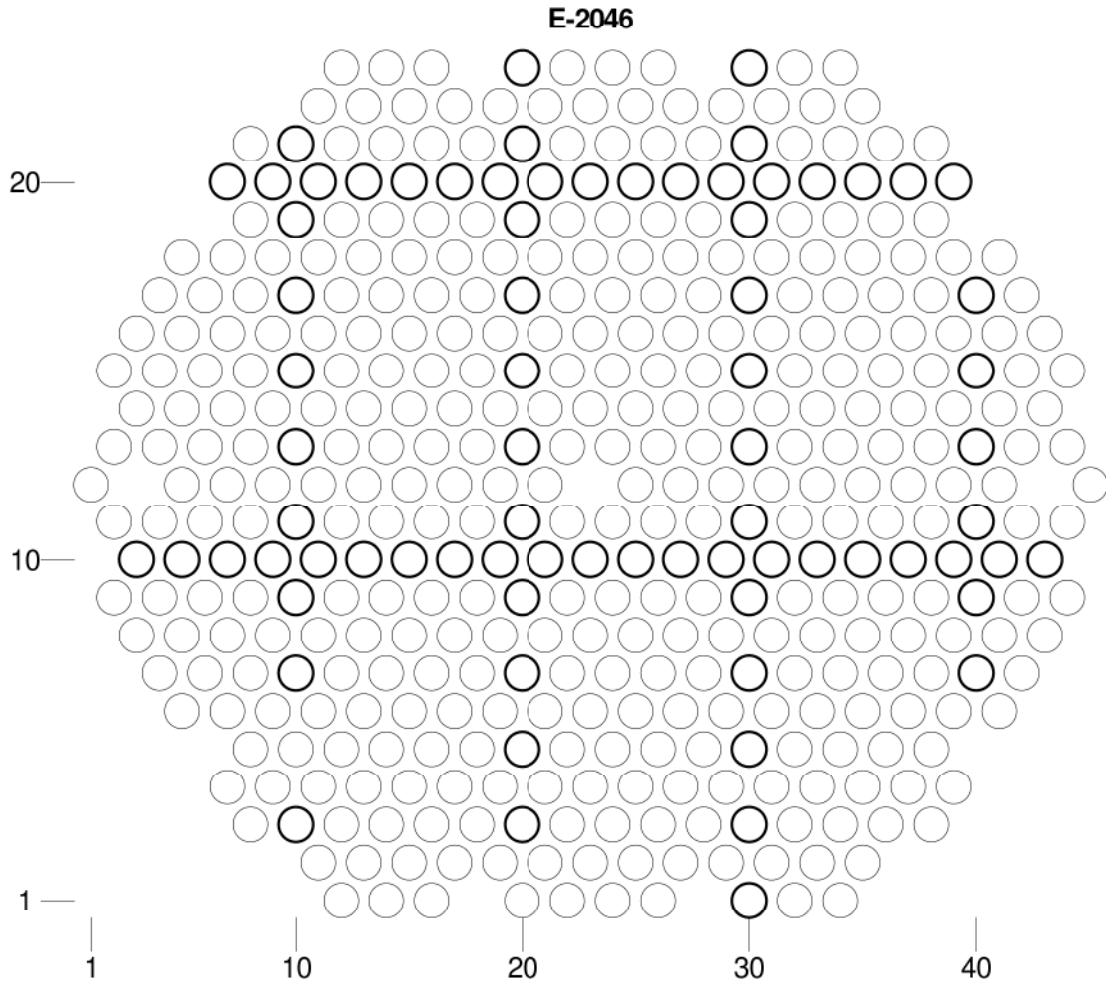
APPENDIX 01

view : Outlet

subject : E-2046
page(s) : 1 from 1
client : Shell UK
site : Gannet Alpha Platform
order-no. : 1698
K.-No. : K055-11
Date : 17:09:2011
Material : Duplex
Tube length : 4100 mm
Ø External : 19.05 mm
Ø Internal : 14.83 mm
Wall thickness : 2.11 mm
WinDevos Ver. 2.09.1120 build 2323

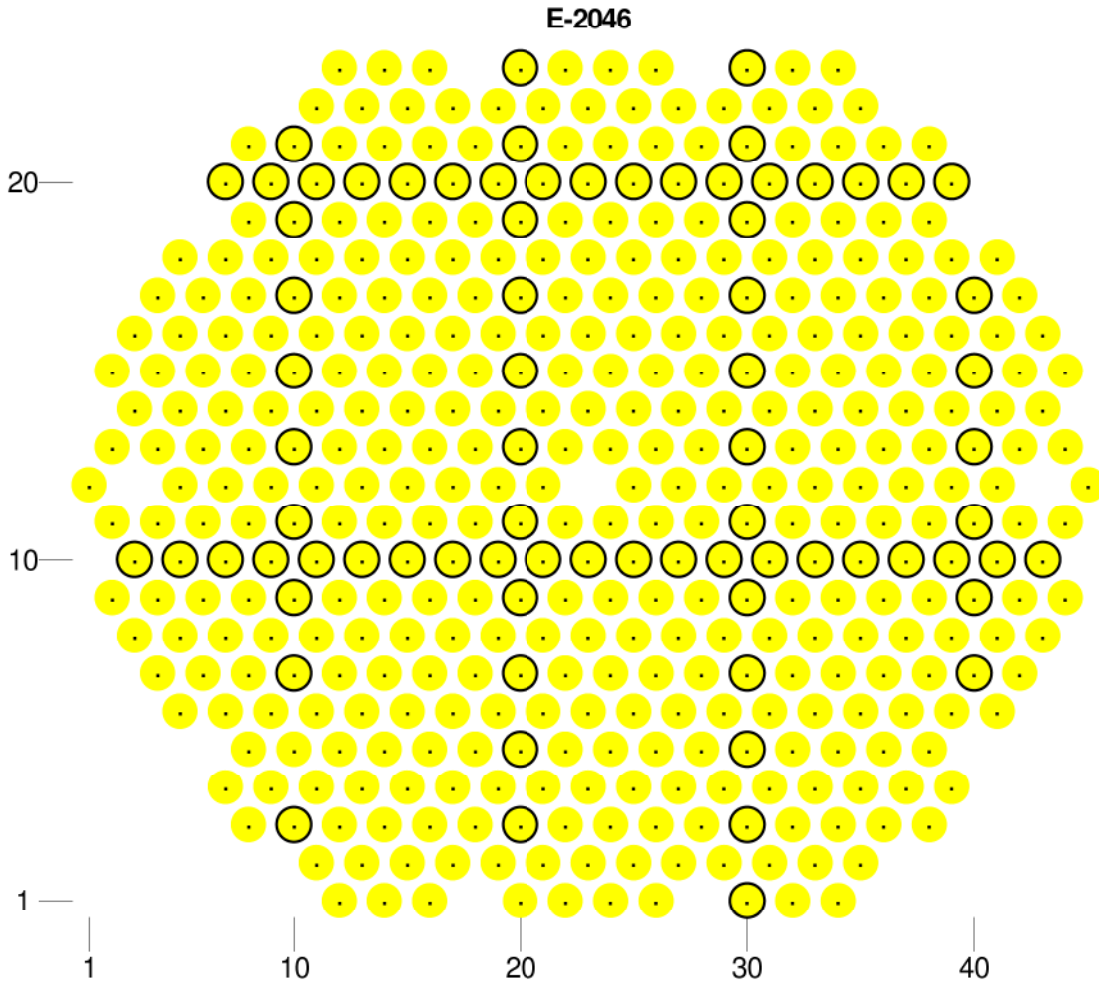
APPENDIX 02

No defects indications were found within the E-2046 Glycol Inlet Trim Cooler. Minor indications were noticed with Magnetic-Bias inspection; however for confirmation these were not confirmed by using the Remote Field and IRIS inspection techniques.

internal defects

- ① 10 % - 19 %
- ② 20 % - 29 %
- ③ 30 % - 39 %
- ④ 40 % - 49 %
- ⑤ 50 % - 59 %
- ⑥ 60 % - 69 %
- ⑦ 70 % - 79 %
- ⑧ 80 % - 89 %
- ⑨ 90 % - 100 %

external defects

view : Outlet

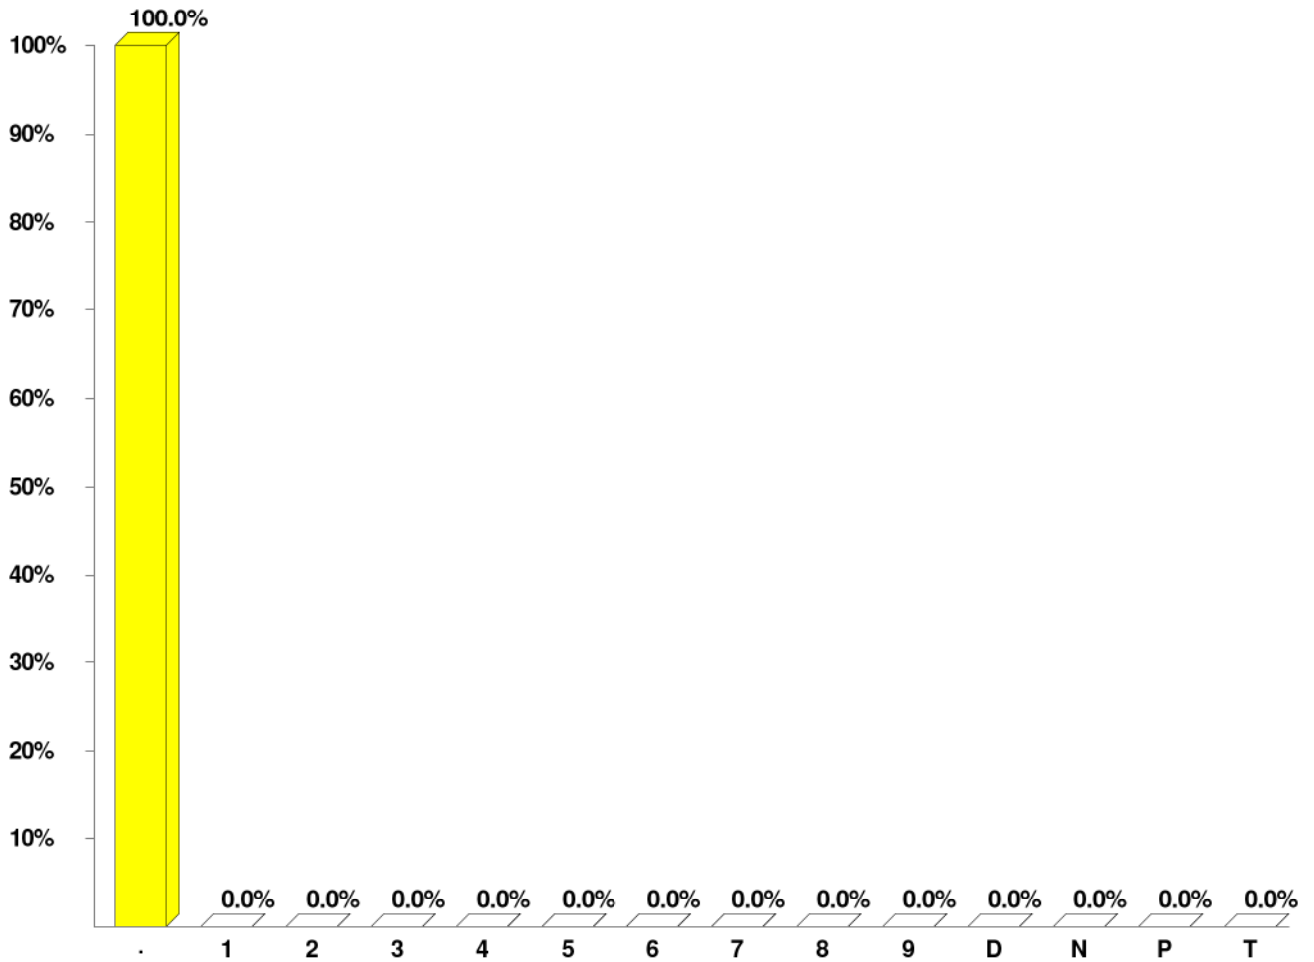
**E-2046 - Statistic
final result - all section
(100% = all tubes)**

[1] : all tubes	414		
[2] : all tubes with indication	0	0.0% from [1]	
[3] : all inspected tubes	414	100.0% from [1]	
internal defects	number	% [1]	% [2] % [3]
1 10 % - 19 %	0	0.0	0.0
2 20 % - 29 %	0	0.0	0.0
3 30 % - 39 %	0	0.0	0.0
4 40 % - 49 %	0	0.0	0.0
5 50 % - 59 %	0	0.0	0.0
6 60 % - 69 %	0	0.0	0.0
7 70 % - 79 %	0	0.0	0.0
8 80 % - 89 %	0	0.0	0.0
9 90 % - 100 %	0	0.0	0.0
external defects	number	% [1]	% [2] % [3]
1 10 % - 19 %	0	0.0	0.0
2 20 % - 29 %	0	0.0	0.0
3 30 % - 39 %	0	0.0	0.0
4 40 % - 49 %	0	0.0	0.0
5 50 % - 59 %	0	0.0	0.0
6 60 % - 69 %	0	0.0	0.0
7 70 % - 79 %	0	0.0	0.0
8 80 % - 89 %	0	0.0	0.0
9 90 % - 100 %	0	0.0	0.0
	number	% [1]	% [2] % [3]

- No Defect	414	100.0	100.0
D Dent	0	0.0	0.0
N Not Decidable	0	0.0	0.0
I No Throughpass of Probe	0	0.0	0.0
P Existing Plug(s)	0	0.0	0.0
○ Tube Not To Be Inspected	0	0.0	0.0
● Tube To Be Inspected	0	0.0	0.0
V Additional plug(s) required	0	0.0	0.0
X Extra Plugging Requested	0	0.0	0.0

Plug criteria
 internal defects : From: 40%
 external defects : From: 40%
 D, T

updated:
 plugged tubes: 0 0.0%
 available tubes: 414 100.0%
