EddyMax™ Tube Inspection

Items Inspected: Inlet Heater

Inspection Method: Eddy Current Tube Inspection

Type of Report: Final Report

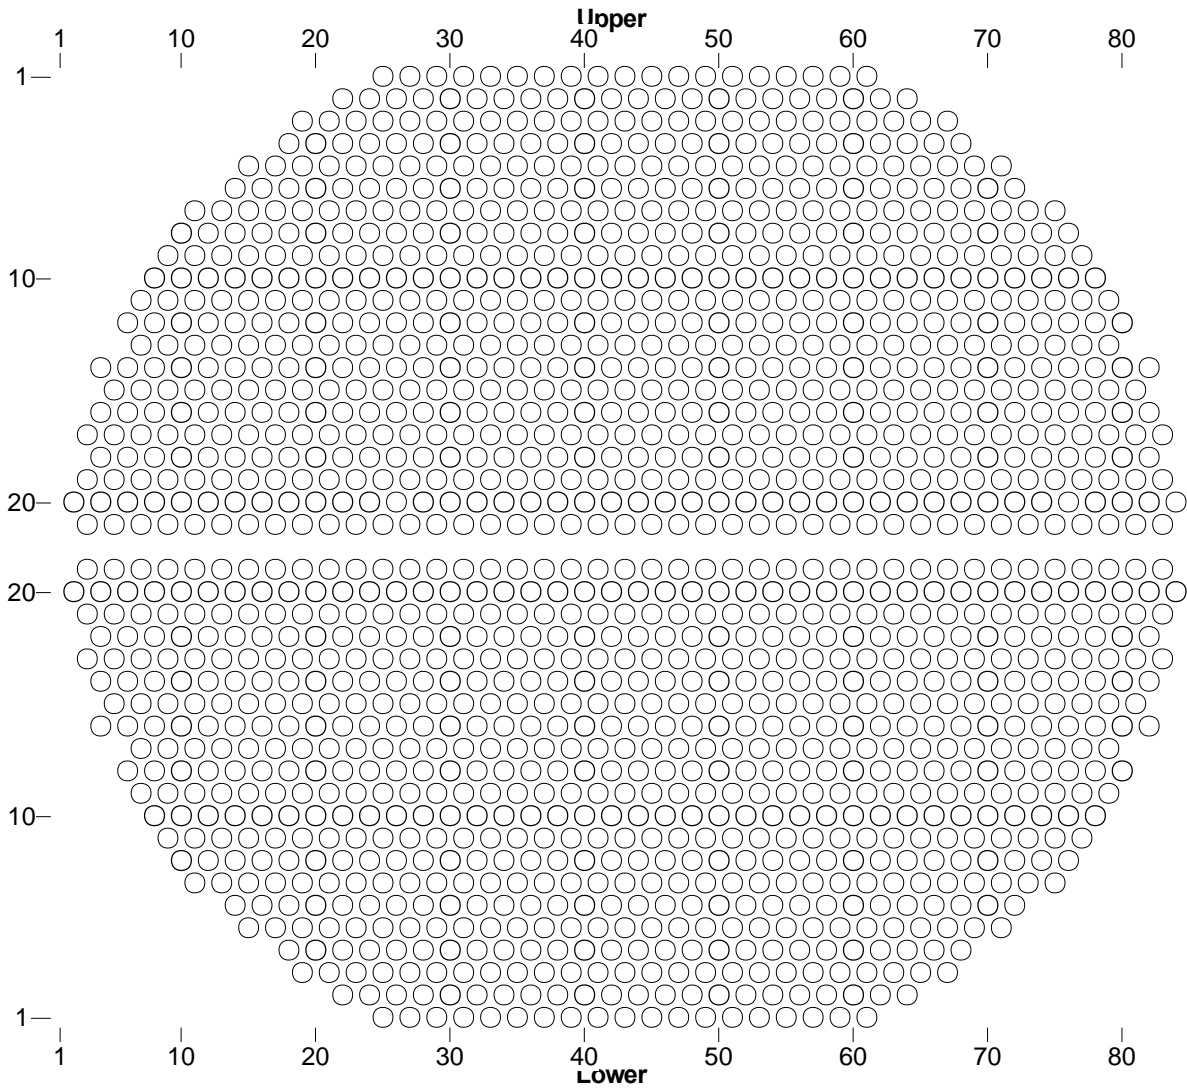
Abbot Inlet Heater Tube Array

Despite the reduction in the probe diameter (and fill factor), it can be seen that a total of 188 tubes still refused to allow a successful bobbin probe through-pass.

The Multiple Frequency Eddy Current Tube inspection indicated 77 tubes, where internal pitting was detected.

[1] : all legs	1450			
[2] : all legs with indication	265		18.3% from [1]	
[3] : all inspected legs	1450		100.0% from [1]	
internal defects	number	% [1]	% [2]	% [3]
① 10 % - 19 %	0	0.0	0.0	0.0
② 20 % - 29 %	38	2.6	14.3	2.6
③ 30 % - 39 %	26	1.8	9.8	1.8
④ 40 % - 49 %	13	0.9	4.9	0.9
⑤ 50 % - 59 %	0	0.0	0.0	0.0
⑥ 60 % - 69 %	0	0.0	0.0	0.0
⑦ 70 % - 79 %	0	0.0	0.0	0.0
⑧ 80 % - 89 %	0	0.0	0.0	0.0
⑨ 90 % - 100 %	0	0.0	0.0	0.0
external defects	number	% [1]	% [2]	% [3]
① 10 % - 19 %	0	0.0	0.0	0.0
② 20 % - 29 %	0	0.0	0.0	0.0
③ 30 % - 39 %	0	0.0	0.0	0.0
④ 40 % - 49 %	0	0.0	0.0	0.0
⑤ 50 % - 59 %	0	0.0	0.0	0.0
⑥ 60 % - 69 %	0	0.0	0.0	0.0
⑦ 70 % - 79 %	0	0.0	0.0	0.0
⑧ 80 % - 89 %	0	0.0	0.0	0.0
⑨ 90 % - 100 %	0	0.0	0.0	0.0
	number	% [1]	% [2]	% [3]
● No Defect	1185	81.7		81.7
○ Dent	0	0.0	0.0	0.0
○ Not Decideable	0	0.0	0.0	0.0
⊗ No Throughpass of Probe	188	13.0	70.9	13.0
⊙ Existing Plug(s)	0	0.0		
○ Tube Not To Be Inspected	0	0.0		
● Tube To Be Inspected	0	0.0
