MEC (Extended SLOFEC) and UT Caisson Inspection Report

Client	Client
Facility	Platform xx
Items Inspected	Open Drain Caisson x
Inspection Method	MEC (Extended SLOFEC and UT
Date Commenced	19th April 2014
Date Completed	20th April 2014
Type of Report	Final
Report Number	K xxxx

EXTERNAL CAISSON INSPECTION REPORT

Final Report: Kxxx Rev 0

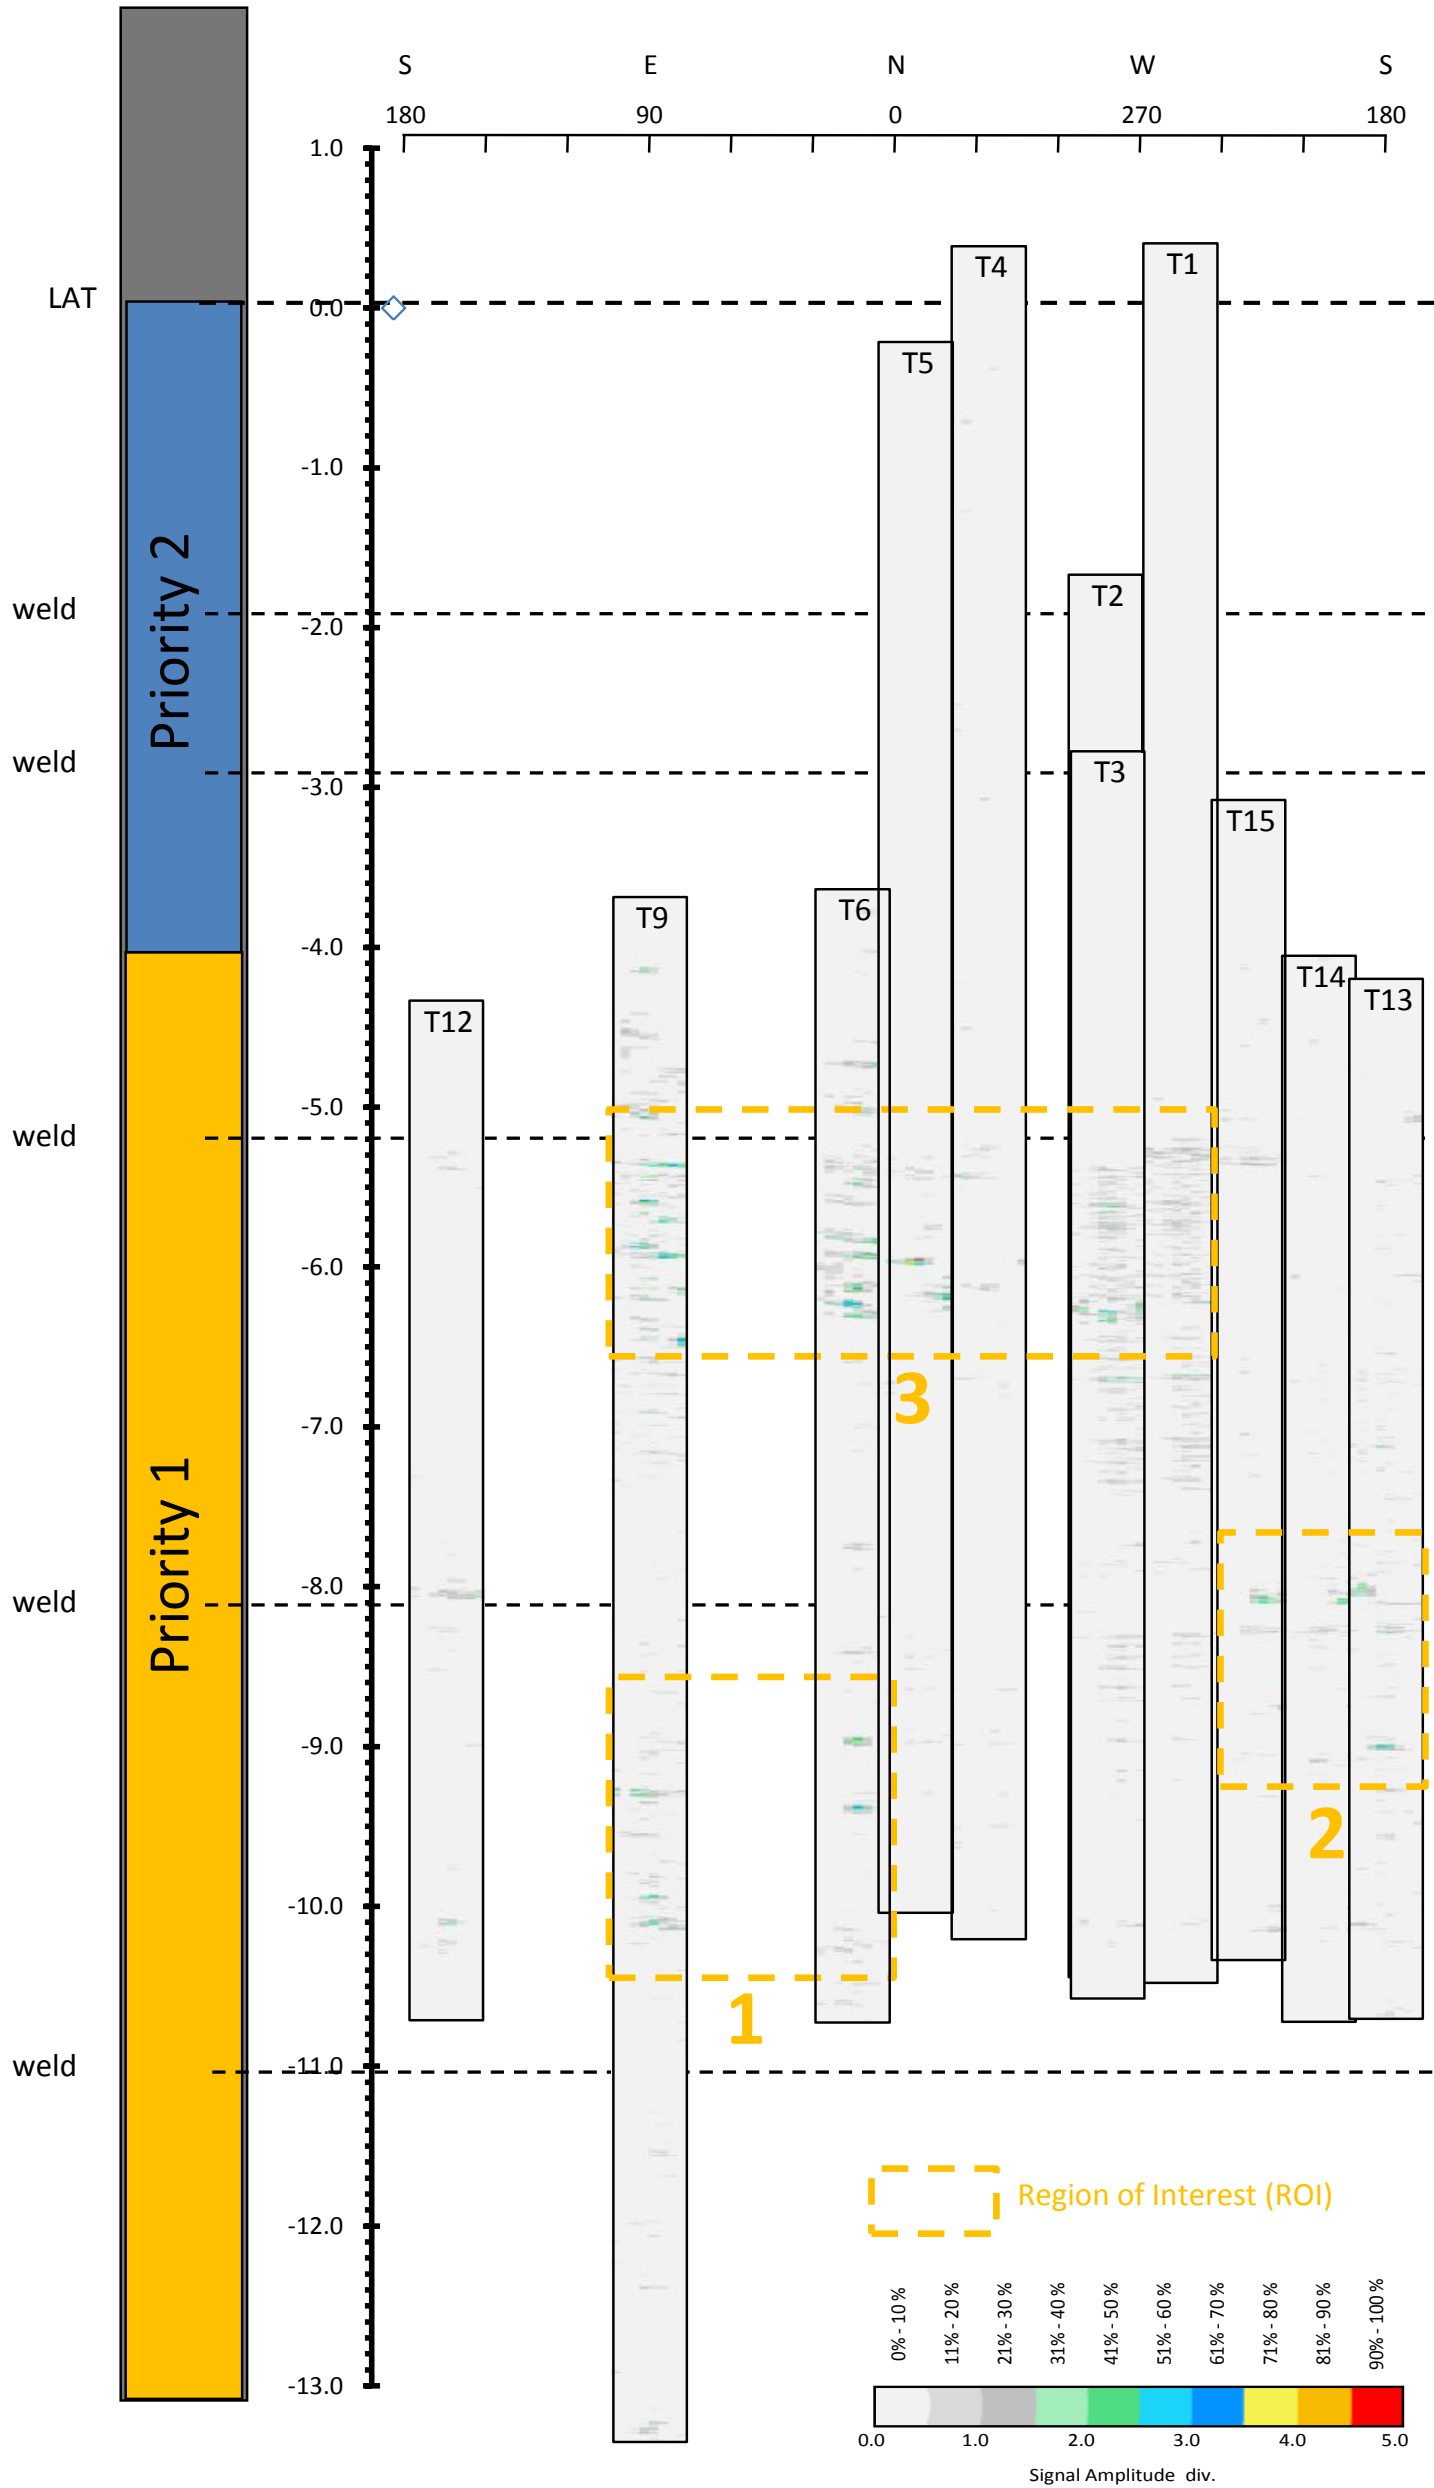
Scan Results and Track Position Overview (internal corrosion)

Several severe indications of internal metal loss have been found. They are isolated pitting type indications. The wall thickness in between these indications seems to be unaffected. The typical size of these indications is in the region of 20-30 mm with wall loss readings in the order of 60% - 90%. None of them seems to have grown through the surface. However, the depth of the deepest of these indications seems to be close to a through hole.

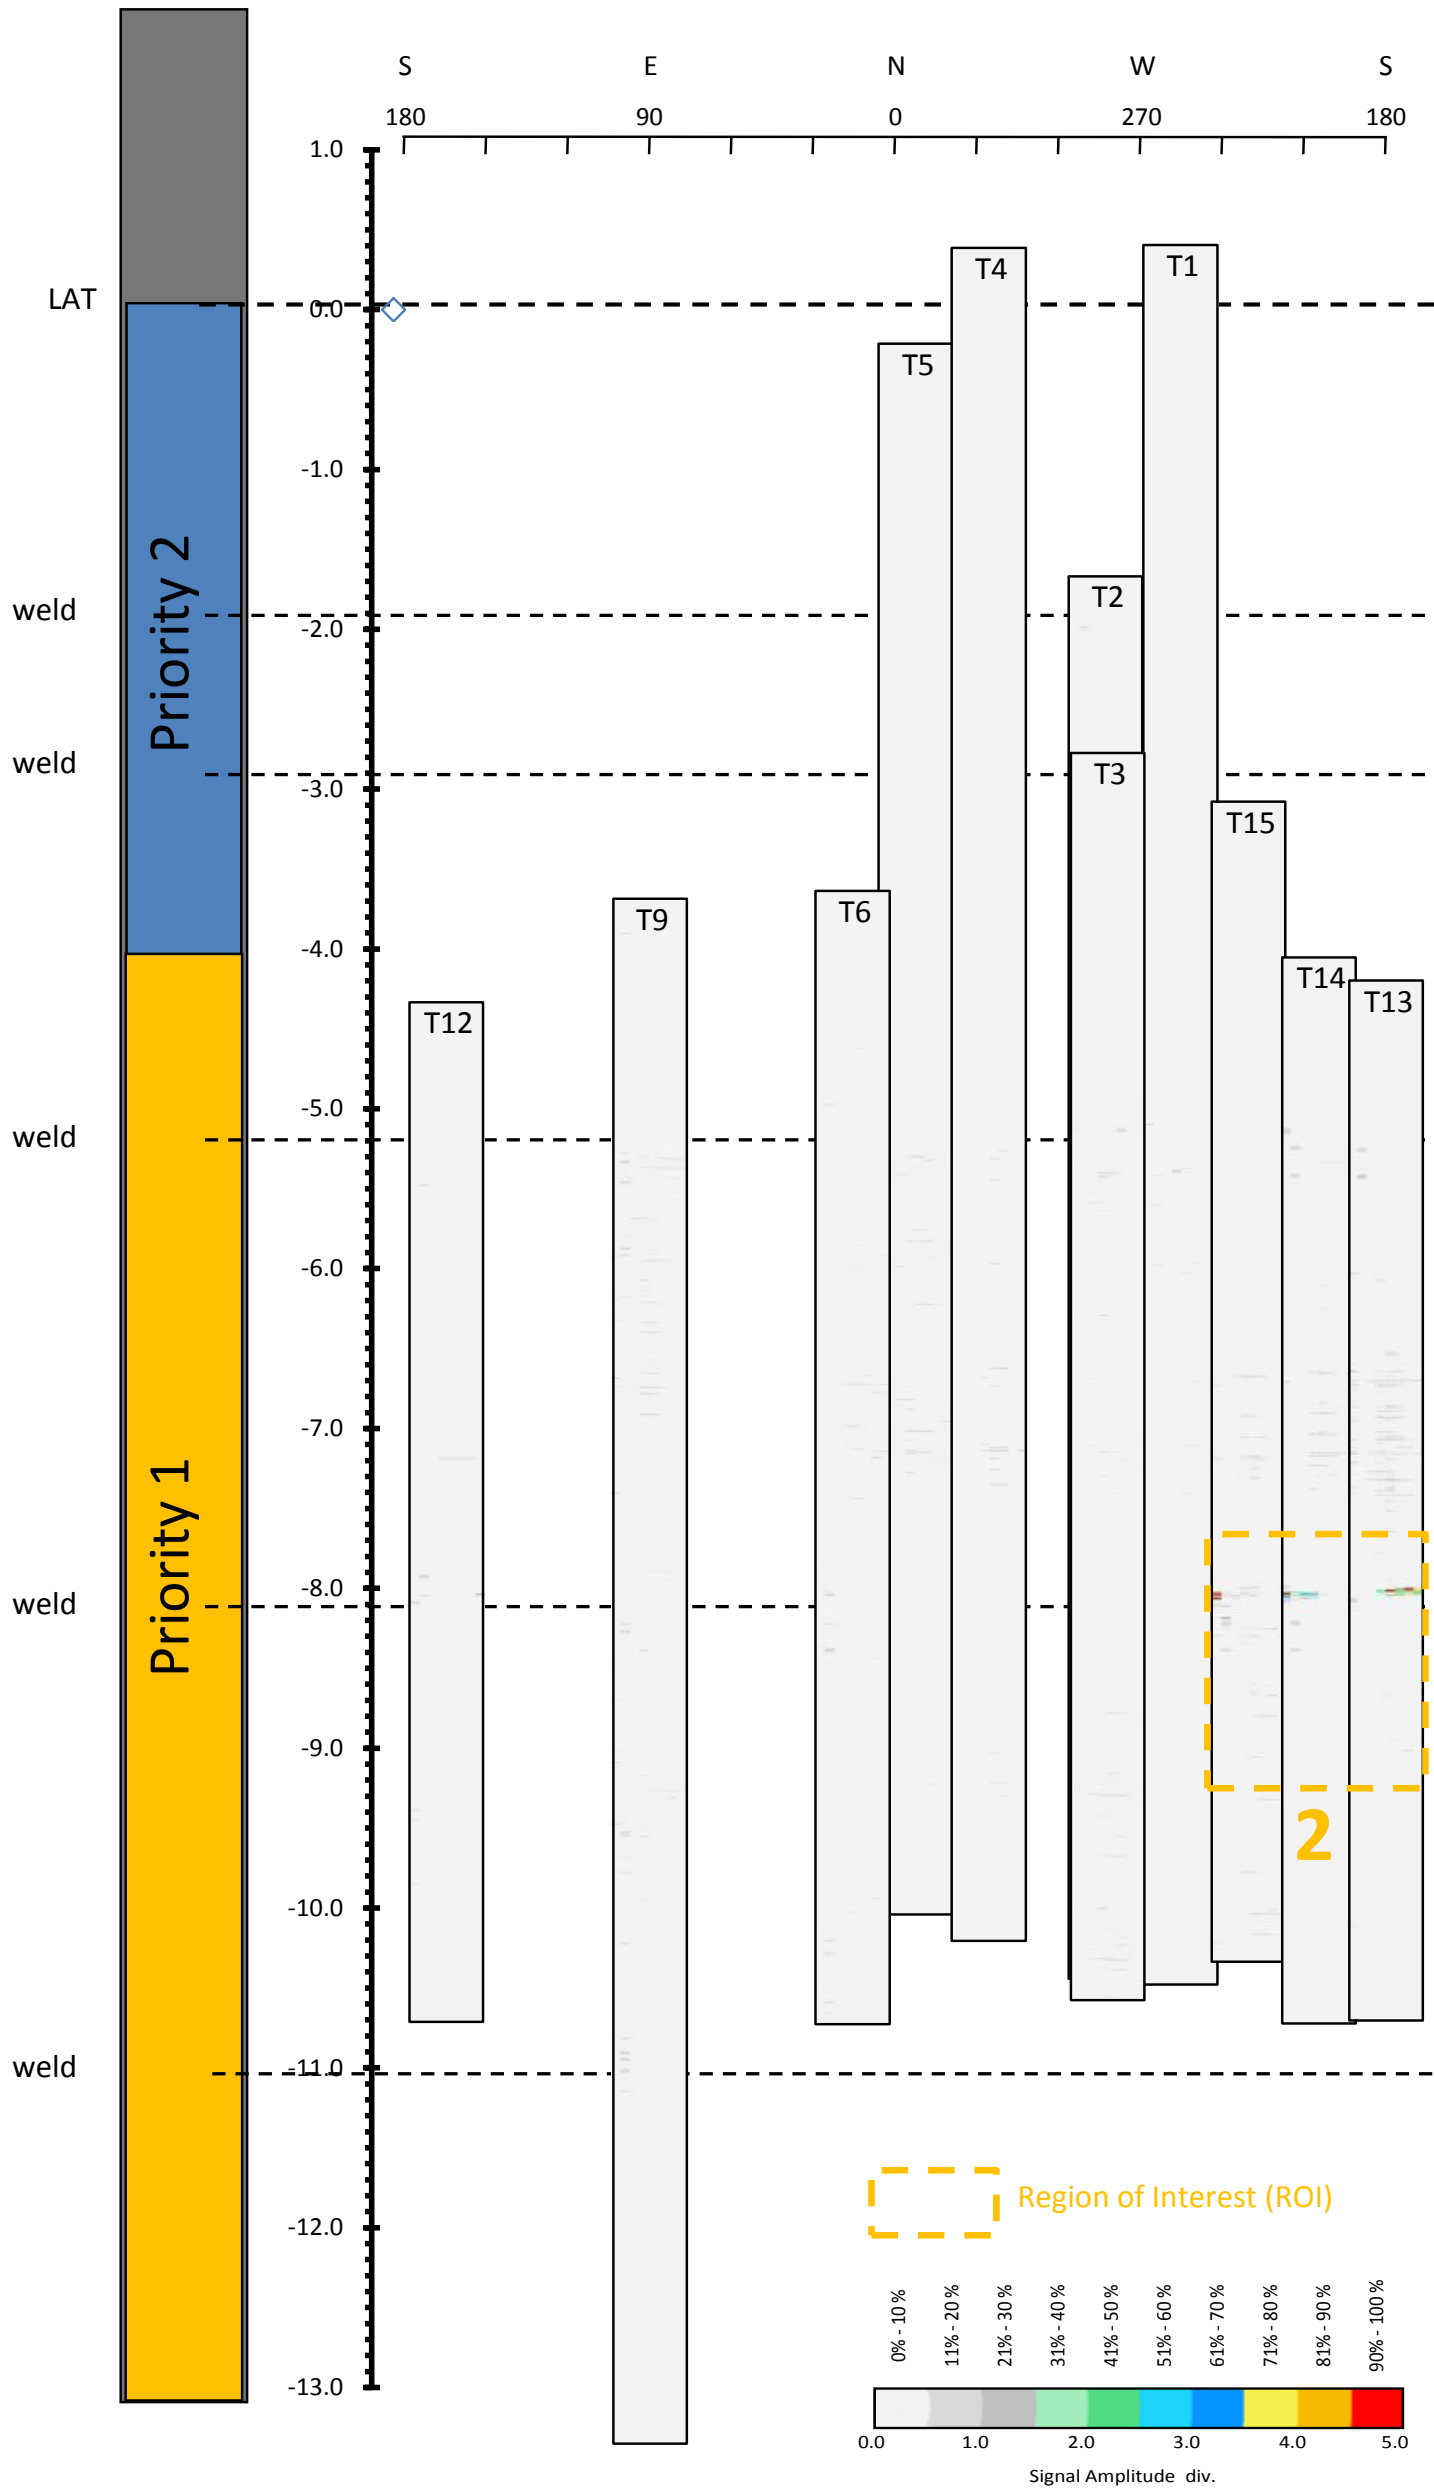
Scan Results and Track Position Overview (external corrosion)

In addition a severe indication was found immediately above the weld at -8 m (see Figure 11). The components are marked 2.6 to 2.8 in the table. In the MEC-Data it appears internal and external. In some areas the depth of the indication is rated to 100% meaning that it has grown to the outside. It can clearly be assigned to an area observed in the video data. The section is shown in Figure 11. The area is marked in red and also shows a through hole since water in- and outflow has been observed in the corresponding video footage. The axial extend of the indication is in the order of 50 mm. It runs in the circumference for some 50 cm.
