MEC Conductor Inspection Report

Client: OIL COMPANY

Facility: Oil Field WHT

Items Inspected: WHT01
30" Conductors No. 1-3

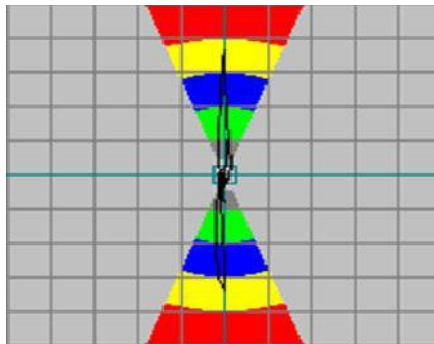
Figure 1: Sample signal display of internal defect

The differential channels of all the sensors were set so that internal defects were indicated in the vertical signal phase direction as shown in Figure 1. By moving the scanner in the positive forward direction, the internal defect signal would show the first peak down, followed by the second peak up with an upward movement.

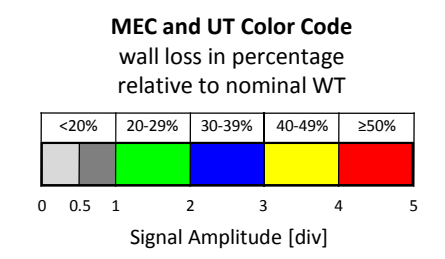
WHT Conductor 2 - Section 3 Wall Loss Condition Map

Results:
 Large internal metal loss at -4.75 m.
 Estimated depth: 60%.
 Large external metal loss at -4.65 m.
 Estimated depth: 45%.

Remarks:
 Four tracks could not be done due to obstacles (lifting pad eyes)
