Platform / Riser	Flexible Riser Inspection Report	Report: No Kxxxx-xx

FLEXIBLE RISER EXTERNAL INSPECTION REPORT

Using MEC-FIT™

Final Report: Kxxx-xx

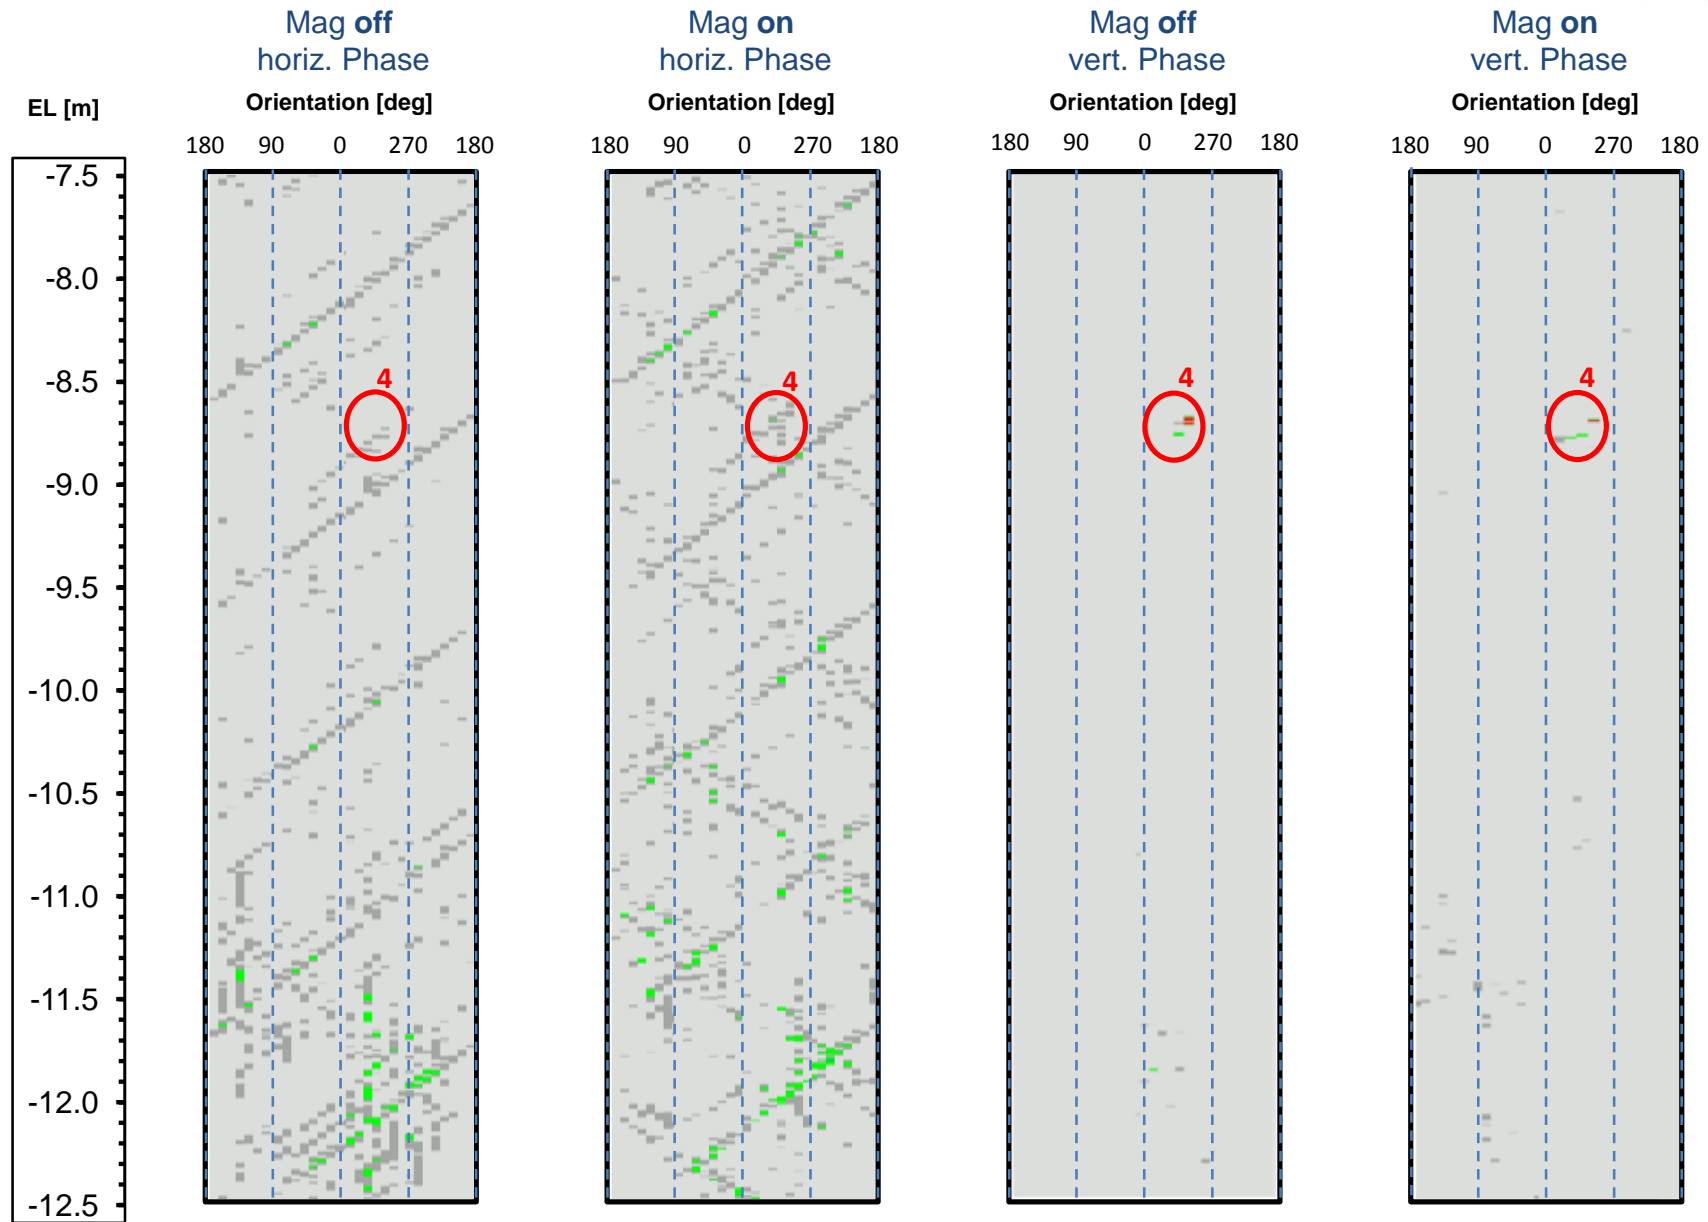
Riser Section 4 (EL -12.5 m to EL -7.5 m)

Ind.	EL [m]	Orientation [deg]	Length [mm]	Width [mm]	Depth % of one wire thickness	Affected wires	Description
1	+0.2	300	20	20	0-25	1-2	Surface corrosion
2	-1.1	315	500	100	0-25	>10	Surface corrosion
3	-4.5	270	400	300		1-2	Surface wire misalignment
4	-8.7	300	<5	20	25-50	1	Crack-like indication

The signal of indication 3 is shown in Figure 9. It is a very localised indication. The appearance indicates a crack in a single wire. The signal is only seen on a single sensor. The crack is likely to be at least 50% through the thickness of the outer armour layer. The signal remains with the magnet off. Hence it grows from the outside. A completely snapped wire would produce a larger signal.
