Client	Combined MEC™ Inspection with video	Page 1 of 9
Caisson	MEC™ Internal Caisson (marinised) Inspection Report	Report:J1739

Executive Summary

Innospection has carried out an internal **Magnetic Eddy Current (MEC)** inspection on the client's caisson. MEC is the next generation and improved version of **Saturation Low Frequency Eddy Current (SLOFEC™)**. This report details the inspections which were carried out during the inspection campaign.

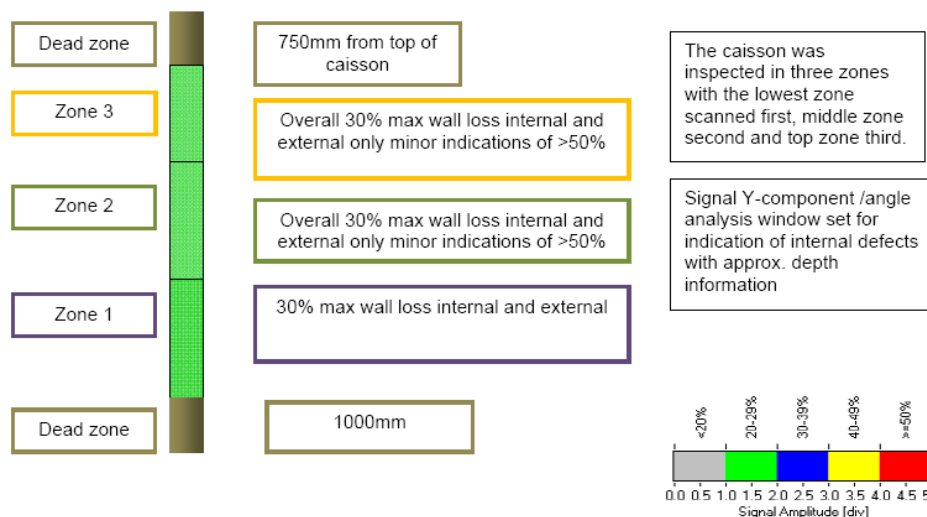
No.	Pipe zone No.	Caisson Length (mm)	Comments	Max % Wall Loss in Pipe Section	Overview
1	1	15,000	External Corrosion	<30%	Mainly small corrosion areas approx. 10-20mm Very minor indications >50%
2	1	15,000	Internal Corrosion	<30%	Mainly small corrosion areas approx. 10-20mm Very minor indications >50%
3	2	15,000	External Corrosion	<30%	Mainly small corrosion areas approx. 10-20mm Very minor indications >50%
4	2	15,000	Internal Corrosion	<30%	Mainly small corrosion areas approx. 10-20mm Very minor indications >50%
5	3	6,000	External Corrosion	<30%	Mainly small corrosion areas approx. 10-20mm
6	3	6,000	Internal Corrosion	<30%	Mainly small corrosion areas approx. 10-20mm

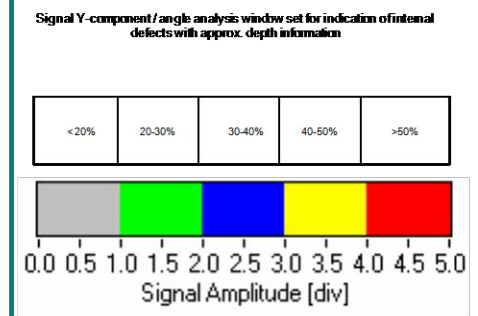
External Scan Report Zone 1

No severe wall losses:
Maximum wall loss up to 30%. Very minor indications of >50% wall loss (In comparison to calibration)

Very small amount of red indications highlighted with red circles are >50% max wall loss
