MEC™ TANK FLOOR INSPECTION

Client: Client a

Facility: site b

Items Inspected: Tank c

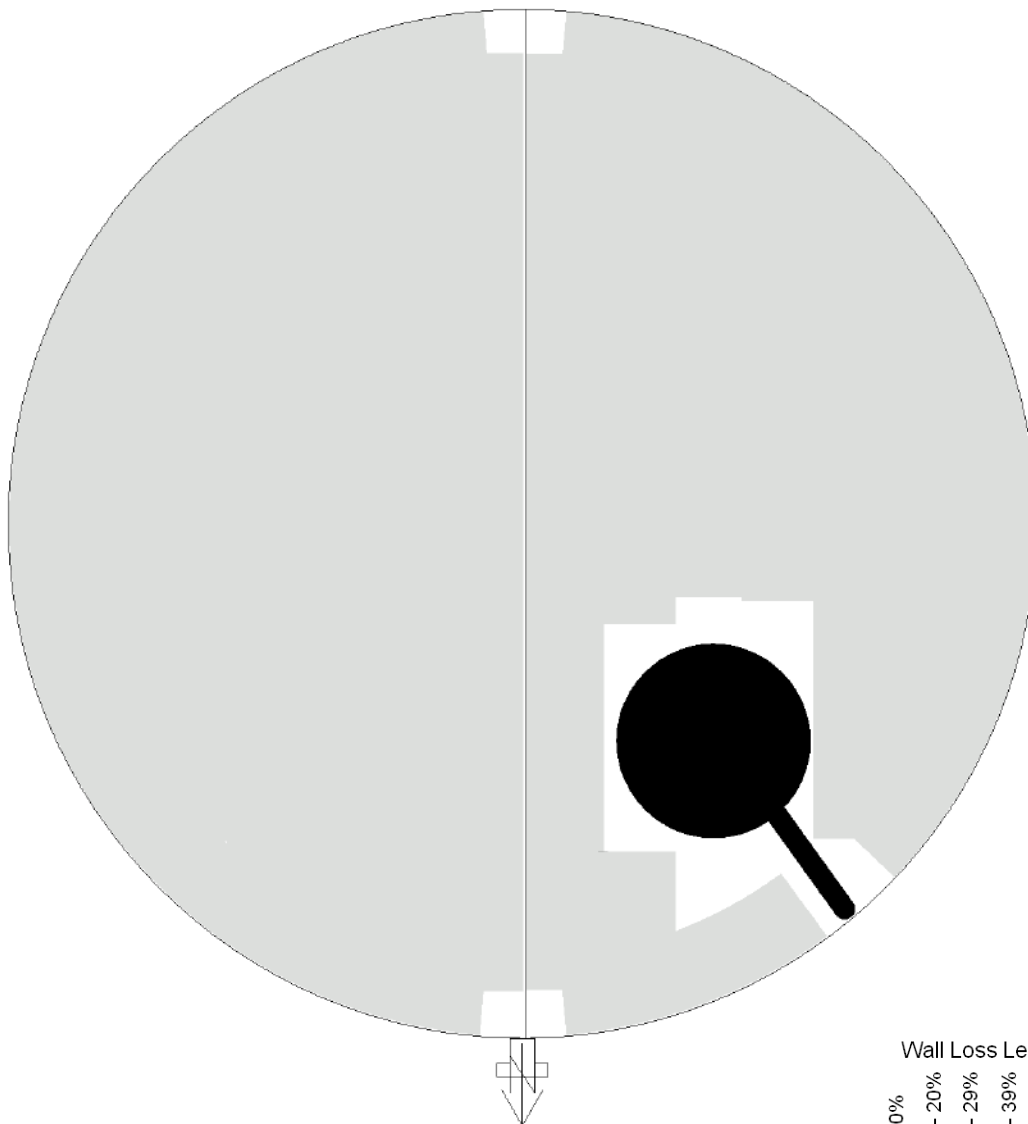
Underside View

No significant defect indications were detected during the inspection.

No significant defect indications were detected during the inspection, several minor indications were observed in a close proximity to the circumferential weld and either side of the central weld seam. These were marked up and inspected with ultrasound.
