INSPECTION REPORT

Facility: Platform Legs

Item Inspected: B2, K2 and K3

SLOFEC™/UT Inspection of Platform Legs

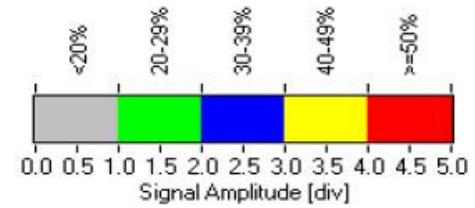
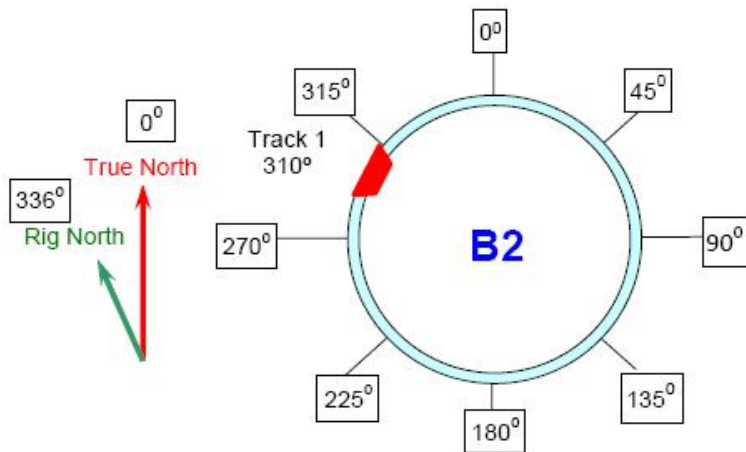
Signals were analysed and no defects were detected. No severe wall loss detected as the indicated signals were above tolerance levels.

Elevation corrected +0.5m for UT Sensor

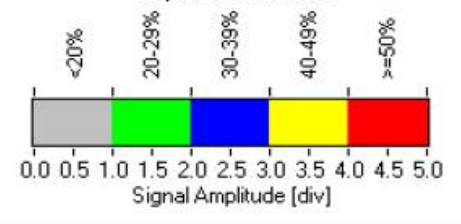
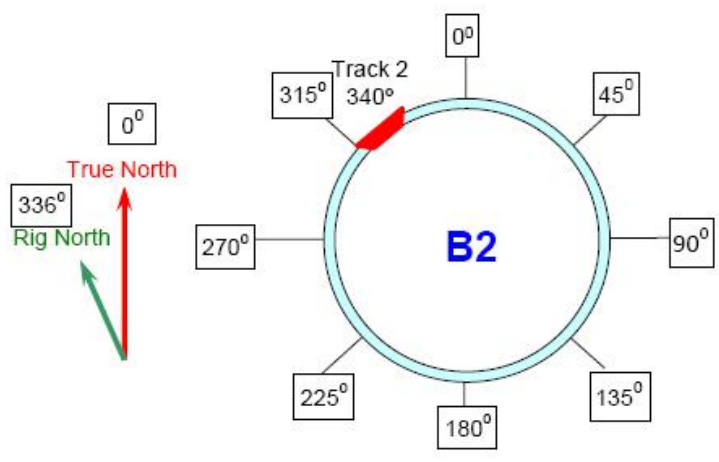
REMARKS:
 Signals were analysed and no defects were detected. No severe wall loss detected as the indicated signals were above tolerance levels.

Elevation corrected +0.5m for UT Sensor offset

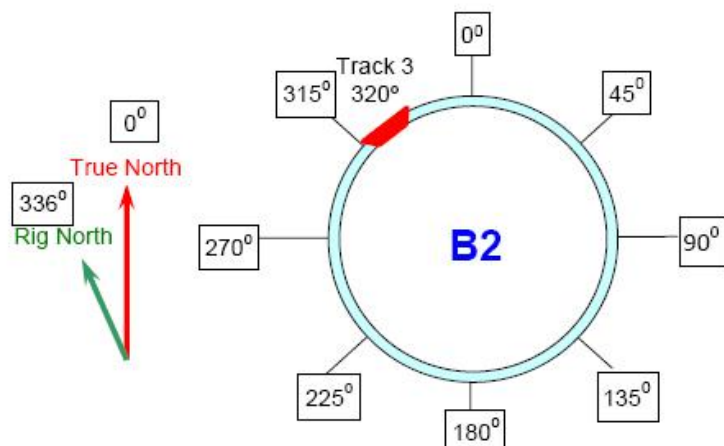
Signals were analysed and no defects were detected. No severe wall loss detected as the indicated signals were above tolerance levels.

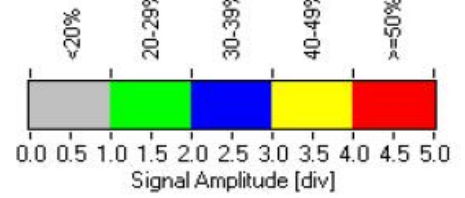
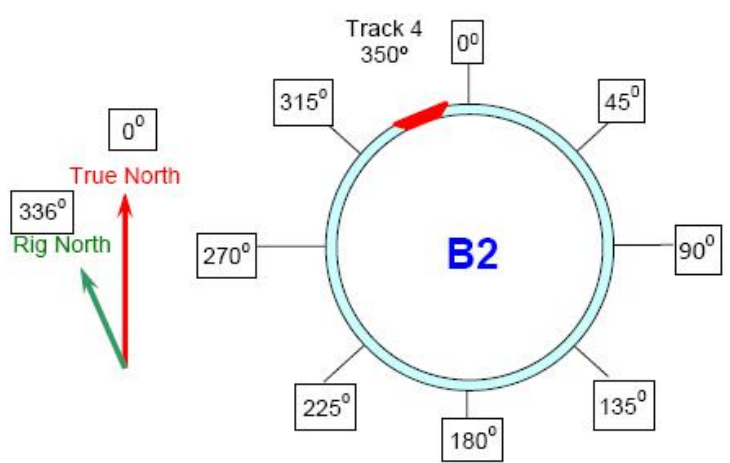
Signals were analysed and no defects were detected. No severe wall loss detected as the indicated signals were above tolerance levels.

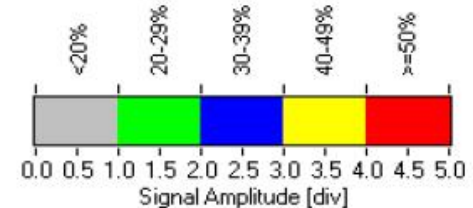
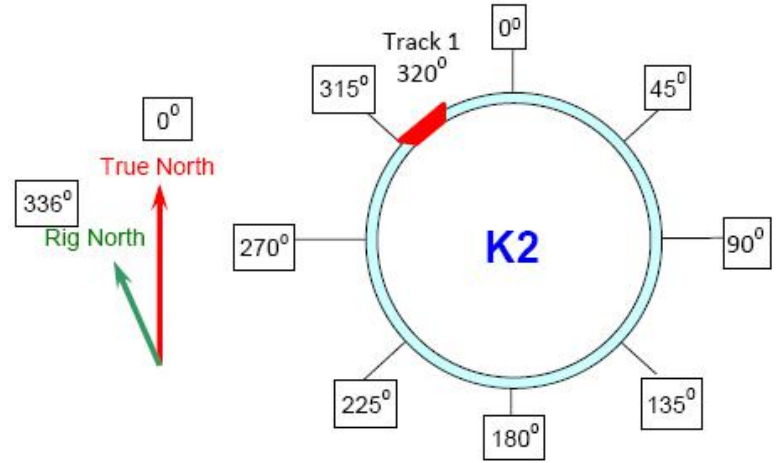
REMARKS:
 Signals were analysed and no defects were detected. No severe wall loss detected as the indicated signals were above tolerance levels.

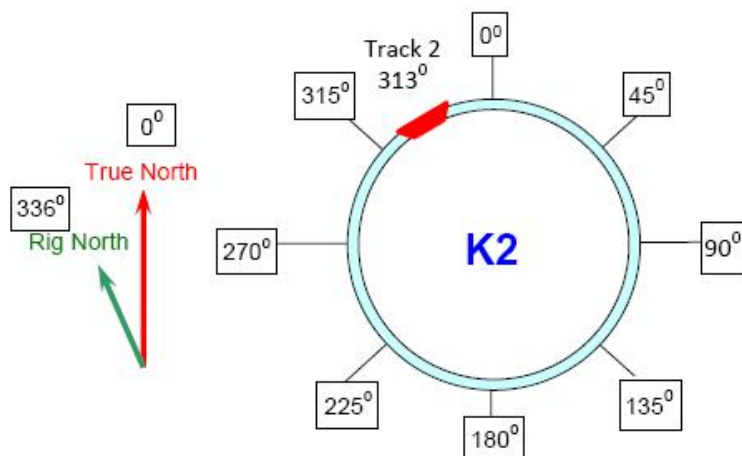
Signals were analysed and no defects were detected. No severe wall loss detected as the indicated signals were above tolerance levels.

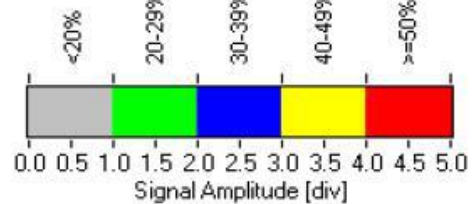
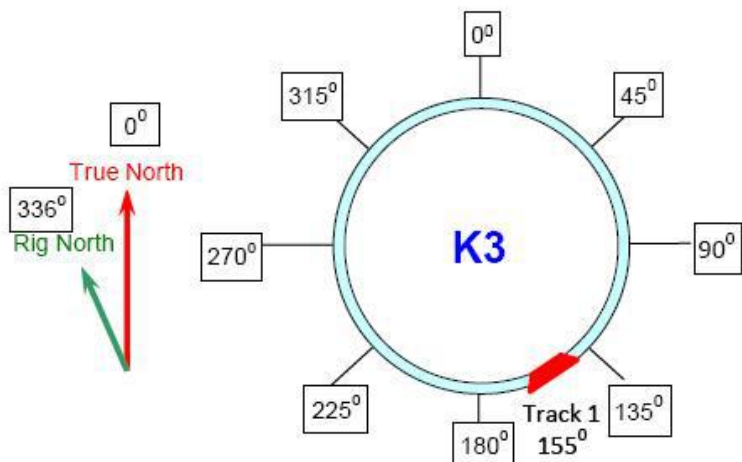
Signals were analysed and no defects were detected. No severe wall loss detected as the indicated signals were above tolerance levels. No severe external or internal wall losses detected. Area scanned is approx 3 m long. The scan starts at minus 8.5 m to minus 11.5 m. The nominal wall thickness in the scanned area is 44 mm. The area scanned was the cleanest part of the run. Unable to scan higher as surface not clean enough. Area was jet cleaned by Lynx and not by the Fugro crawler as this was unsuccessful. We will not be doing anything above the splash zone at this time.

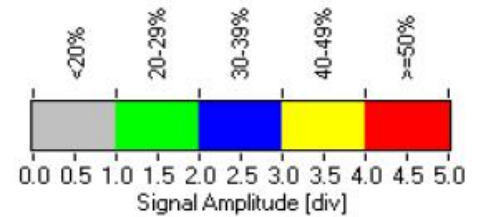
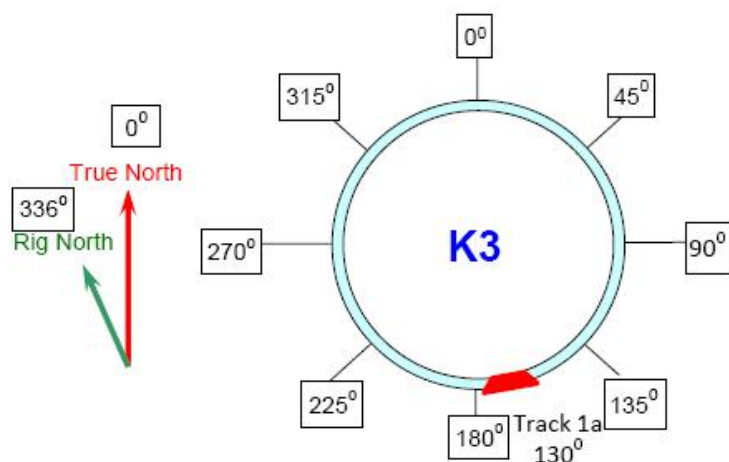
Signals were analysed on other tracks and no defects were detected.
No severe wall loss detected as the indicated signals were above tolerance levels.

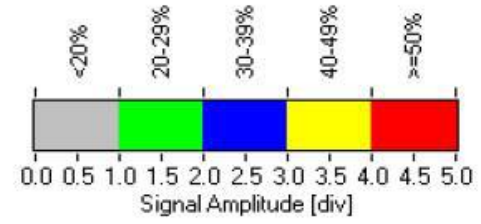
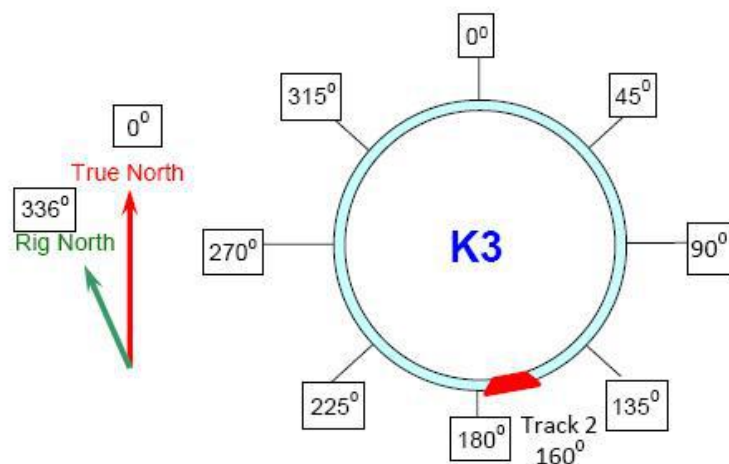
Signals were analysed on other tracks and no defects were detected.
No severe wall loss detected as the indicated signals were above tolerance levels.

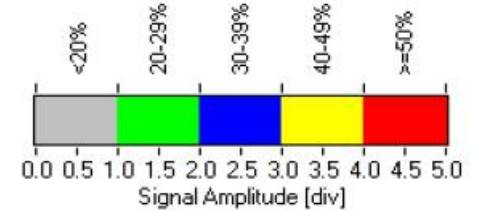
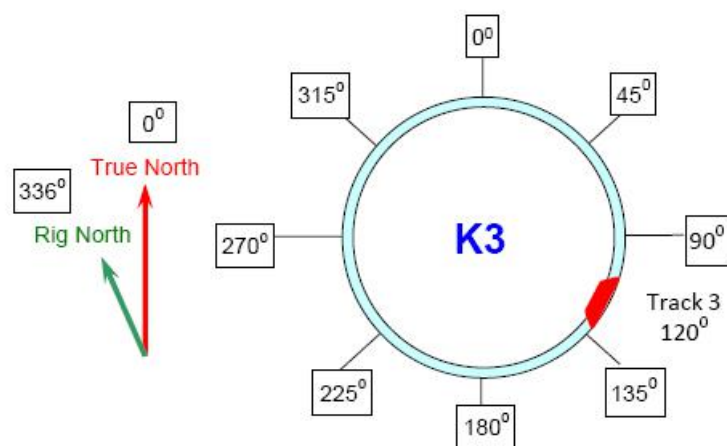
Signals were analysed and no defects were detected. No severe wall loss detected as the indicated signals were above tolerance levels.

No UT readings, Tool fell off after -10 m
