SLOFEC™ Technique for Tank Scanning

One of the main applications of Innospection's SLOFEC™ technique is the inspection of storage tanks.

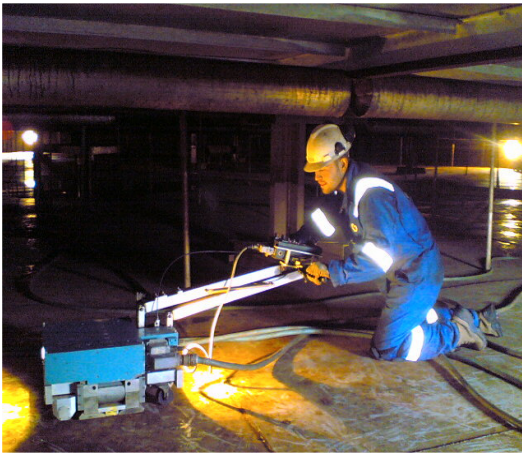
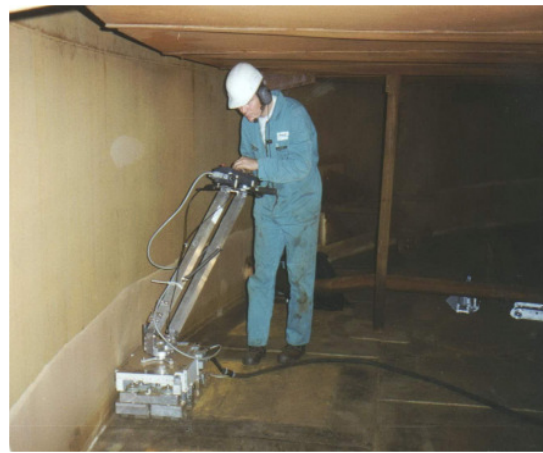
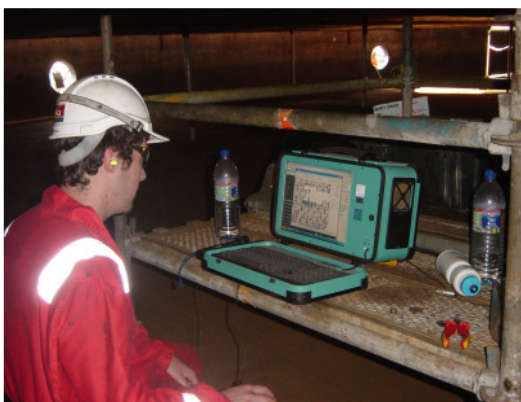
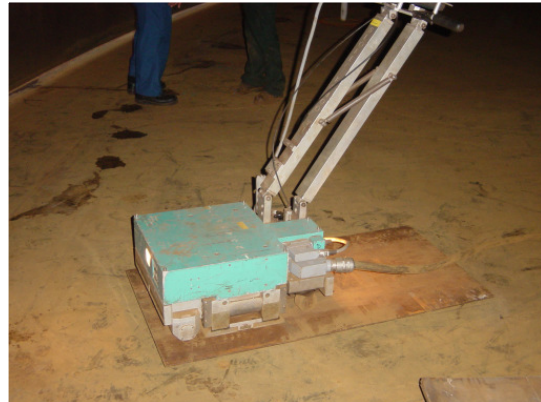
The technique has been proven in the field as a high speed and reliable method in detecting local corrosion in storage tanks.

The SLOFEC capabilities in tank inspection include the following:

- Experienced with inspection up to 35mm wall thickness
- Experienced with inspection of coating up to 10mm
- Experienced with inspection of tanks with temperature up to 150 deg C
- Inspection of stainless steel tanks, carbon steel and non-ferrous tanks
- Inspection of lined and unlined tank floors
- Inspection and detection of corrosion at overlap welds in lined tanks
- Differentiation of top and underside defects through separate mapping
- Computer Aided Mapping with high speed results
- Comprehensive inspections, acquisition and interpretation of NDT data, tank life forecasts, repair recommendations and high quality reports (as per EEMUA 159 & API 653)

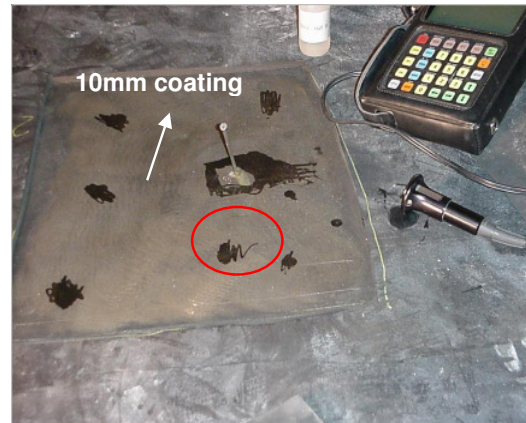
Example 1: Tank floor inspection

Tankfloor : Chemical Plant
Plate thickness : 12mm
Coating : rubber, 10mm thick

Detected Defects:

- Corrosional pits from the underside
- 20 – 30% loss
- Additional through holes found
- Defects confirmed by Ultrasonic Testing

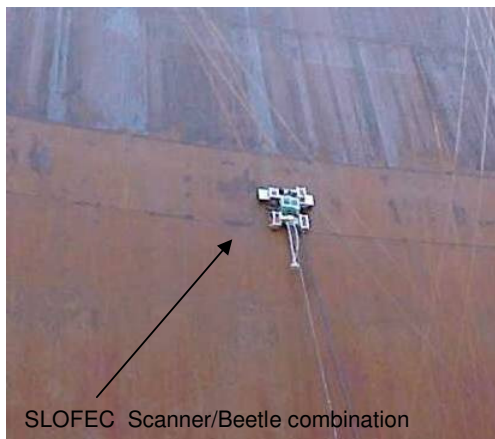
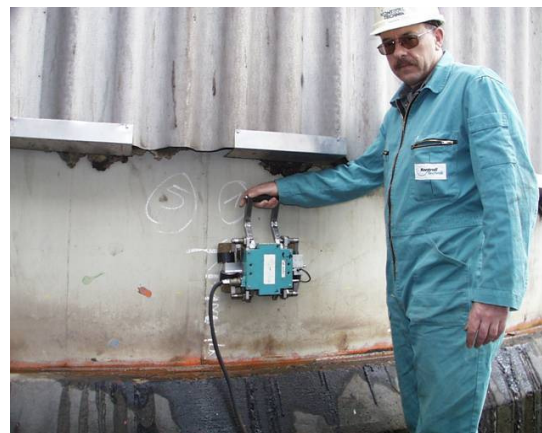
Example 2 : Tank wall inspection

Tank shell : general tank shell
Detected Defects : isolated pits and general

The reporting software also allows the colour display of the individual section as well as for the whole tank. In addition, the various features of the software include individual defect analysis, statistical defect analysis, repair plate modes, the addition of other results such as Ultrasonic verifications and more.

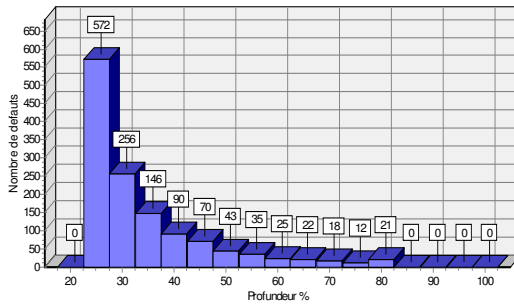
No. of defects detected: Topside

More interesting is the easy handling of the reporting software, setting of the required or changed colour levels and defect severity display. Diagram 2 shows a statistical overview of the inspection results and Diagram 3 shows the repair plate report and repair plate list.

Diagram 2: Inspection Result Statistical Overview

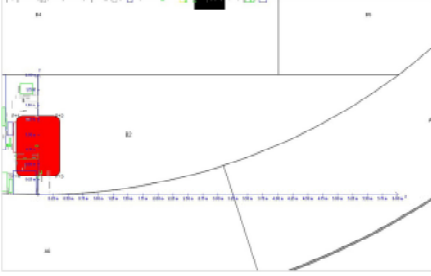
Diagram 3: Repair Plate Report & Repair Plate List

SLOFEC™
Inspection - Repair Plates

Reference Plate : B2	
Width	: 0.72 m
Height	: 1.00 m
Coordinates	: X: 0.00 m Y: 0.81 m
P1	: X: -0.36 m Y: 1.31 m
P2	: X: 0.36 m Y: 1.31 m
P3	: X: 0.36 m Y: 0.31 m
P4	: X: -0.36 m Y: 0.31 m
Thickness	: 5.00 mm
Material	: steel
