**SLOFEC**  
**&**  
***Specialised Ultrasonics***  
***Vessel Inspection Project***

***Platform A-***

***March 2004***

External vessel inspection VJ 20001 A  
Platform ABC  
March 2004

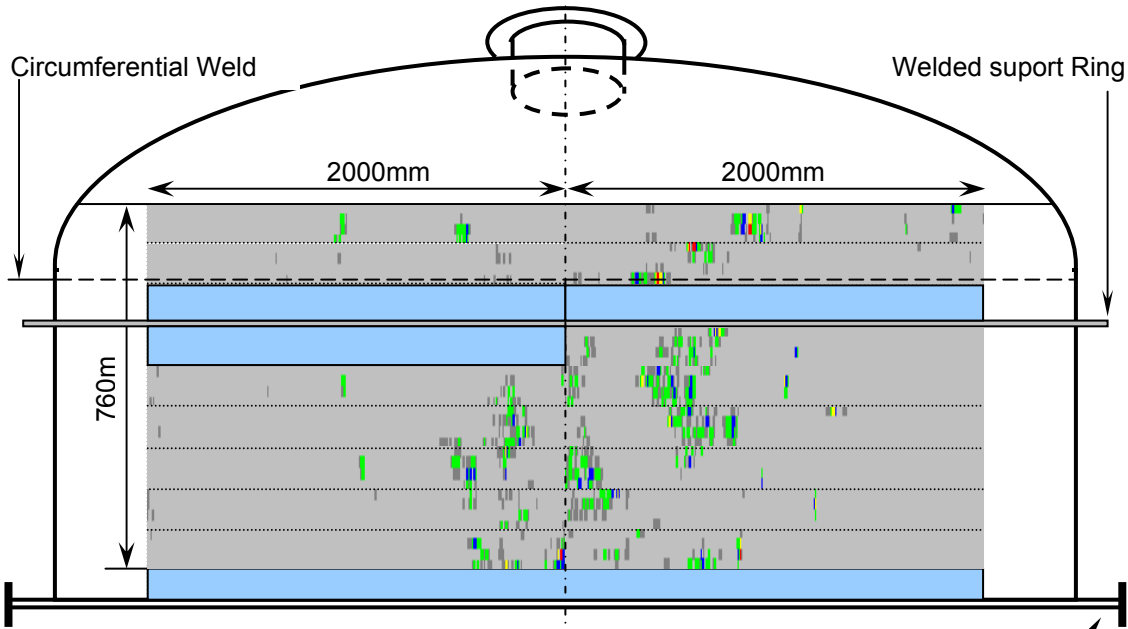
**Section Area A1**

Viewed from inside the Vessel and facing to the North

Signal Y-component / angle analysis window set for indication of internal defects with approx. depth information

Dead Zone Area

Stiffener Ring S1

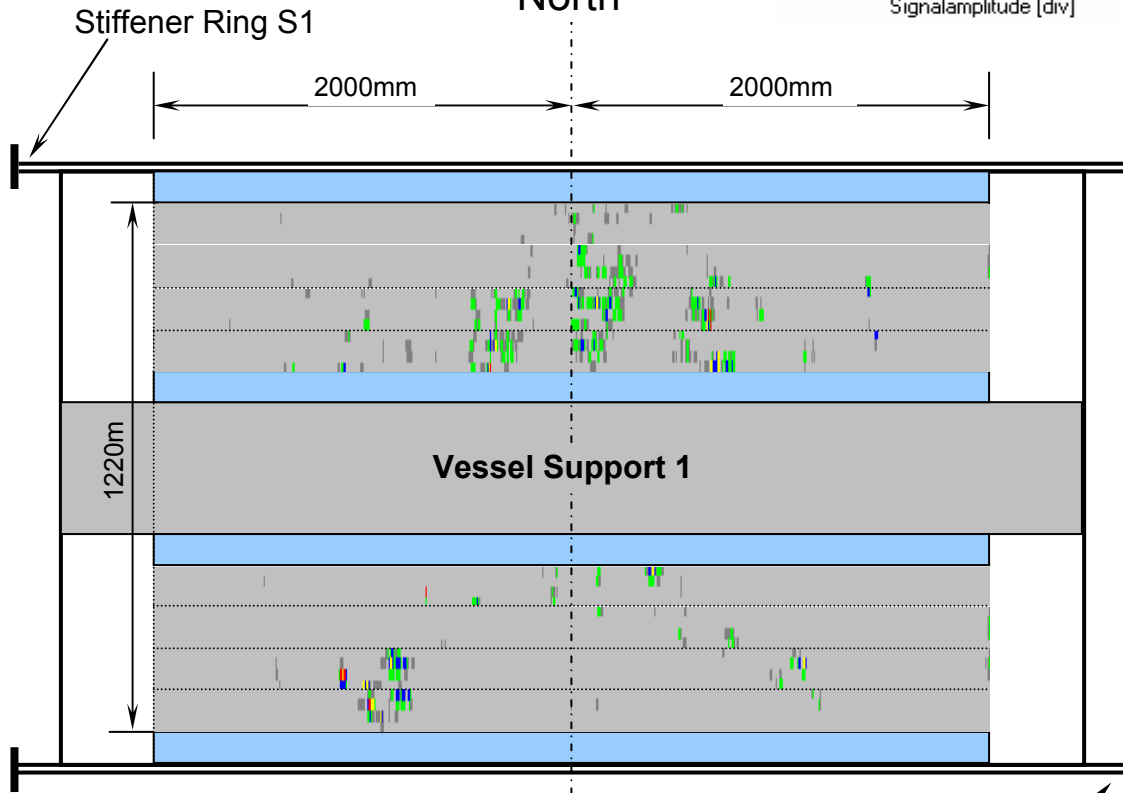
**Section Area A2**

Viewed from inside the Vessel and facing to the North

Signal Y-component / angle analysis window set for indication of internal defects with approx. depth information

Dead Zone Area

Stiffener Ring S2
